Safety Recall Launch Notification

Campaign #	NHTSA ID / CA DMV #	Description
2026010001	25V865	25P5491322

Check and Rework Transmission Wiring Harness

CAMPAIGN NO.	2026010001
CAMPAIGN DESC.	25P5491322
NHTSA ID	25V865
SUBJECT	Check and Rework Transmission Wiring Harness
MODEL(S)	AMG E 53 Hybrid 4MATIC+ (214 platform)
MODEL YEAR(S)	2025
CAMPAIGN POPULATION	117

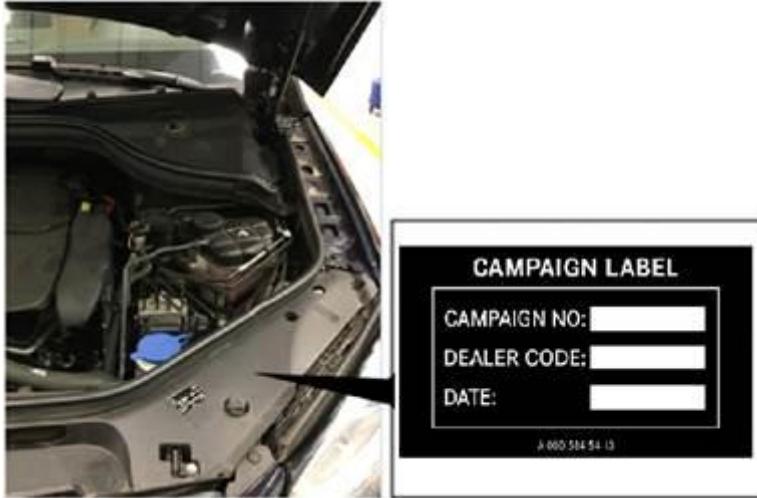
Figure 1

Apply Proof of Correction Label (A 000 584 54 13) to area identified in **Figure 1**. Fill in the blank areas of the label. The “Campaign No.” for the California Proof of Correction is unique and must be entered as such (25V865), your “Dealer Code”, and the “Date” of the repair, using a black permanent marker.
