GROUP	MODEL
Safety Recall Campaign	2023-2025MY Niro HEV, PHEV and EV (SG2 P/HEV, SG2 EV)
NUMBER	DATE
SC332 (Rev 1, 07/02/2025)	January 2025

SAFETY RECALL CAMPAIGN

FLOOR HARNESS INSPECTION AND

PROTECTIVE COVERING INSTALLATION (SC332)

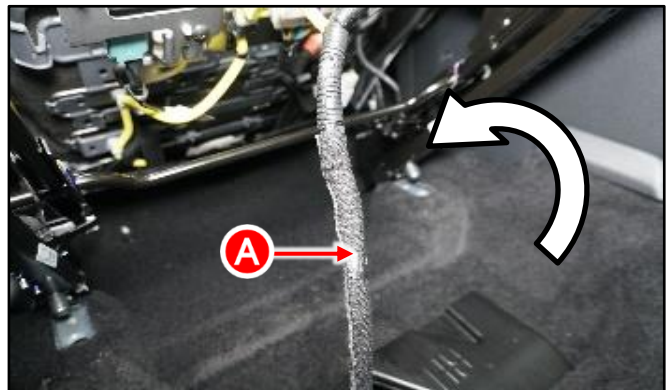
Note: The seat wiring harness (A) coming from under the carpet will only allow the seat to be tilted up to a certain degree.

2. Carefully, lift-tilt the front of the seat backward towards the rear seat to access the under-seat wiring and connectors.

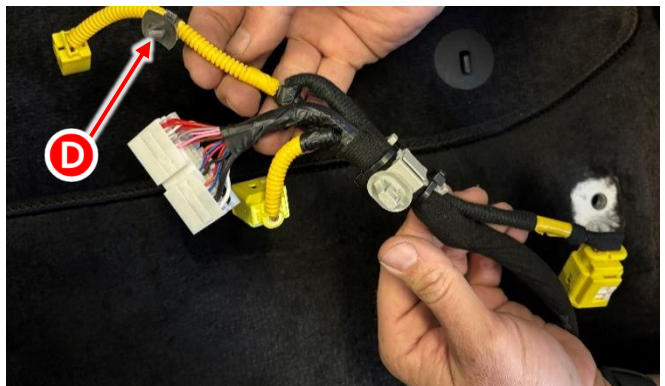
Note: The wiring protective covering installation for Niro EV models should look as shown.

- Install the new cable tie clip fastener on the connector (D) wiring and cut-off any remaining cable tie end.
