GROUP	MODEL
Safety Recall Campaign	2023-2025MY Niro HEV, PHEV (SG2 P/HEV) and Niro EV (SG2 EV)
NUMBER	DATE
SC332	January 2025

FLOOR HARNESS INSPECTION AND

PROTECTIVE COVERING INSTALLATION (SC332)

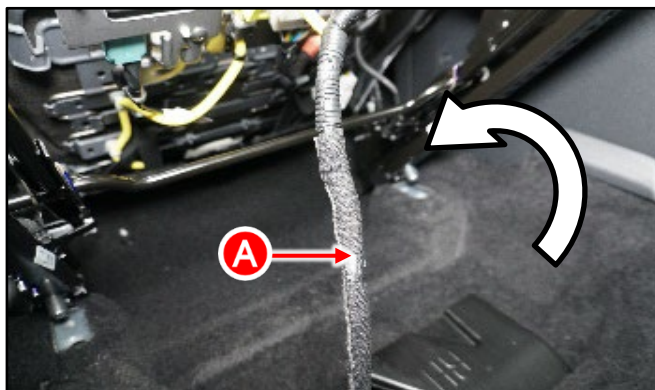
Note: The seat wiring harness (A) coming from under the carpet will only allow the seat to be tilted up to a certain degree.

2. Carefully, lift-tilt the front of the seat backward towards the rear seat to access the under seat wiring and connectors.
