# Safety Recall

## N242490120 Chrome Grille Deflector May Detach

**Release Date:** March 2025

<b>Condition</b>	General Motors has decided that a defect which relates to motor vehicle safety may exist in certain 2022 model year GMC Sierra 1500 vehicles equipped with chrome front grille deflectors. One or more of the attachments that hold the front upper grille deflector in place may fracture over time. If all eight attachment points break, the deflector may detach from the vehicle while driving. If a front grille deflector detaches unexpectedly while driving, there is increased risk of a crash.
<b>Correction</b>	Dealers will reinforce or repair all attachment points on the chrome front grille deflector.

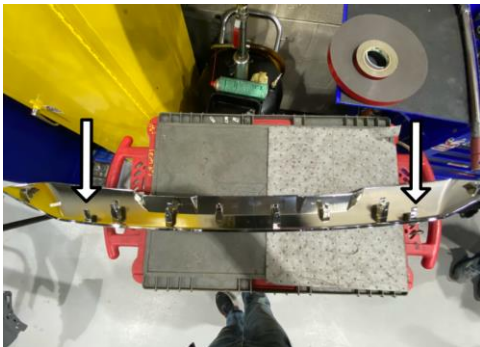
6832853

**Note:** Component removed for greater clarity.

**Caution:** Only apply enough force to release the retainer. Use extreme care to not damage the retainer or its housing.

4. Insert one ear of a long reach trim prybar in the outer retainer housing as pictured above. Once inserted, disengage the retainer lock, and gently pull back the retainer out of its housing.
5. Gently wedge a nylon prybar between the Upper Grille Deflector and the Front Grille to prevent the lock re-engaging.

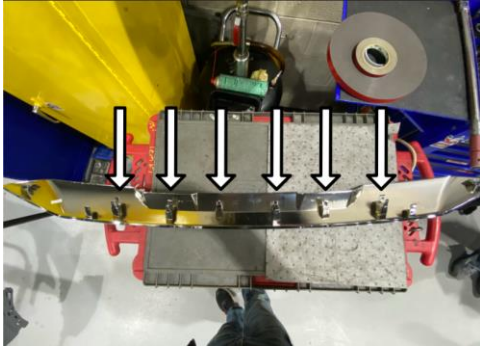
6832851

**Note:** Component removed for greater clarity.

**Caution:** Only apply enough force to release the retainer. Use extreme care to not damage the retainer or its housing.

**Note:** Some of the retainers may separate from the Upper Grille Deflector and remain in their housing on the Front Grille. This is expected, continue to remove the Deflector and wait to remove the separated retainers until Step 10.

6. Using a 90° pick, insert the pick into the retainer housing as pictured above. Once inserted, disengage the retainer lock, and gently pull back the retainer out of its housing.
7. Gently wedge a nylon prybar between the Upper Grille Deflector and the Front Grille to prevent the lock re-engaging.
8. Repeat Steps 6-7, working down the length of the Upper Grille Deflector until you reach the final outer retainer.
9. Remove the final outer retainer by repeating Step 4.
