# Safety Recall

## N242490120 Chrome Grille Deflector May Detach

**Release Date:** June 2025

<b>Condition</b>	General Motors has decided that a defect which relates to motor vehicle safety may exist in certain 2022 model year GMC Sierra 1500 vehicles equipped with chrome front grille deflectors. One or more of the attachments that hold the front upper grille deflector in place may fracture over time. If all eight attachment points break, the deflector may detach from the vehicle while driving. If a front grille deflector detaches unexpectedly while driving, there is increased risk of a crash.
<b>Correction</b>	Dealers will reinforce or repair all attachment points on the chrome front grille deflector.

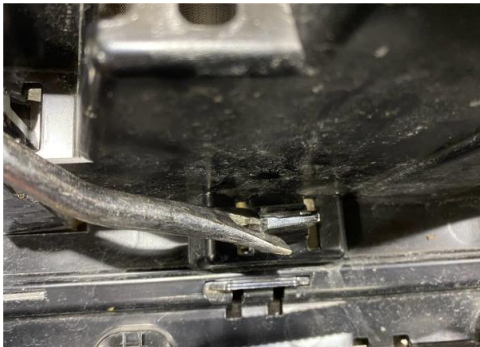
6828842

**Caution:** Only apply enough force to release the retainer. Use extreme care to not damage the retainer or its housing.

**Note:** Some of the retainers will separate from the Upper Grille Deflector and remain in their housing on the Front Grille. **This is expected, the separated retainers will be reattached to the Deflector on Steps 17 & 18. DO NOT REPLACE THE FRONT GRILLE OR THE UPPER DEFLECTOR.**

4. Insert one ear of a long reach trim prybar in the outer retainer housing as pictured above. Once inserted, gently twist the tool to disengage the retainer lock, and gently pull back the retainer out of its housing.
5. Gently wedge a nylon prybar between the Upper Grille Deflector and the Front Grille to prevent the lock re-engaging.

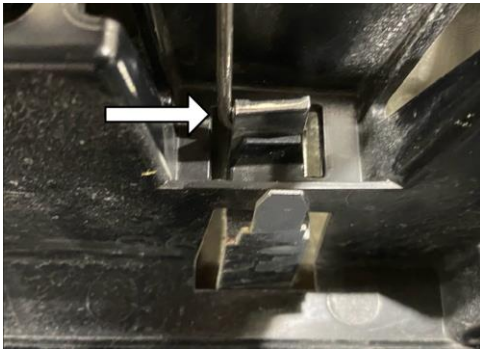
**Caution:** Only apply enough force to release the retainer. Use extreme care to not damage the retainer or its housing.

**Note:** Some of the retainers will separate from the Upper Grille Deflector and remain in their housing on the Front Grille. **This is expected, the separated retainers will be reattached to the Deflector on Steps 17 & 18. DO NOT REPLACE THE FRONT GRILLE OR THE UPPER DEFLECTOR.**

6. Using a 90° pick, insert the pick into the retainer housing as pictured above. Once inserted, gently twist the pick to disengage the retainer lock, and gently pull back the retainer out of its housing.
7. Gently wedge a nylon prybar between the Upper Grille Deflector and the Front Grille to prevent the lock re-engaging.
8. Repeat Steps 6-7, working down the length of the Upper Grille Deflector until you reach the final outer retainer.
9. Remove the final outer retainer by repeating Step 4.

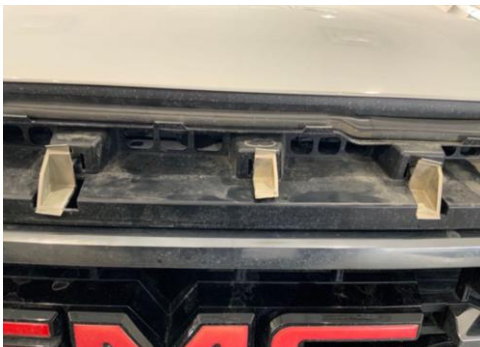
**Important:** Some of the retainers may separate from the back side of the Upper Grille Deflector and remain in their housing within the Front Grille. **This is expected, the separated retainers will be reattached to the Deflector on Steps 17 & 18. DO NOT REPLACE THE FRONT GRILLE OR THE UPPER DEFLECTOR.**

10. Using Steps 3-9 as a reference, remove any retainers that remained inside of the Front Grille retainer housings.
  - If the vehicle came in with the Deflector still attached to the Front Grille, note the retainer locations, and set aside. DO NOT DISCARD.
  - If the vehicle came in with the Deflector detached or missing from the Front Grille, remove and discard the retainers.

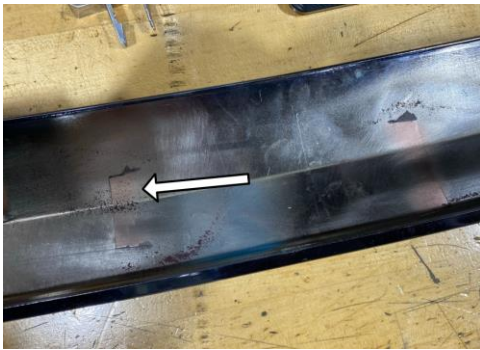
**Note:** It is not necessary to remove the retainers from the Deflector if they remained attached during removal. Sand and prep the area around where the retainer sits for good adhesion between the epoxy and the retainer.

**Important:** Prepare ALL surfaces prior to opening epoxy to prevent the epoxy from drying too quickly inside the applicator nozzle. Ensure that ALL of the chrome coating is removed from the back of the Deflector, and the deflector retainers. **FAILURE TO DO SO COULD RESULT IN AN INSUFFICIENT BOND BETWEEN THE RETAINER AND THE DEFLECTOR**
