**HYUNDAI**
Technical Service Bulletin

GROUP RECALL	NUMBER 25-01-014H
DATE FEBRUARY 2025	MODEL(S) IONIQ 5 (NEA EV)

SUBJECT: REAR SEAT FLOOR WIRING HARNESS CONNECTOR TERMINALS
INSPECTION/HARNESS REPLACEMENT (RECALL 274)

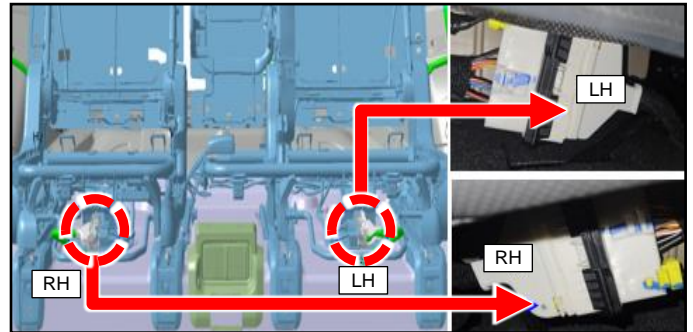
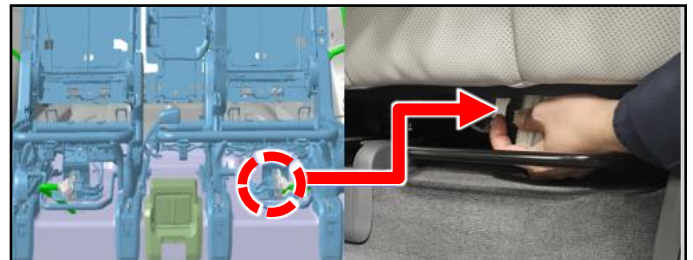
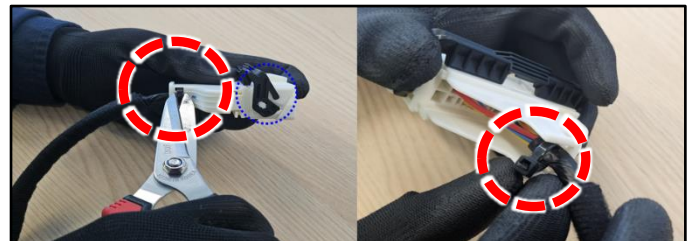
1. Turn the engine off and disconnect the 12V battery terminal (-).
2. Find the indicated connectors under the vehicle's LH and RH rear seat.
3. Press and lift the locking lever for the LH and RH connectors and pull to disconnect them.
4. Cut and remove the indicated zip tie on both connectors.

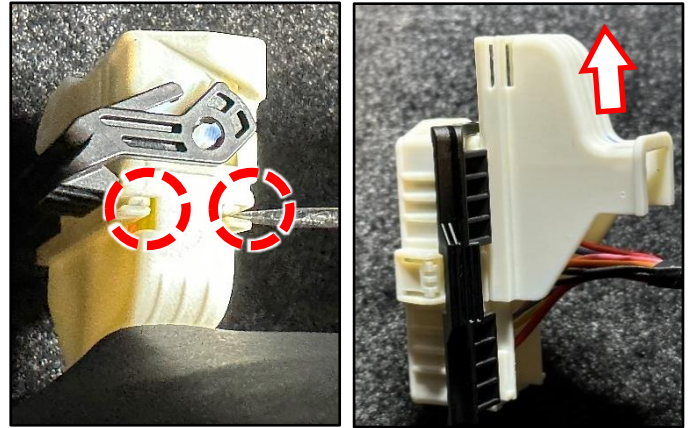
5. Lift the **two locking parts** with the terminal tool and slide to remove the cover as shown for both connectors.

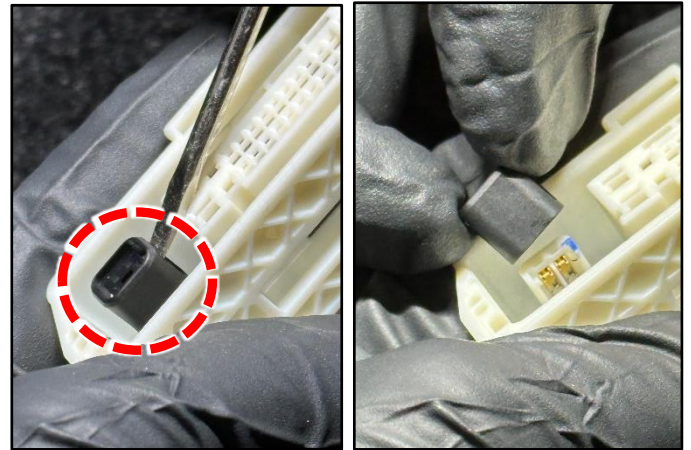
6. Lift the black retainer with the terminal tool and remove the retainer from both connectors.

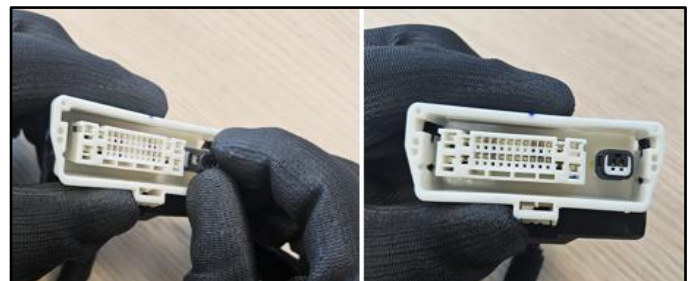
12. Insert the black retainer into the LH and RH connectors.

If the terminals are **NOT** fully inserted, the retainer will **NOT** sit correctly.

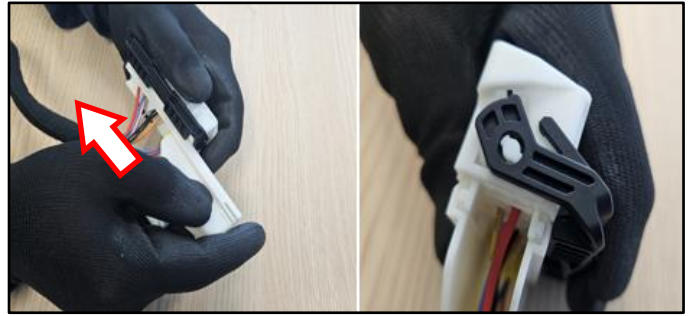
13. Slide to install the rear cover on the LH and RH connectors so it locks into place.

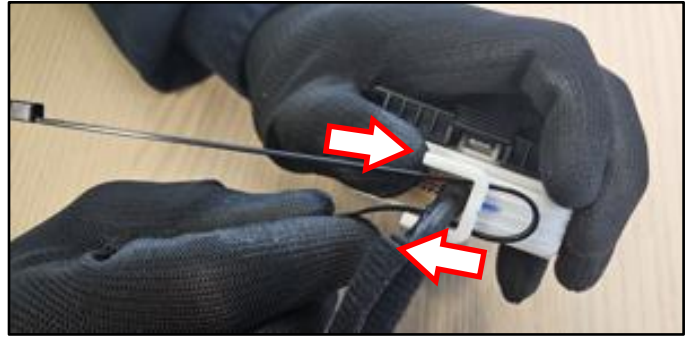
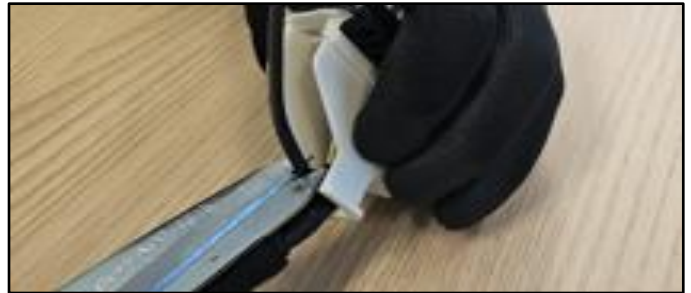
14. For the LH and RH connectors, insert the zip tie as shown. Fasten it so it holds the wire bundle in place. Cut off the excess zip tie.

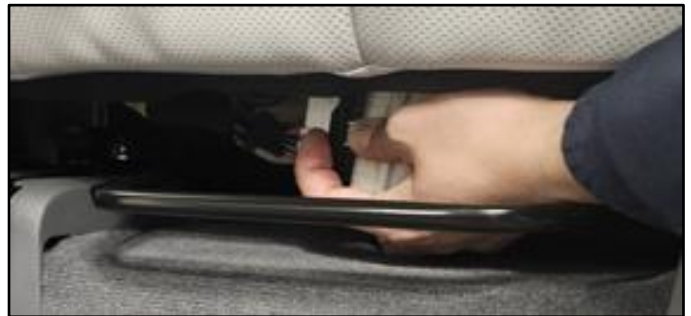
15. Reconnect the LH and RH connectors under the rear seat so the black lever locks into place.

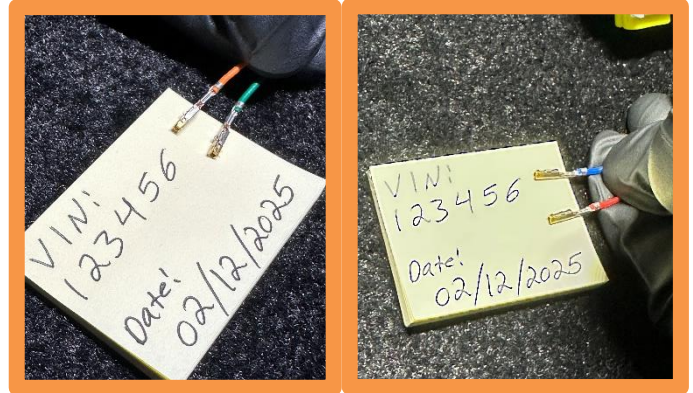
Using STUI, take two close-up photos, one of the new LH terminals and one of the new RH terminals with the last 6 digits of the VIN and the date of repair on a piece of paper.
