# Compliance Recall

## Code: 90AV

#### Camera Control Unit

**Subject: Compliance Recall 90AV - Camera Control Unit**

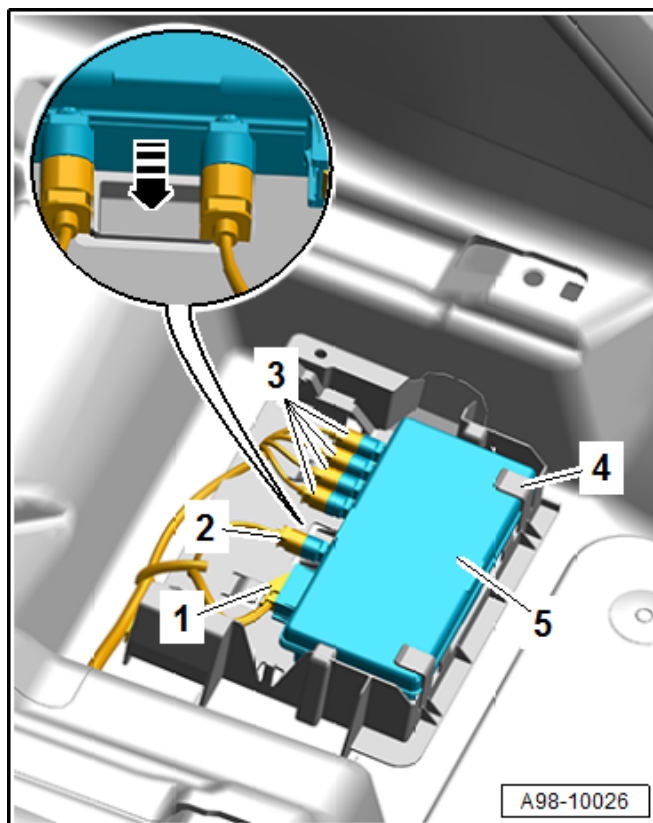
- Customer concern may be, “no camera images are displayed”.
- DTC U104C00: “Rear view camera system control module no communication” is stored in the Gateway (DA 0019).
- J928 may be offline when vehicle is scanned.

### Replace Peripheral Camera Control Module -J928-

- See ELSA Repair Manual: *Repair Manual > Electrical System > Driver Assistance Systems > 98 Assistance Systems > Sensors and Control Modules > Peripheral Camera Control Module J928, Removing and Installing*
- **The new control module does not require the software update.**
