Safety Recall

N252494000 L87 Engine Loss of Propulsion

Release Date: May 2026

Revision: 13

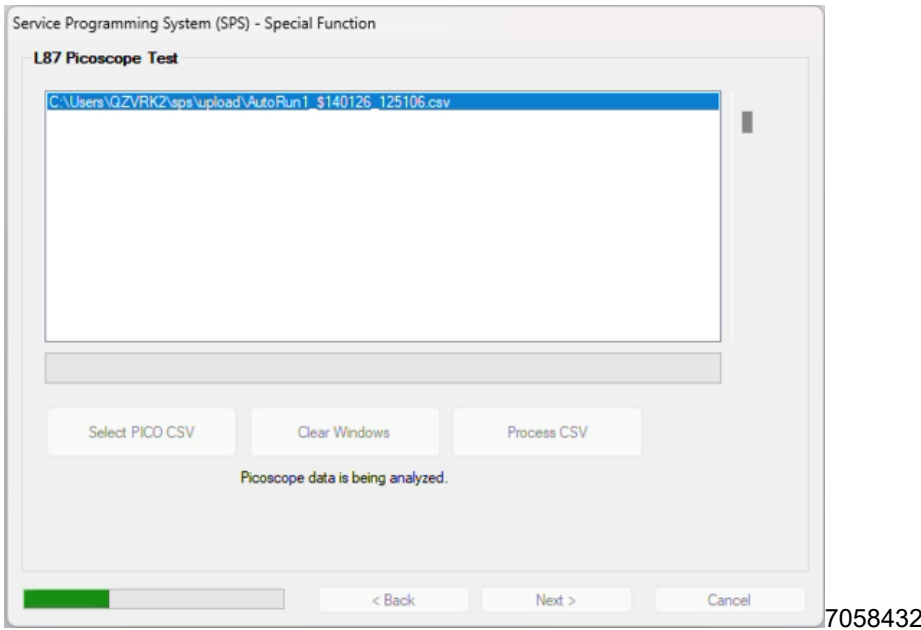
16. When GM Waveform Capture has completed its sequence, the program will automatically save and upload the captured data.
17. The next screen will automatically populate with a PASS or FAIL result. After recording the result, press “Next” on the following screens to retrieve the Warranty Claim Code and exit the procedure.

- If the engine FAILS the test, refer to *Engine Replacement* in SI. Transfer the engine oil cap from the original engine to the replacement engine and fill the engine with the oil grade that is indicated on the cap.

18. FOR ENGINES THAT PASS: Perform an oil change to 0W-40 Oil, *Refer to Engine Oil and Oil Filter Replacement* in SI. Install a NEW engine oil cap and place the owner's manual insert(s) in the glovebox.
