# Safety Recall

## N252494000 L87 Engine Loss of Propulsion

**Revision:** 09

<b>Condition</b>	General Motors has decided that a defect which relates to motor vehicle safety may exist in certain 2021 – 2024 model year Cadillac Escalade and Escalade ESV, Chevrolet Silverado 1500, Suburban, and Tahoe, and GMC Sierra 1500, Yukon, and Yukon XL vehicles equipped with the 6.2L V8 gas engine (RPO L87). The connecting rod and/or crankshaft engine components in these vehicles may have manufacturing defects that can lead to engine damage and engine failure. If the engine fails during vehicle operation, the vehicle will lose propulsion, increasing the risk of a crash.
<b>Correction</b>	Dealers will inspect the engine. If the vehicle fails the inspection procedure, the engine will be repaired or replaced. Vehicles that pass inspection will be provided a higher viscosity oil, which will also require a new oil fill cap identifying the new required oil grade, an oil filter replacement, and an owner's manual insert free of charge.

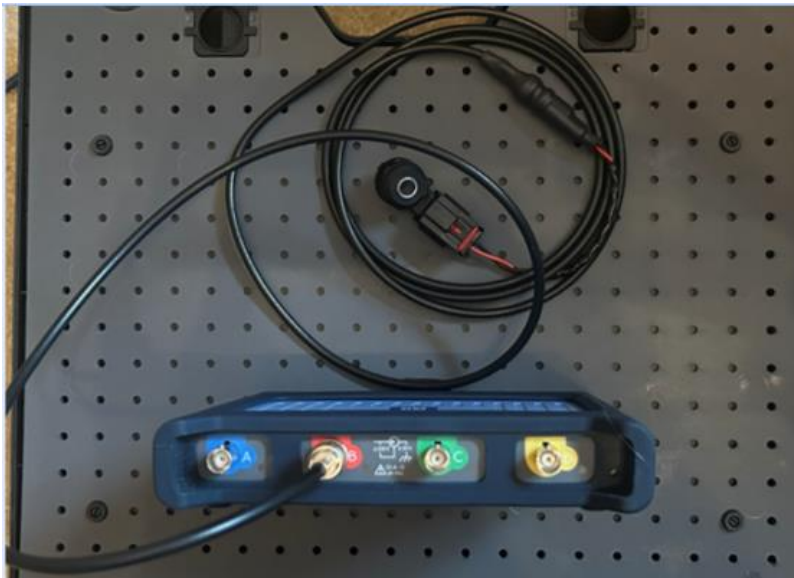
6952616

5. Install the test sensor into the unused M8 boss on the left-hand side of the engine directly above and in front of the engine oil cooler line junction block. **DO NOT USE THE FACTORY KNOCK SENSOR, OR THE FACTORY KNOCK SENSOR LOCATION.** Torque the M8X1.25X35 bolt to 16 lb-ft/22 N-m.
6. Route the test sensor harness in a manner in which it is not contacting any hot components of the vehicle and which allows the harness to reach your laptop or PC.
