Safety Recall

N252494000 L87 Engine Loss of Propulsion

Release Date: January 2026

Revision: 10

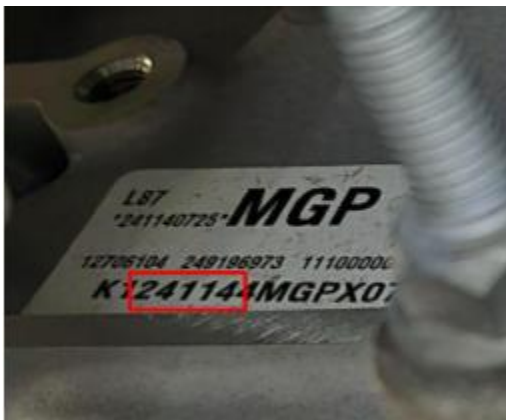
6908278

- For Replacement Engines: Looking upwards from under the vehicle towards the rear of the Left Hand cylinder head, inspect the digits indicated on the sticker above to determine the build date of the engine. The first two digits circled are the build year ('24 in this example), and the next three digits are the build day (day 114 in this example).

- If the engine was built ON or BEFORE day 153 or 6-1-2024, proceed to Step 3.
 - If the engine was built AFTER day 153 or 6-1-2024 no further action is required. Submit inspect-only labor operation 9107967. **BE SURE TO RECORD THE NEW ENGINE SERIAL NUMBER IN THE CORRECTION FIELD OF THE REPAIR.** The new engine serial number MUST be included in the warranty information.

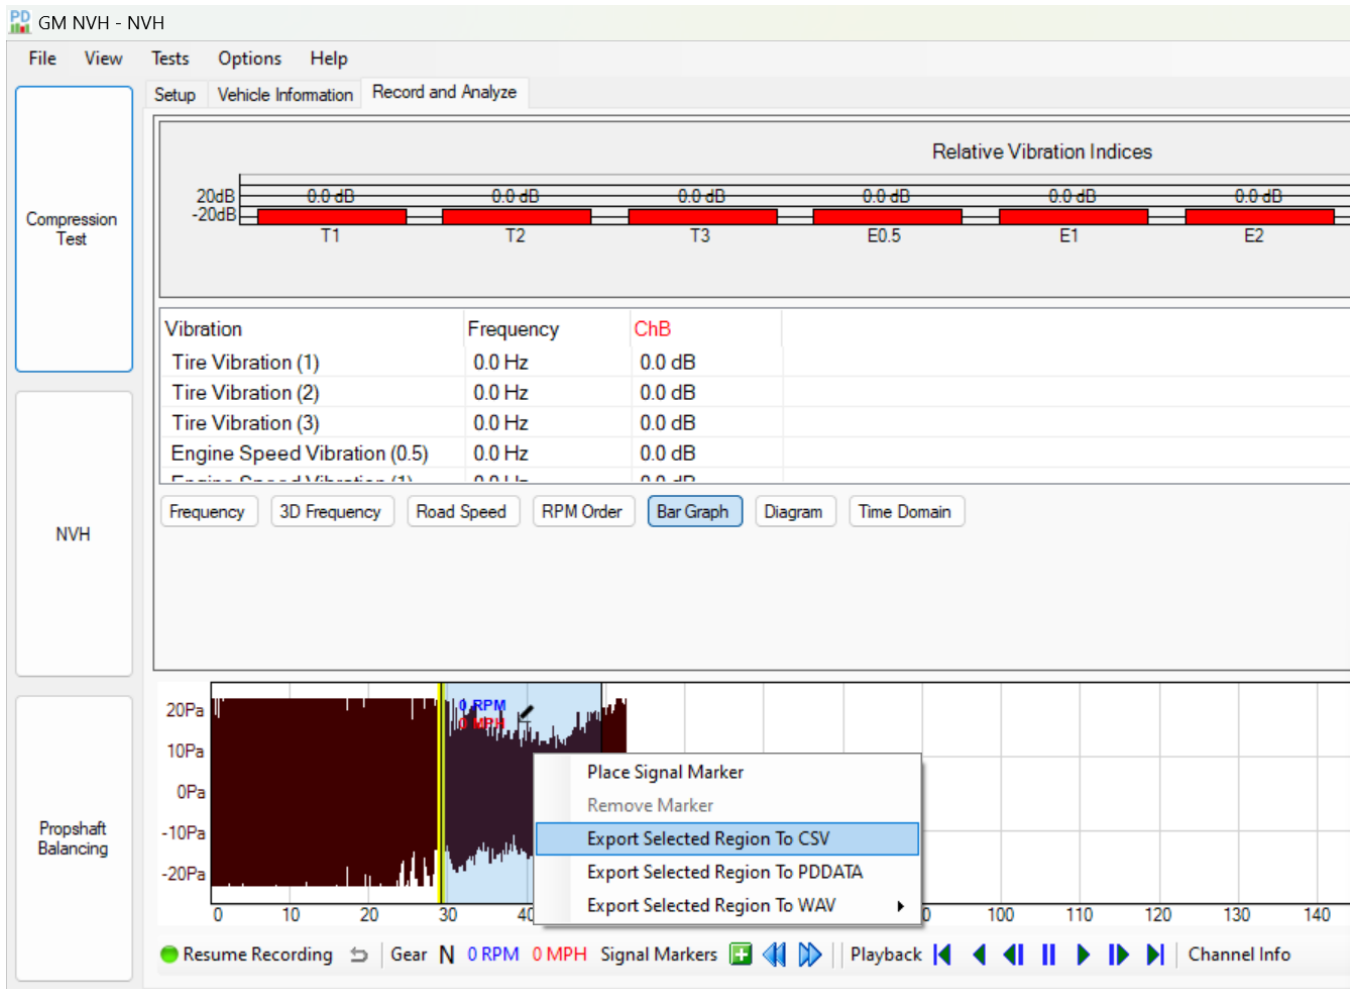
6932383

28. Select a roughly 20-second-long clip of the data displayed at the bottom, as shown above. You may select data by clicking and dragging the vertical bars. Then, right click it and hit “export selected region as CSV” as shown above. Note where the file is saved to, or save it to an easy to find location such as ‘my documents’ or your desktop. It may be helpful to name the file with the last 8 of the VIN if you will be running a lot of these tests. **THE FILE MUST BE SAVED ON THE LOCAL (C:) DRIVE. THE FILE MAY TAKE A LONG TIME TO SAVE. BE PATIENT. SAVING MUST COMPLETE BEFORE YOU PROCEED TO THE NEXT STEP OR YOU WILL GET AN ERROR.**

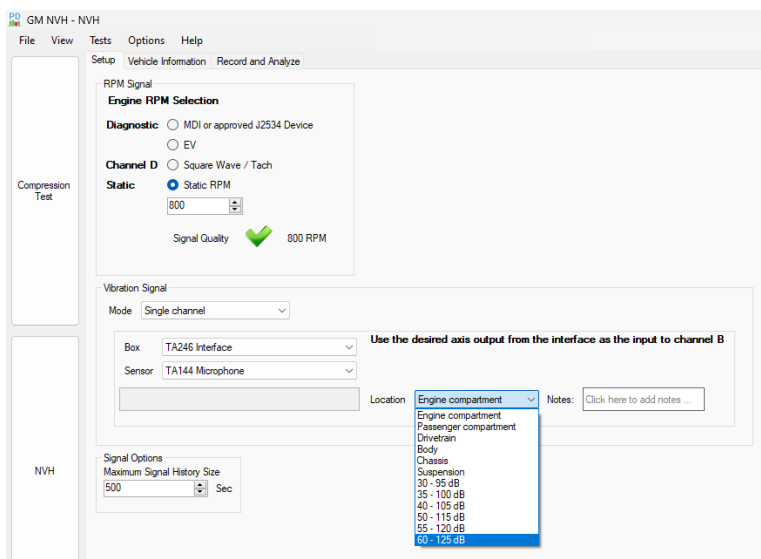
6994622

4. On the Setup screen, change the location to “60-125 dB” as shown above. Proceed with the remainder of the procedure as normal.
