# Safety Recall

## N252494000 L87 Engine Loss of Propulsion

**Release Date:** October 2025

**Revision:** 08

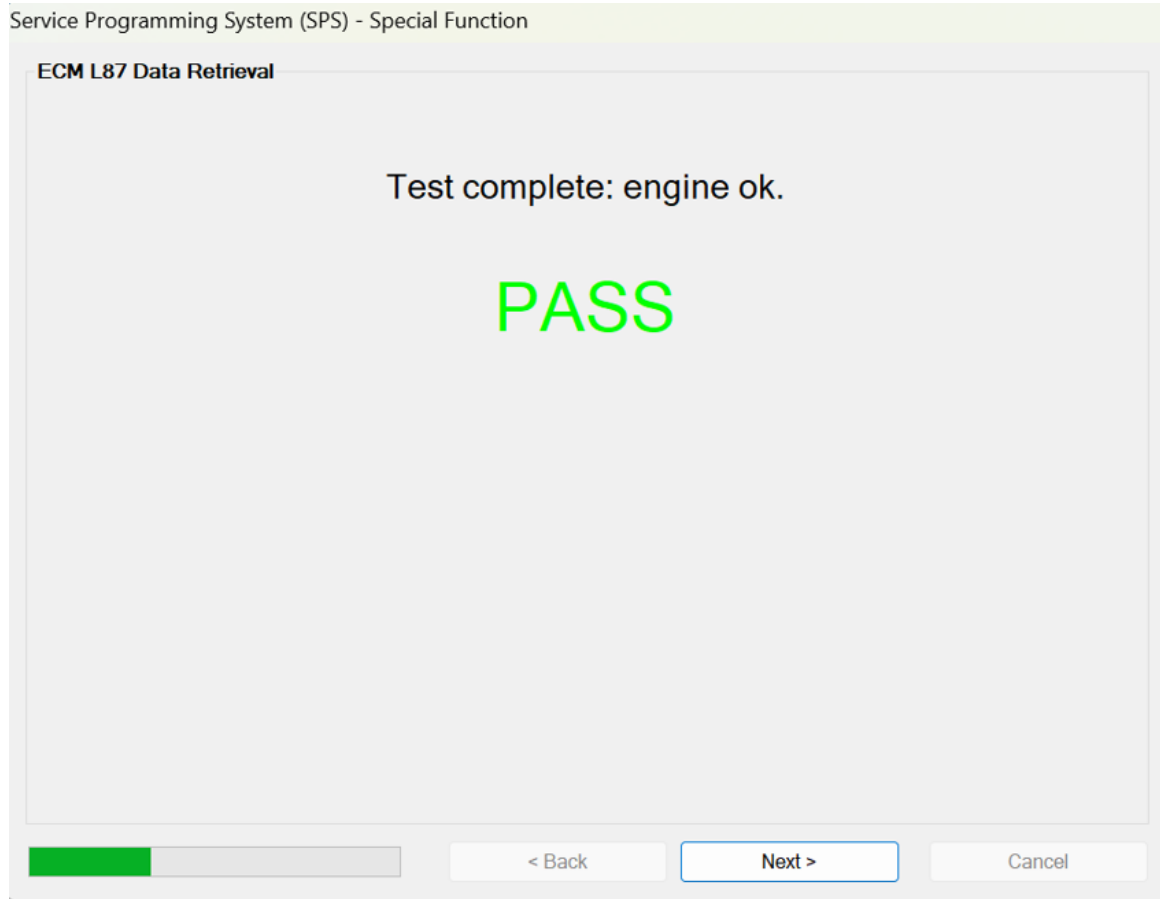
31. Select “Process CSV.” An automated diagnostic will run, which will give you a result at the end determining whether the engine has passed or failed the test.

- If the engine PASSES the test, proceed to the next step.

- If the engine FAILS the test, refer to *Engine Replacement* in SI. Transfer the engine oil cap from the original engine to the replacement engine and fill the engine with the oil grade that is indicated on the cap.

32. FOR ENGINES THAT PASS: Perform an oil change to 0W-40 Oil, Refer to *Engine Oil and Oil Filter Replacement* in SI. Install a NEW engine oil cap and place the owner's manual insert(s) in the glovebox.
