Safety Recall

N252494000 L87 Engine Loss of Propulsion

Release Date: January 2026

Revision: 11

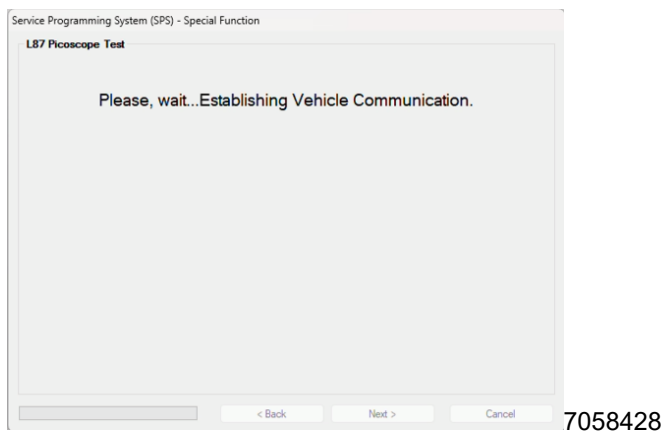
11. The above screen will pop up, indicating the procedure has been initiated.
12. The next screens will instruct you to connect the Picoscope to the vehicle and to start the engine, please follow the instructions as they are displayed.

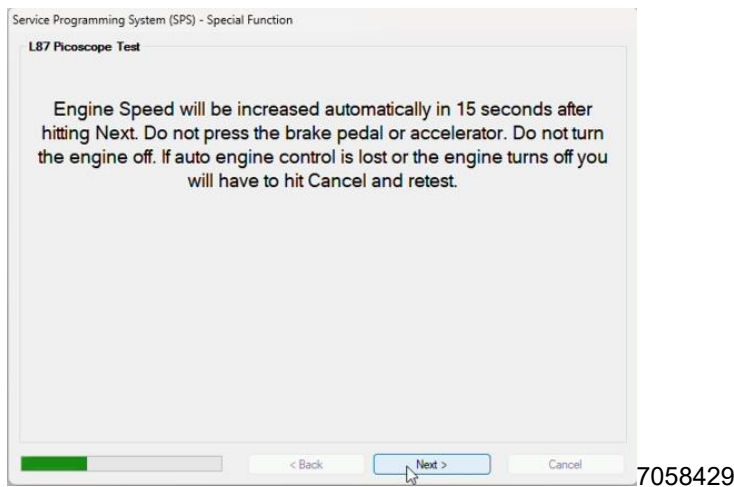
13. The above screen will display when the Picoscope is connected, engine is running, and after pressing next. 15 seconds after clicking “Next”, engine speed will be increased automatically to 2000 RPMs.

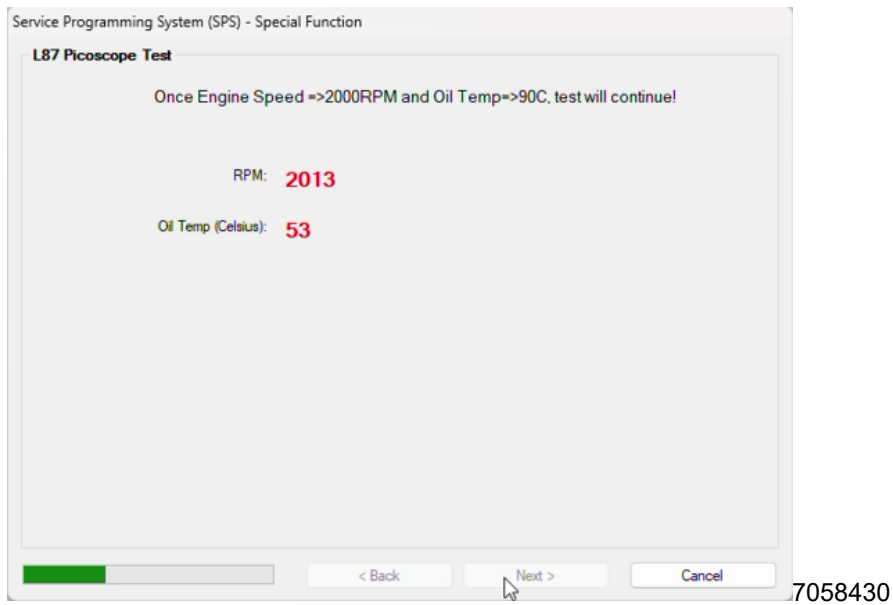
14. The above screen will display until the listed parameters are met. Engine Speed must be 2000 RPM and Oil Temp must reach 90 degrees Celsius. Please do not touch the accelerator pedal during the procedure.

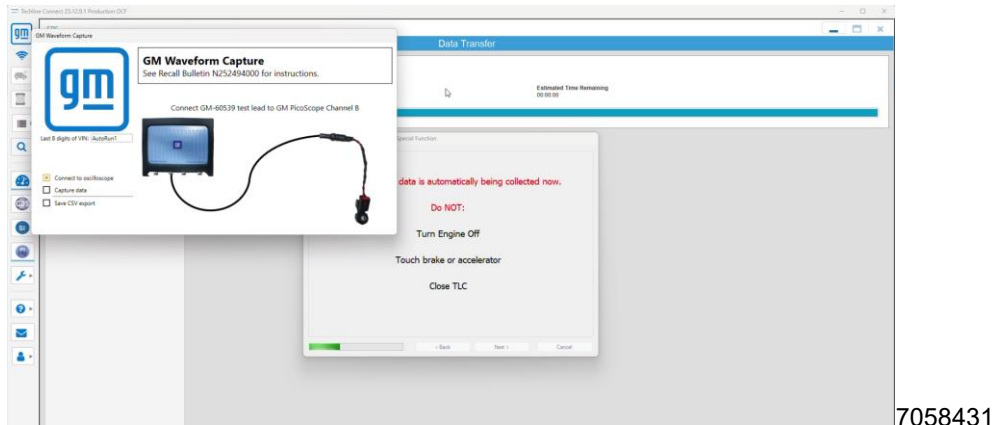
15. After the parameters have been met, the screen will change and GM Waveform Capture will open. No action needs to be completed at this time. The program will automatically record and capture the required data.
