# Safety Recall

## N252513060 Roof Rail Airbag Inflator May Rupture

Release Date: June 2025

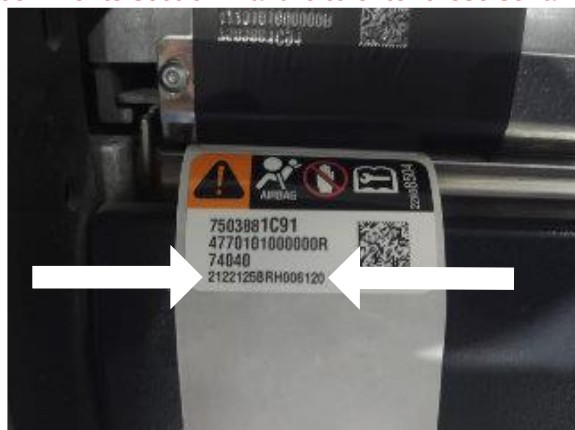
6070604

**IMPORTANT: \* (TECHNICIAN and WARRANTY ADMINISTRATOR) SERIAL NUMBER RECORDING REQUIREMENT.** The replacement left and right roof rail airbag assembly serial numbers must be captured by the technician and recorded on the job card. The Warranty Administrator **MUST** enter the replacement left and right roof rail airbag assembly serial numbers in GWM (Global Warranty Management) or in DMS (Dealer Management System). Enter the serial number of the replacement **RIGHT** roof rail airbag in the 'Serial Number' field per the screen below. Enter the serial number of the **LEFT** roof rail airbag in the 'General Comments' comments section. Failure to enter these serial numbers will cause the claim to reject.

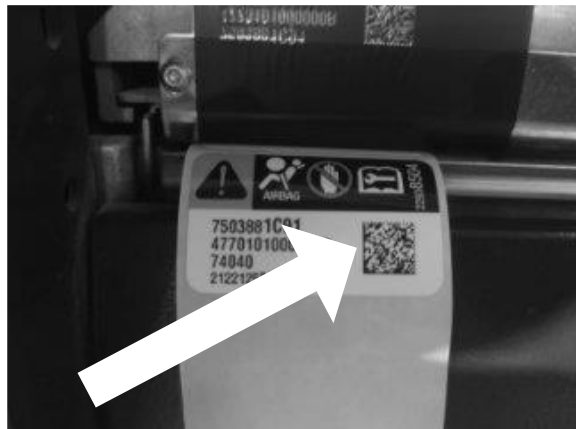
6070519

**IMPORTANT NOTE: Since there are 2 new parts being installed for this recall remedy, you are REQUIRED to use RPT to:**
