IMPORTANT SAFETY RECALL

NHTSA Safety Recall 25V-478

SUBJECT: Campaign # 199 – Under Seat Wire Routing

Under Seat Wire Routing / Airbag May Fail to Deploy

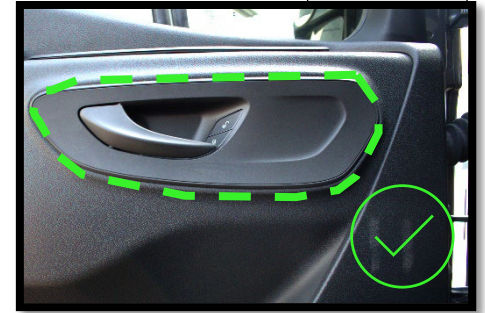
Figure 1

A. Seat adjustment type: If electronic seat controls are not present (See Figure 1), confirm that the manual controls are available on the seat itself (See Figure 2).

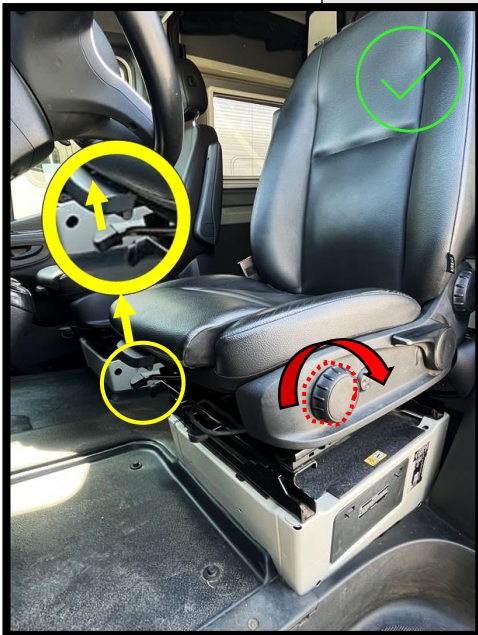
Figure 2

- B. Position both the driver and passenger seats to their maximum height and slide them as far back as possible to allow and provide additional access to the wire routing area.
- Rotate the Dial clockwise to raise the seat to maximum height (Figure 2 – Red Arrow).
 - Push the seat adjustment lever up and push the entire side while holding this lever up to move the seat forward and backwards (Figure 2 – Yellow Arrow).
 - Push up the Seat Adjustment Handle on the side of the seat many times until the back of the seat clears the B-pillar (See Figure 3- Green Arrow). This will allow you to access the Clip mounted on the center circular cutout of the seat swivel for Step 2 (See Figure 4).
 - Swivel each seat, facing them towards their respected door. (See Figure 5)

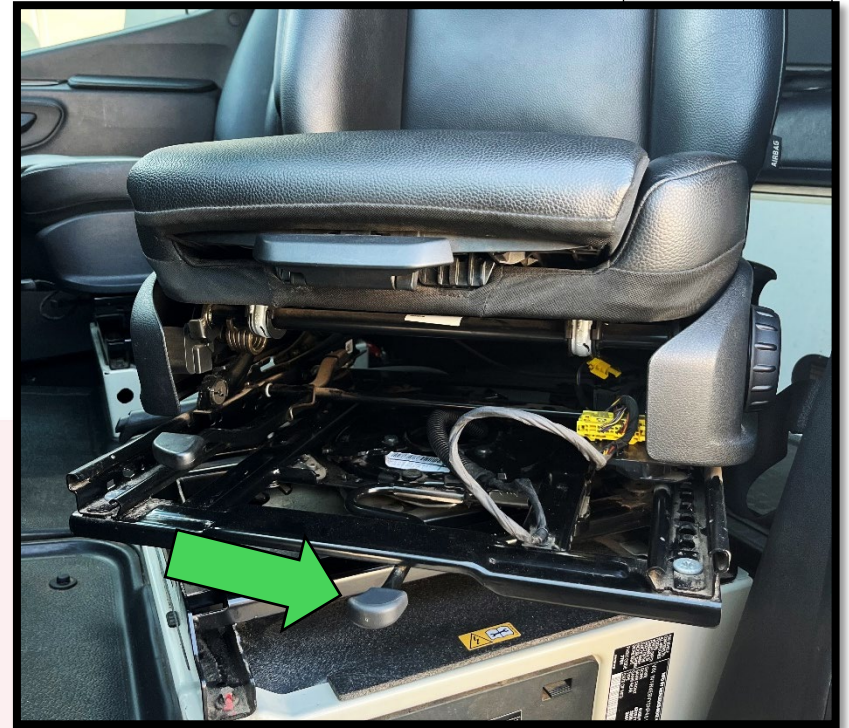
Figure 11

Note: Older Chassis with manually adjustable Driver Seats will also have this wire route with the end connections being the same as shown in Figure 10. Newer chassis manually adjustable Driver seats will have similar wire route but have an additional end connection plug and one different mount location near the end of the wire route. (Figure 11)

- A. Swivel the seat as far as it can go in both directions. See Image 11 for swivel lever identification (green arrow).
1. As the seat is moving, look for the OEM wire harness getting caught or damaged.
 2. Ensure the mounting locations hold their correct position.

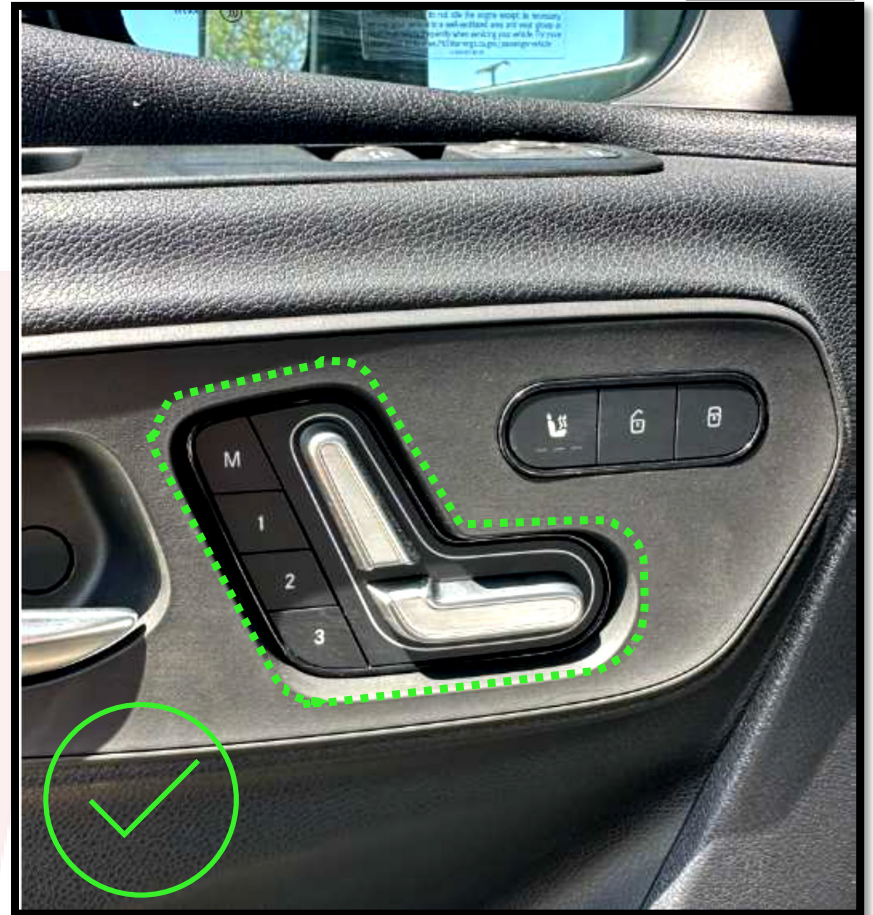
Figure 1

- Seat adjustment type: Confirm electronic seat controls are present. Electronic seat controls are located on the chassis driver/passenger door panel. (See Figure 1)
- Instructions are unique for a chassis with electronically adjustable seats; ensure to review the process for the Electrical Seats to follow the correct instructions for this vehicle.
- Typical Winnebago cab chassis-built coaches will have electronically adjustable seats.

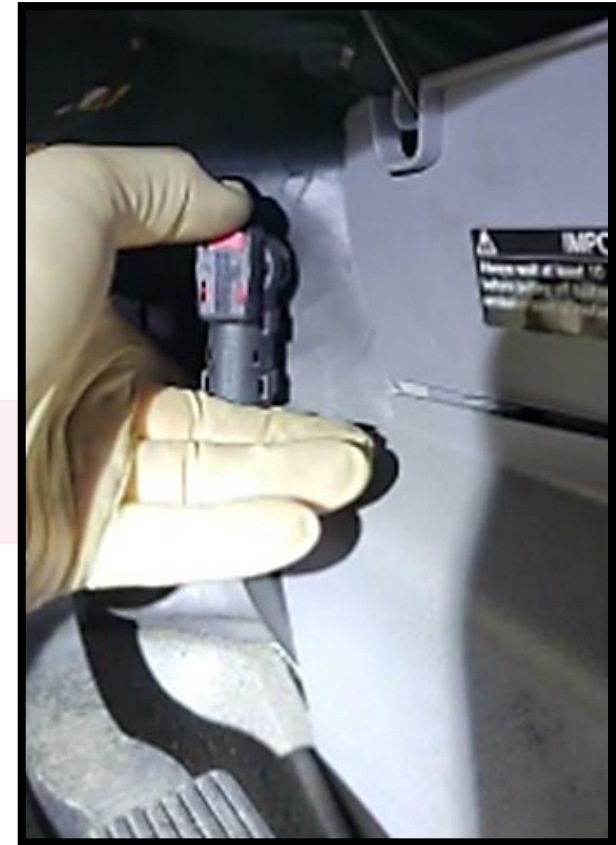
Figure 4

- A. If the wire route must be adjusted, it is **critical** to disconnect the chassis 12V battery beforehand.
- Chassis Battery Quick Disconnect located behind a closeout panel next to the accelerator pedal (See Figure 4).
 - If the unit doesn't have the quick disconnect, refer to the Sprinter user manual to disconnect the ground cable from the battery.
 - Allow for **at least 5** minutes between disconnection of Chassis Battery Quick Disconnect and disconnecting any connectors from the driver and passenger seat.

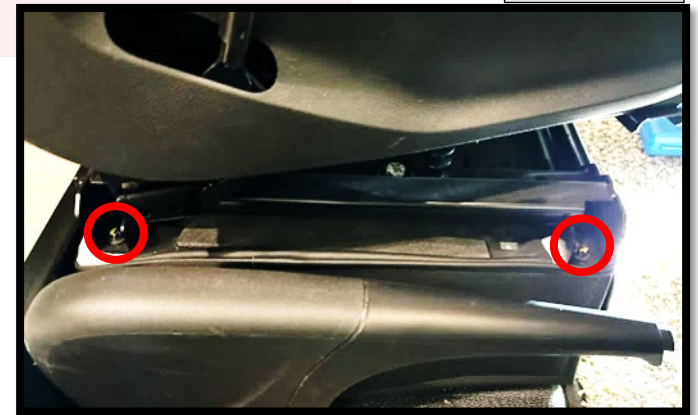
Figure 6

- B. Remove the 4 mounting bolts (2 bolts on each side) from the seat base using a ratchet and E12 Socket, an extension may be required. (See Image 6)

- Note:** Using a torque wrench with an E12 socket and extension, torque the seat pedestal bolts to 37 NM. Re-mark the torqued connections.
- F. Reconnect the affected plugs from the OEM harness to the seat following the OEM route. (See Image 5)
