SAFETY RELATED RECALL

Global Recall Action
Number: N759v5

| Subject: Range Rover (L405) Front Suspension Knuckle Crack | Publication No.: N759v5 |
| | Model Year: 2014 - 2016 |

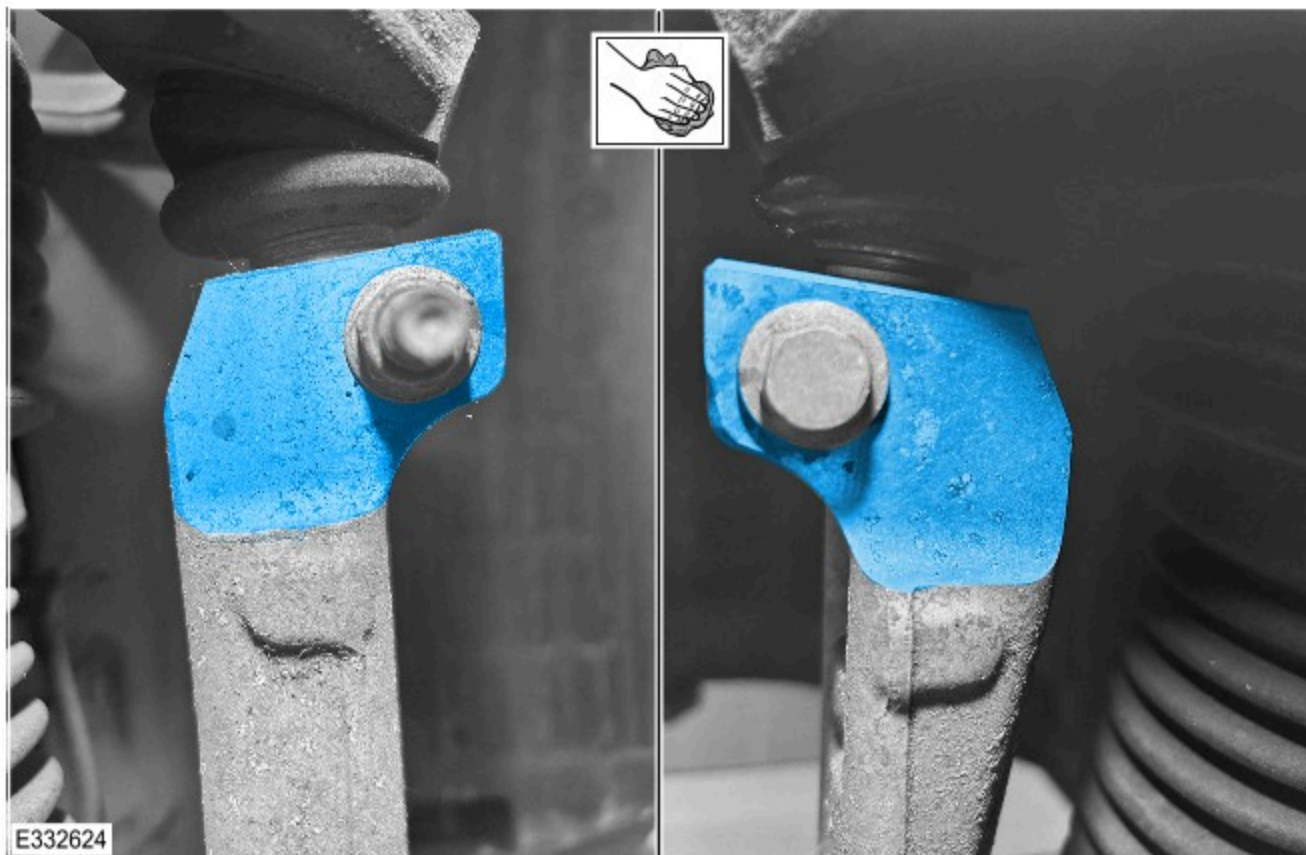
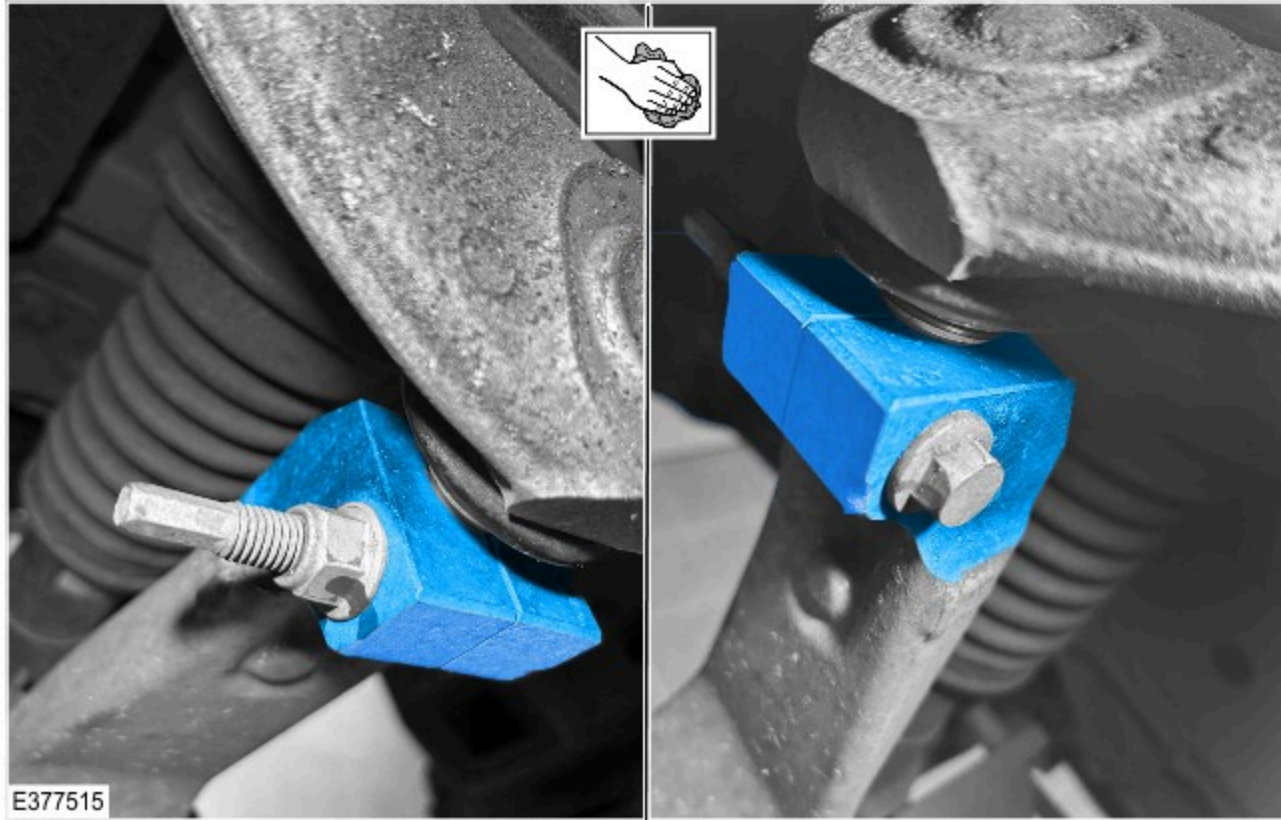
2. Use a non abrasive cloth and suitable cleaning fluid to clean the area of the front knuckle shown highlighted in the illustrations.

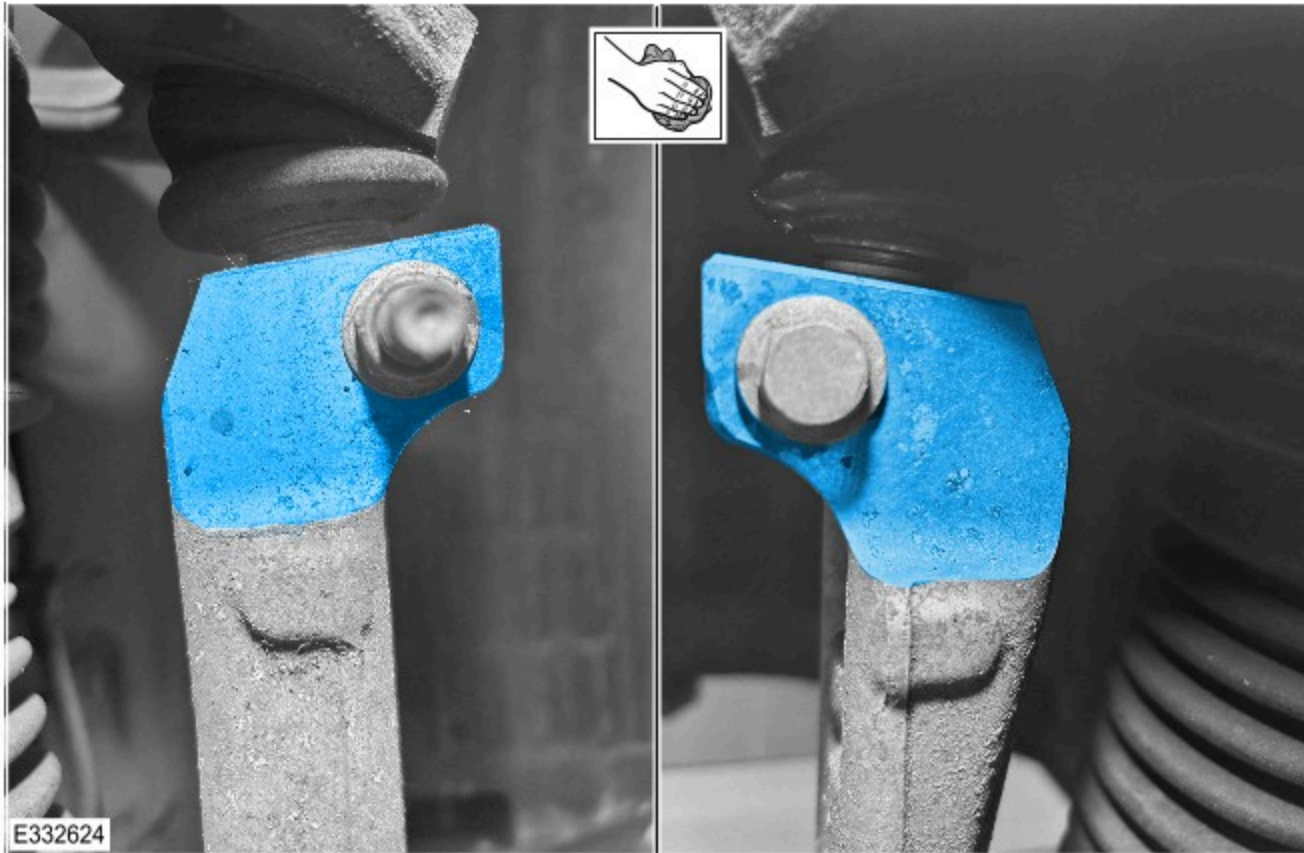
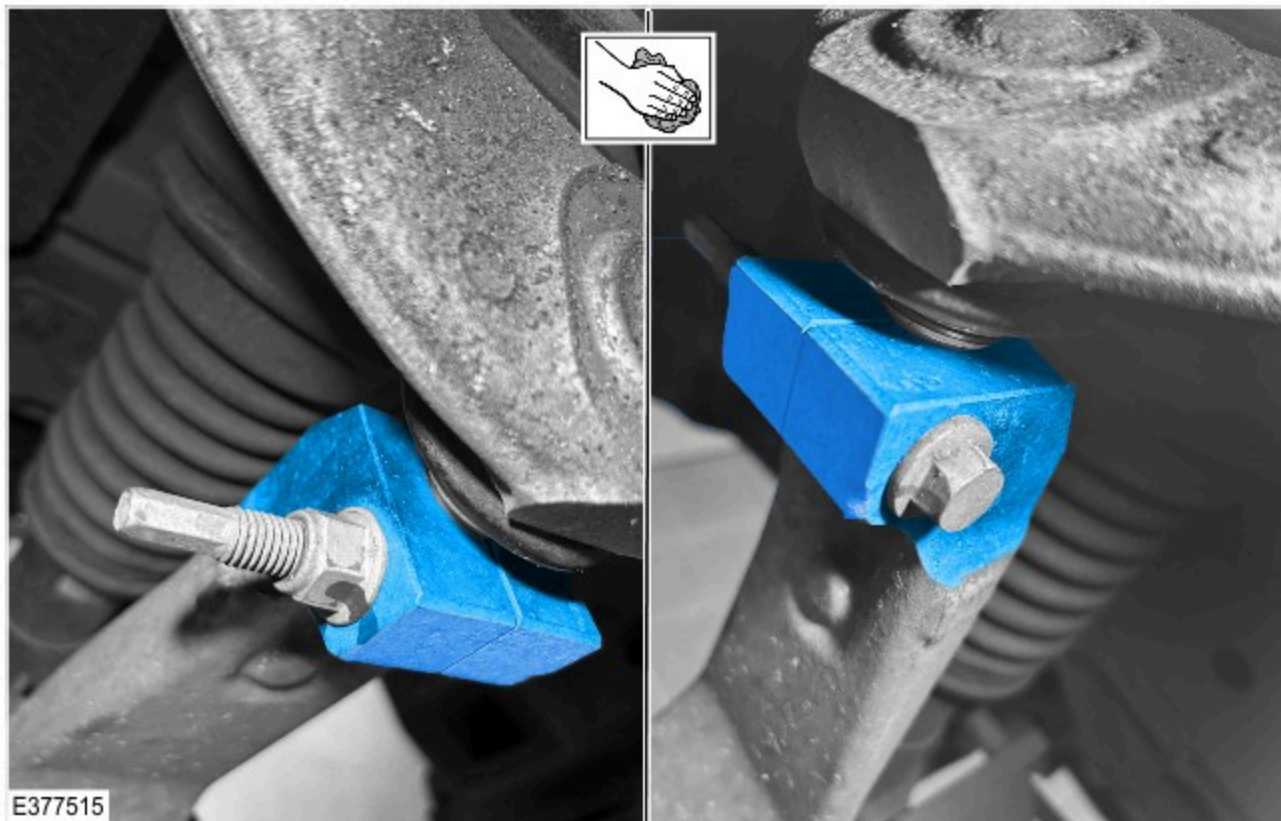
1. The area of the front knuckle shown highlighted in the illustrations must be clean and free from contamination.

2. Install the 2 front knuckle bracket side hooks.

- Apply Loctite® 243 to the bolt.
- Install the bolt, finger tight only at this stage.
