TECHNICAL INSTRUCTIONS

SAFETY RECALL 25TA10

REARVIEW IMAGE MAY NOT DISPLAY

22-25MY TUNDRA/TUNDRA HYBRID

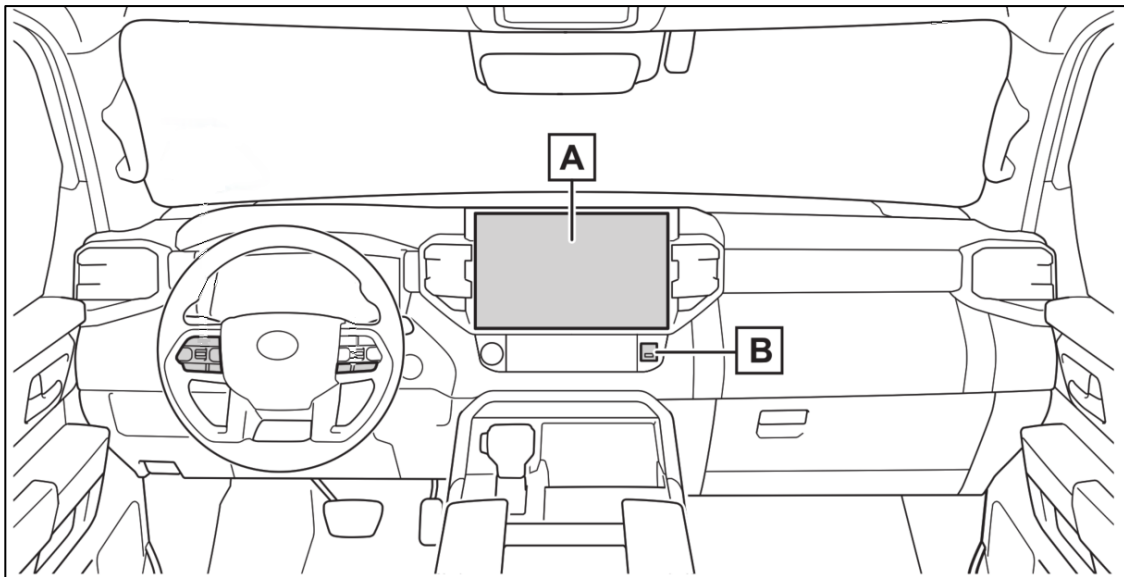
The software in the 14-inch multimedia (center) display in these vehicles could cause the display to show a half green, full green, or full black screen. If this occurs while the vehicle is being reversed, the vehicle may not meet a federal safety standard and there can be an increased risk of a crash with a person behind the vehicle.

(A) 14 inch Display

(B) USB Media Port
