SAFETY RECALL 25TA10

REARVIEW IMAGE MAY NOT DISPLAY

CERTAIN
22-25MY TUNDRA/TUNDRA HYBRID
23-25MY SEQUOIA HYBRID

DATE	TOPIC
10/22/2025	Add details to aid in reducing software update failures

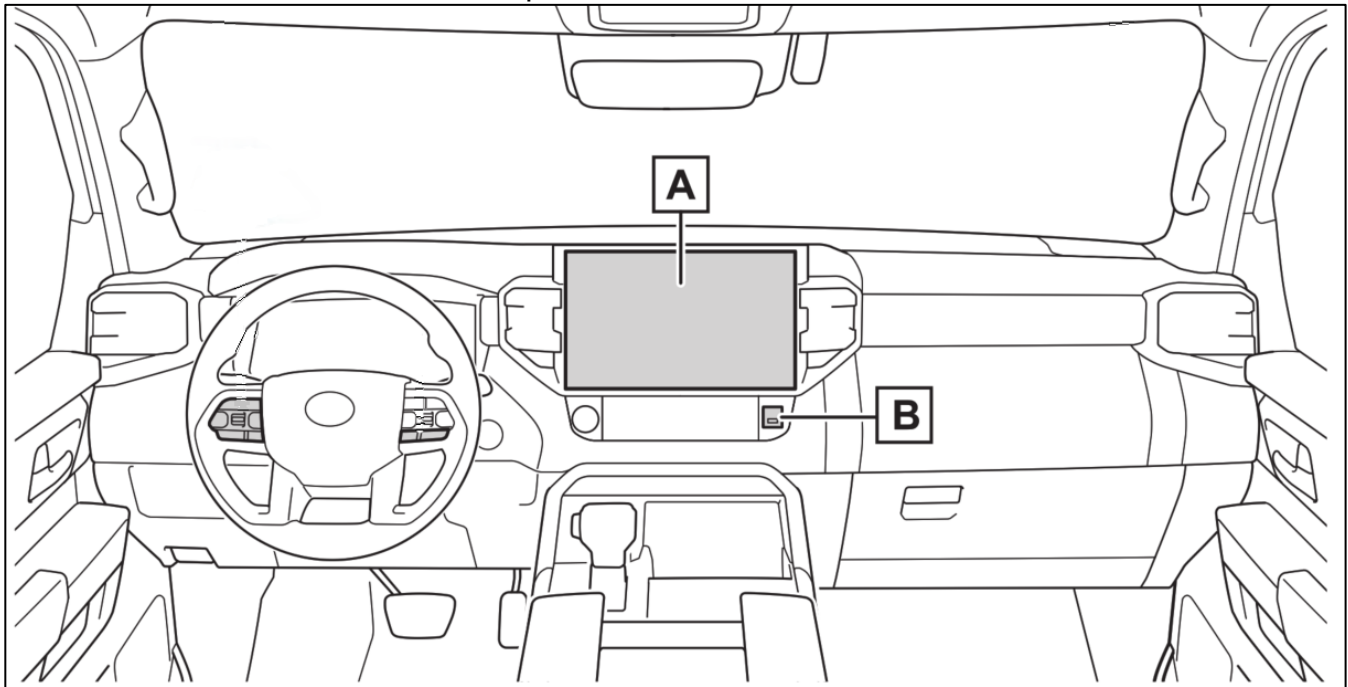
The software in the 14-inch multimedia (center) display in these vehicles could cause the display to show a half green, full green, or full black screen. If this occurs while the vehicle is being reversed, the vehicle may not meet a federal safety standard and there can be an increased risk of a crash with a person behind the vehicle..

(A) 14 inch Display

(B) USB Media Port
