HYUNDAI
Technical Service Bulletin

GROUP RECALL	NUMBER 25-01-073H
DATE OCTOBER 2025	MODEL(S) SANTA FE (MX5A)

SUBJECT: STARTER BATTERY TERMINAL BOOT INSPECTION/ADJUSTMENT
 (RECALL 285)

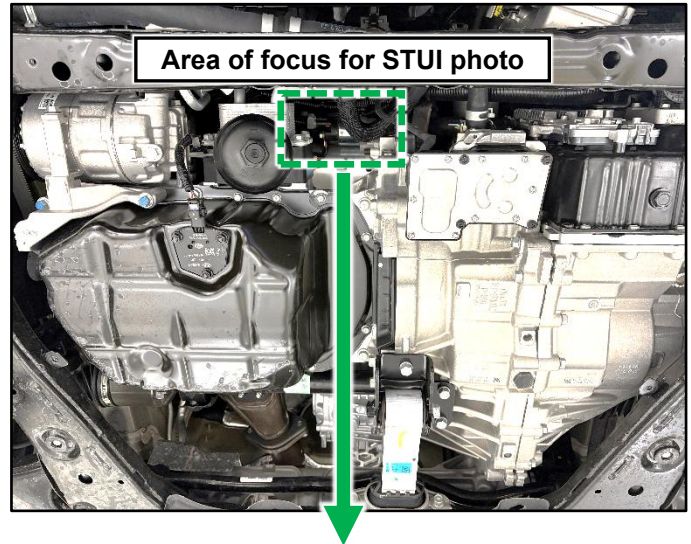
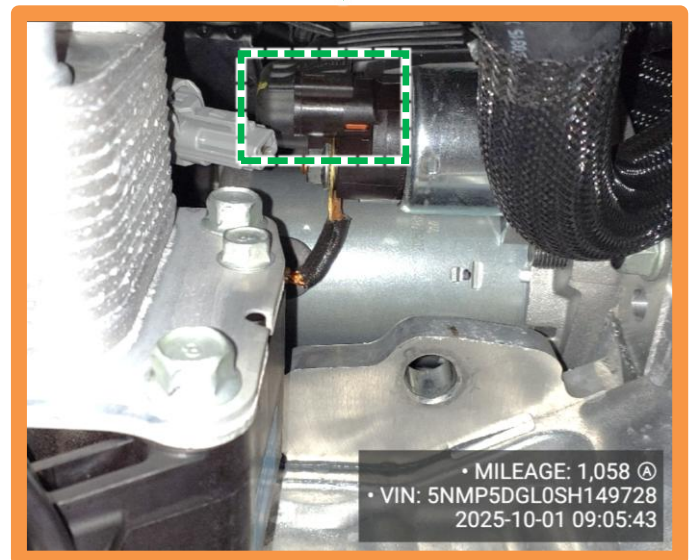
Using the STUI camera function, take a photo of the properly positioned starter battery terminal boot (cover).

5. Reassemble all removed parts in reverse order of the removal process.
6. The service procedure is now complete.
