# Technical Service Bulletin

<b>GROUP</b>	<b>NUMBER</b>
<b>RECALL</b>	<b>26-01-005G</b>
<b>DATE</b>	<b>MODEL(S)</b>
<b>JANUARY 2026</b>	<b>G90 (RS4)</b>

**SUBJECT:** FALSE DETECTION OF VEHICLE IN HDA MODE – FRONT BUMPER BEAM REPLACEMENT (RECALL 030G)

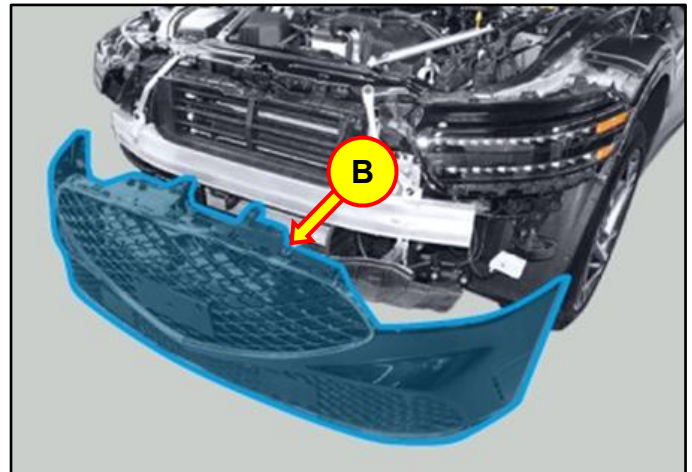
2. Remove the front bumper assembly (B) by referring to the shop manual:

- **Body (Interior / Exterior / Electrical) > Front & Rear Bumper > Front Bumper Assembly > Removal and Installation**

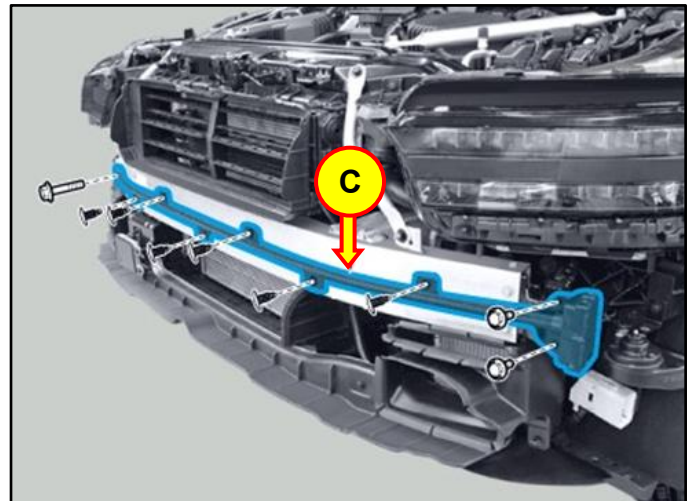
3. If equipped, remove the active hood sensor and unit assembly (C) by referring to the shop manual:

- **Restraint > Active Hood Lift System > Active Hood Sensor & Unit Assembly > Removal and Installation**

**Tightening Torque:**

lb-ft	8.0
lb-in	91
N.m	10.3

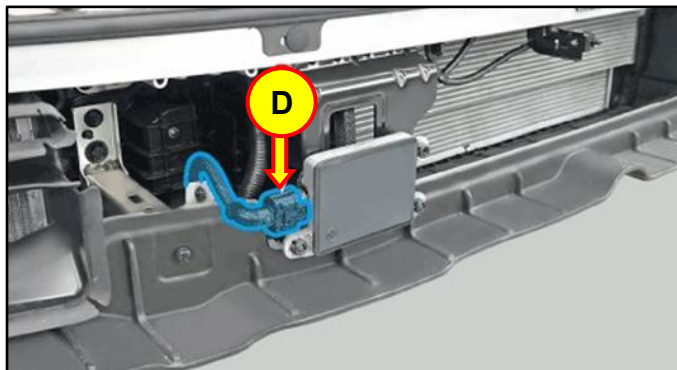
4. Disconnect the front radar connector (D).

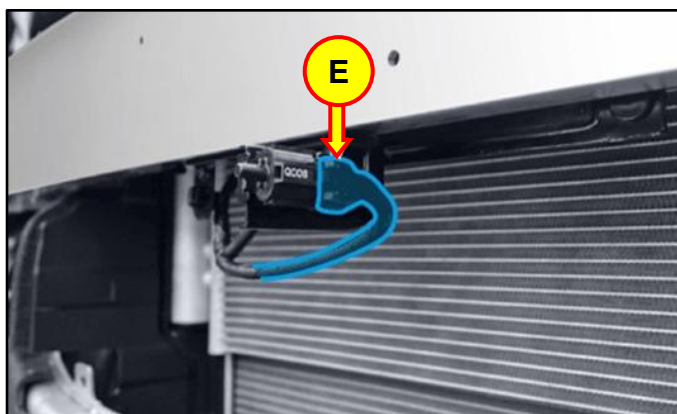
5. Disconnect the ambient temperature sensor connector (E).

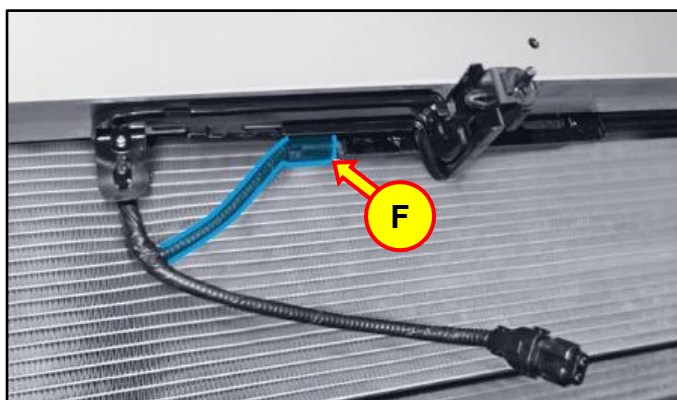
6. Disconnect the smart key antenna connector (F).

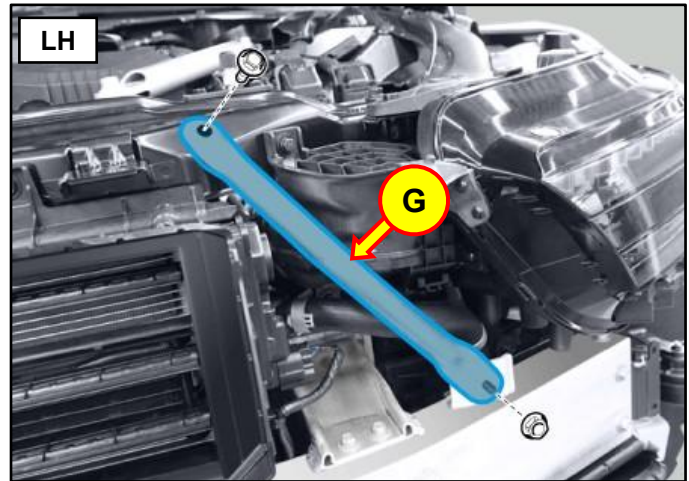
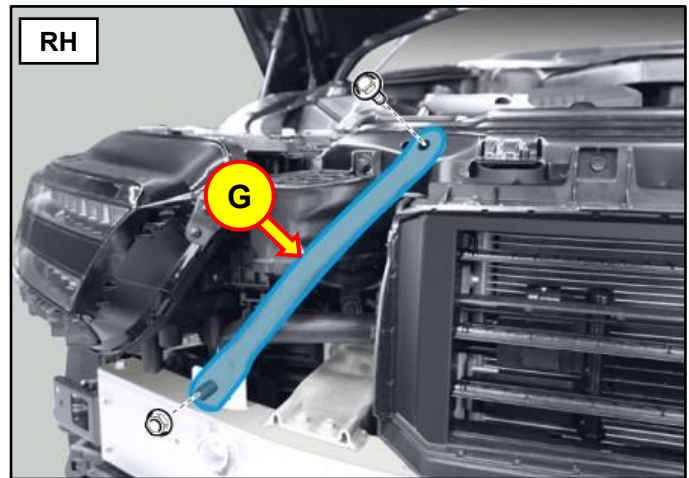
7. Remove the engine room cross bars (G) after removing the bolts and nuts.

**Tightening Torque:**

**Nuts:**

lb-ft	26
N.m	36

**Bolts:**

lb-ft	18
N.m	24

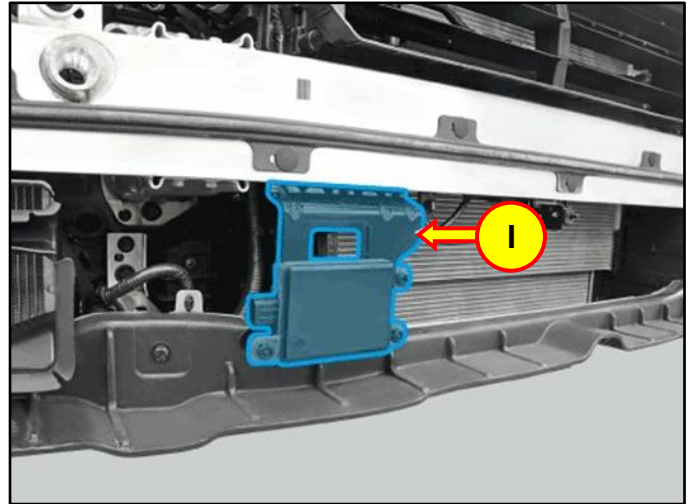
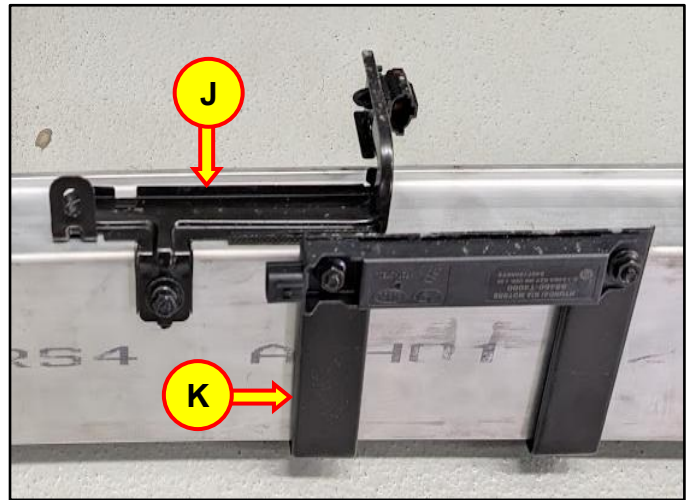
9. Transfer the front radar (I), ambient temperature sensor (J), and smart key antenna bracket (K) onto the new front bumper beam assembly.

**Tightening Torque:**

lb-ft	7.3
lb-in	87
N.m	9.8
