SIB 65 32 25

RECALL 25V-871: REPLACE LEFT AND RIGHT HEAD AIR BAGS

2026-01-05

SIB 65 31 25

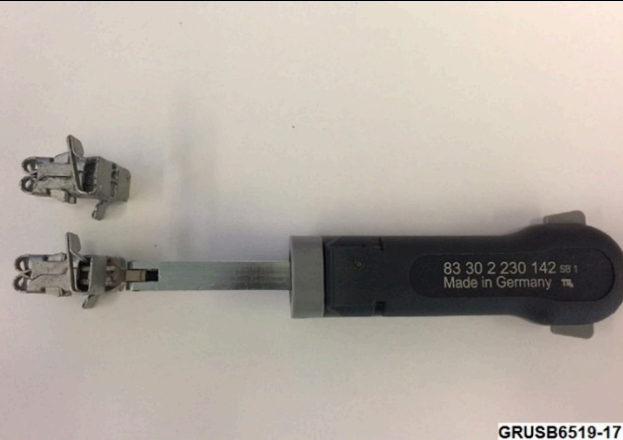
Special Tool 83 30 2 230 142 or its supersession 83 30 2 450 405 is needed to release the spring clips that hold the air bag assembly into the body.

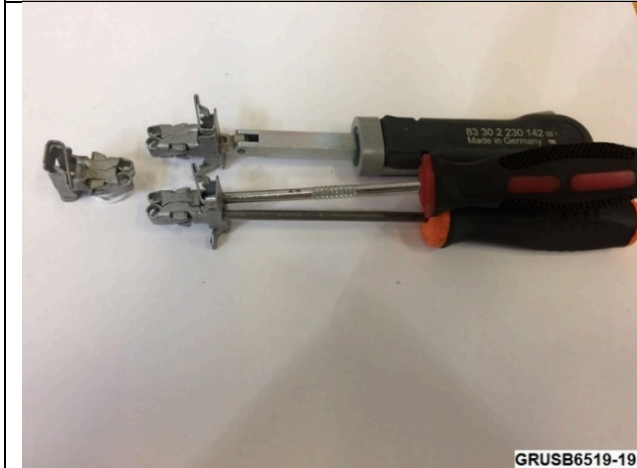
GRUSB6519-19

When the tool is inserted into the spring clip, it will retract the spring-loaded locking clips. This allows the clip to be removed from the blind hole in the vehicle body.

These tools were shipped to dealers previously under the Automatic Tool Shipment Program. If the tool is not available, two straight pick tools can be used.

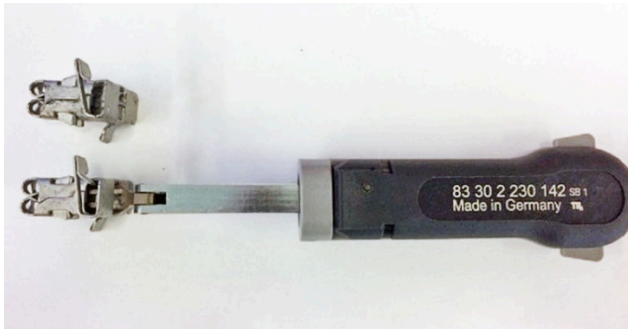
Special Tool 83 30 2 230 142 or its supersession 83 30 2 450 405 is needed to release the spring clips that hold the air bag assembly into the body.

Here is a spring clip that holds the air bag assembly into the body in its installed state.
