PRODUCT CAMPAIGN BULLETIN

APPLICABILITY: 2026MY Forester **NUMBER:** WRG-25R

SUBJECT: Safety Recall and Stop Sale: Rear Gate Stay Bracket **DATE:** 01/30/26

Subaru of America, Inc. (Subaru) has initiated a safety recall for certain 2026 model year Forester Vehicles to replace the rear gate stay and bracket.

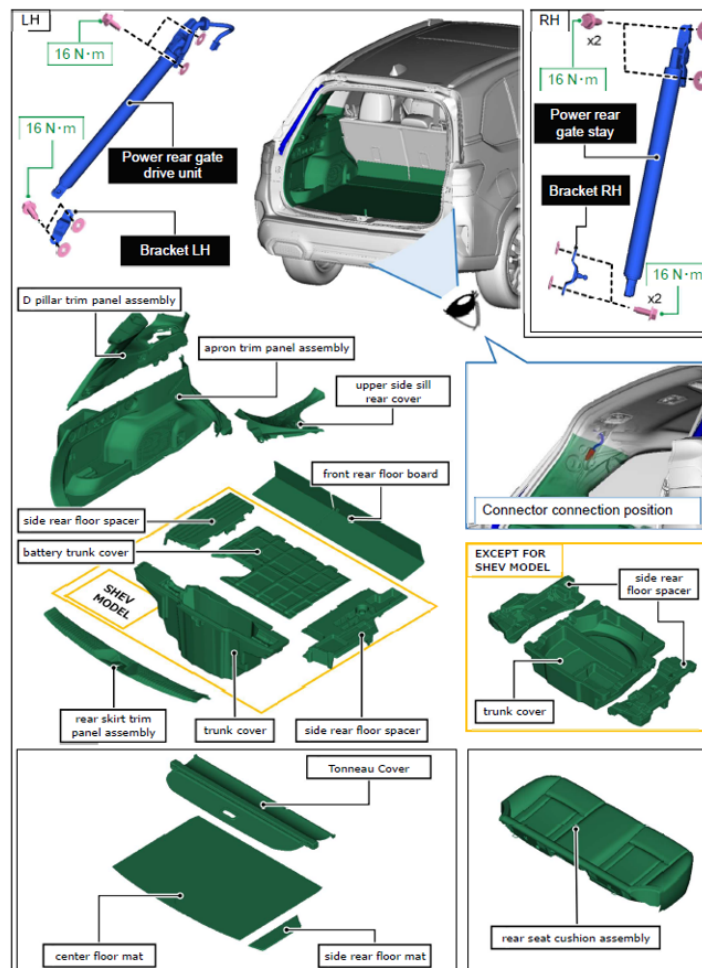
Power rear gate model:

The affected vehicles may have been manufactured with an incorrect and/or incorrectly oriented rear gate stay bracket which may cause the rear gate stay to become detached without prior warning during use.

Important: If either part fails the inspection, both the bracket and stay, or the bracket and drive unit, must be replaced.
