**Recall Service Bulletin
RSB26-900-001**

DATE: 1/23/2026

APPLIES TO: This service bulletin applies to certain model year 2021-2023, 2025 Legend, 2007, 2015-2026 Star Series, and 2019-2020 UST Body model emergency response vehicles built between March 29, 2016 and November 11, 2025.

CONDITION: The ladder lock handle assembly attached to the ladder bracket assembly may have been installed incorrectly. This may result in the handle becoming detached from the thread rod.

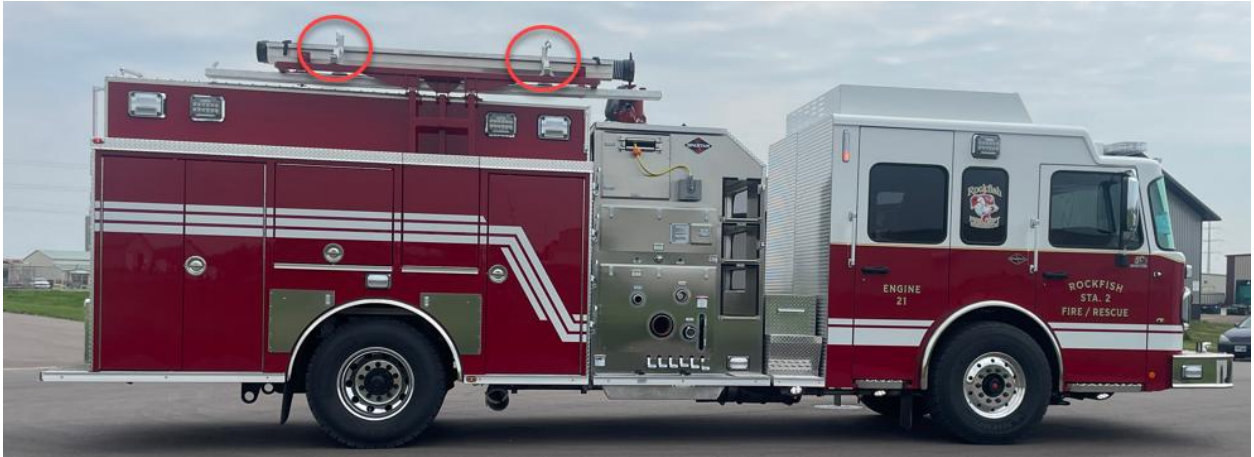
- 2) Remove the ladders from the brackets. The brackets may be a Cast Aluminum Bracket or a Fabricated Aluminum Bracket.
