# Safety Recall

## N252494000 L87 Engine Loss of Propulsion

Release Date: May 2025

Revision: 02

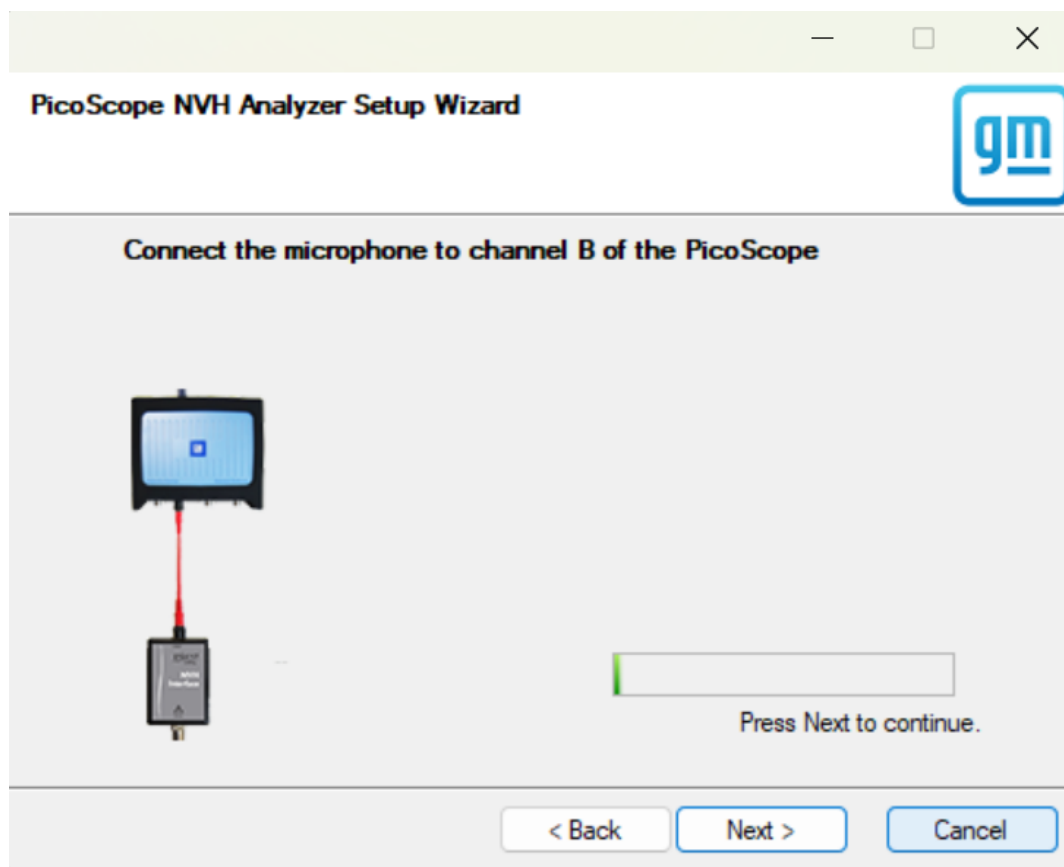
6932377

**Important:** The above screen indicates the PicoScope connected to an NVH interface, however the NVH interface IS NOT used for this procedure.
