Technical Service Bulletin

GROUP RECALL	NUMBER 26-01-014H
DATE FEBRUARY 2026	MODEL(S) KONA (SX2)

SUBJECT: FRONT STEERING KNUCKLE INSPECTION
(RECALL 295)

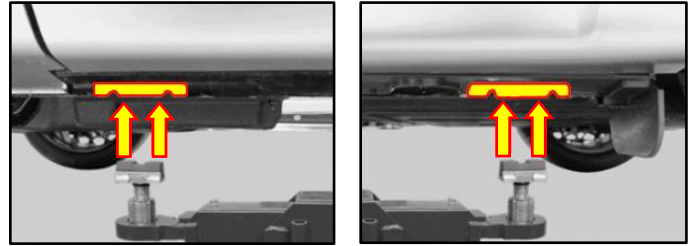
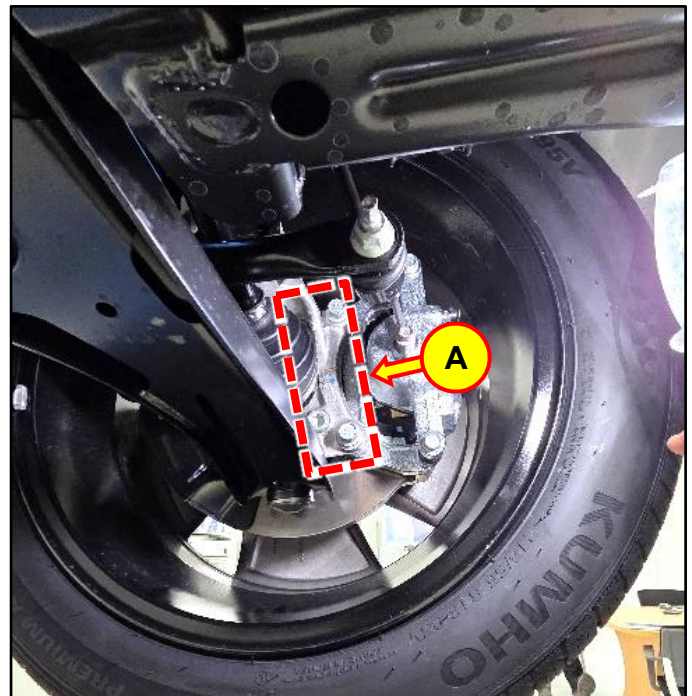
2. Locate the front steering knuckle (A) on the inner side of the wheel.

3. Check the lot code (B) to identify the production year, month, and day as described below.

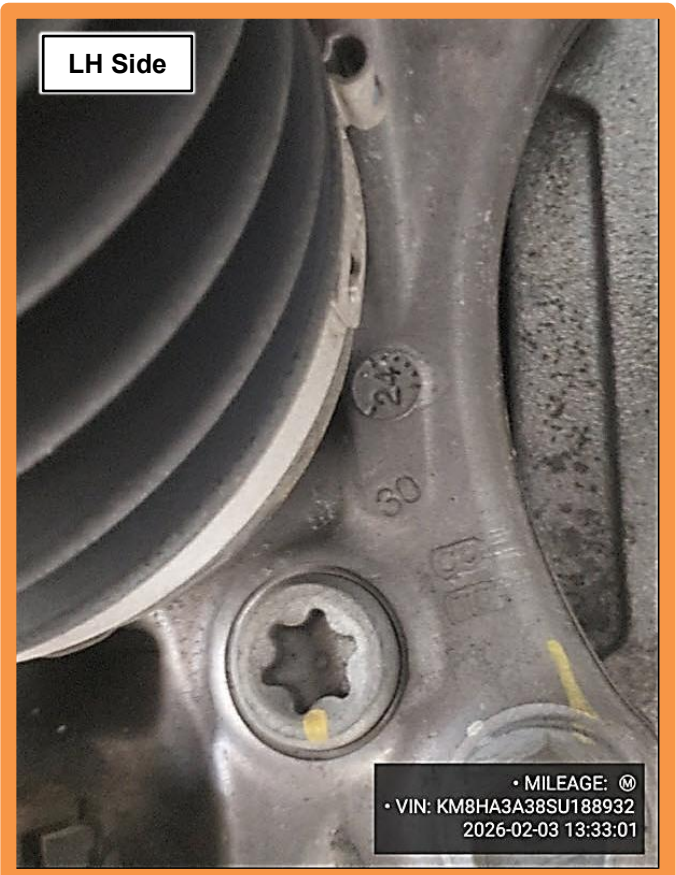
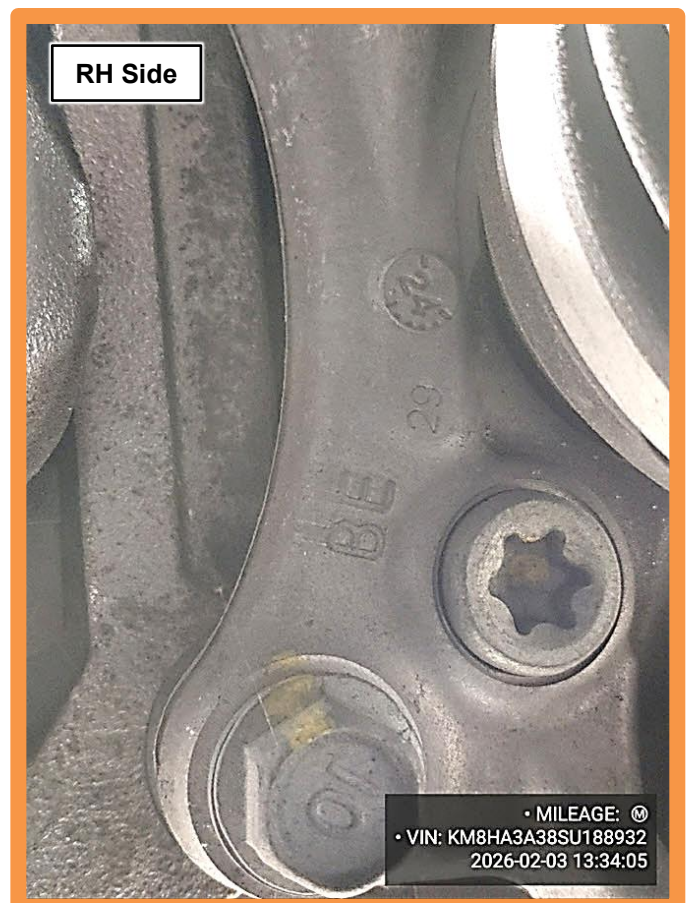
Using the STUI camera function, take photos of the lot code on **BOTH** LH and RH sides.

5. If the lot code is **October 15, 2025**, or if the code is **NOT** readable, proceed to the [Front Steering Knuckle Mold Number Inspection](#) procedure.
- C = Production Year: 2025
 - D = Production Month: October (10 dots)
 - E = Production Day: 15
6. If the lot code is **NOT** October 15, 2025 (e.g., any other date combination), then the front steering knuckles are **OK**.

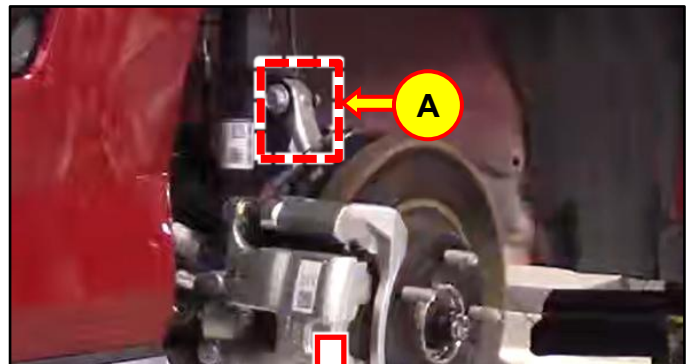
2. Locate the mold number on the front steering knuckle (A).

3. Check the mold number (B) stamped in the front steering knuckle.

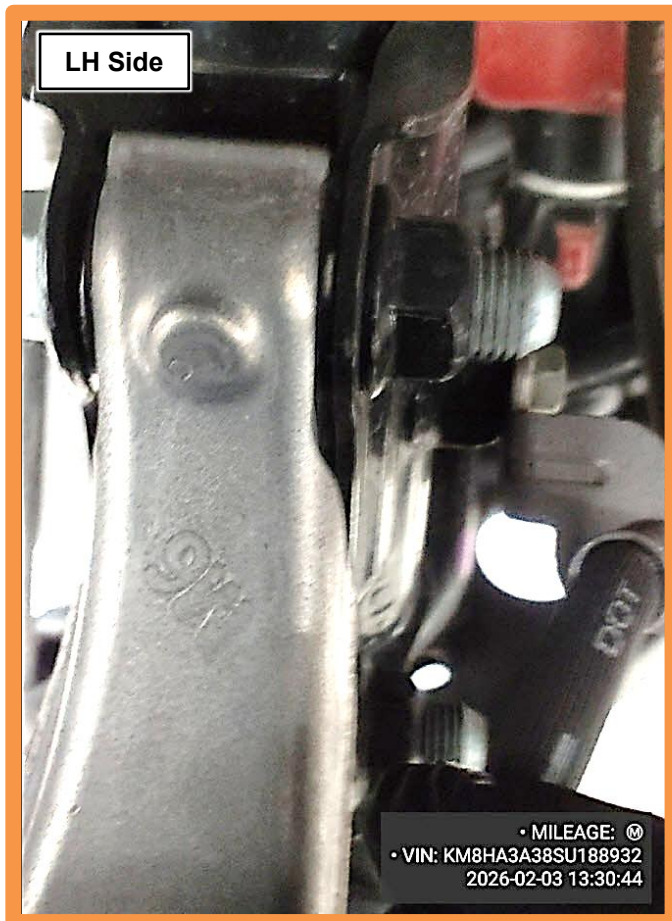
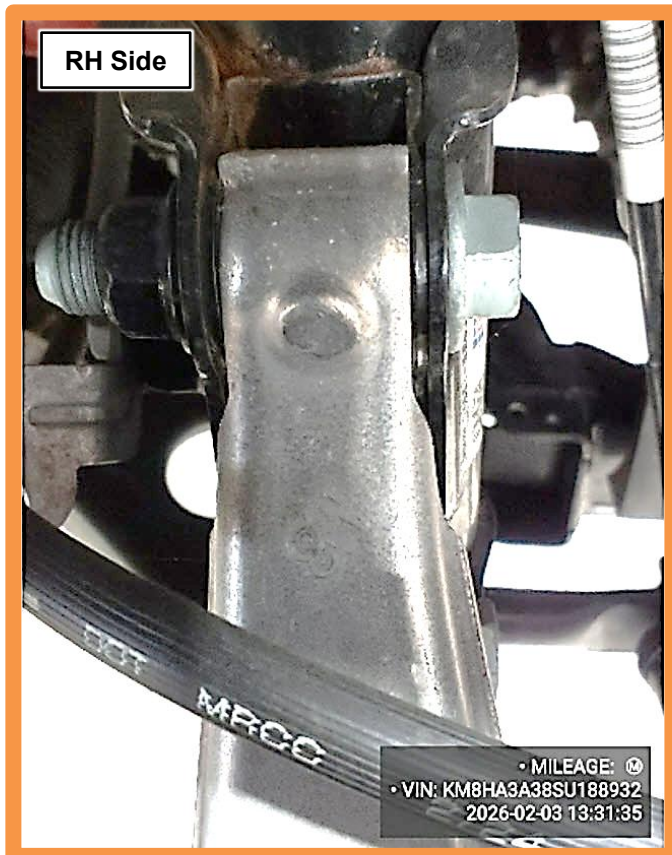
Using the STUI camera function, take a photo of the mold number on **BOTH** LH and RH sides.

5. If the mold number is **M1** on **either** the LH or RH side, or if the code is **NOT** readable, **HOLD** the vehicle.
