SERVICE PROCEDURE

SUBJECT: SAFETY RECALL

2026 and 2027 International® MV™ Series trucks built 11/13/2025 thru 12/08/2025, with Bendix® Fusion™ 3.0 Collision Mitigation, ACC Stop & Driver Go (feature code 0008TRM), and Allison 2000 or 3000 Series™ Generation 6 Transmission (feature codes 0013BAU, 0013BAV, 0013BBA, 0013BBG, 0013BBJ, 0013BBK, 0013BCS, and 0013BDR).

Subject: Bendix® EC-80™ Software Update for International® Motors

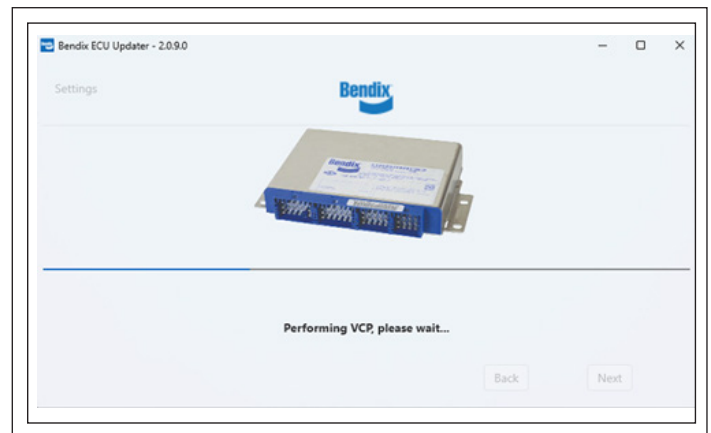
Figure 2 – Update in Progress

7. The software update will change the parameters of the EC-80. To proceed with the update, click **Yes**.
8. Once the update has started, the screen will show the progress. See *Figure 2*.

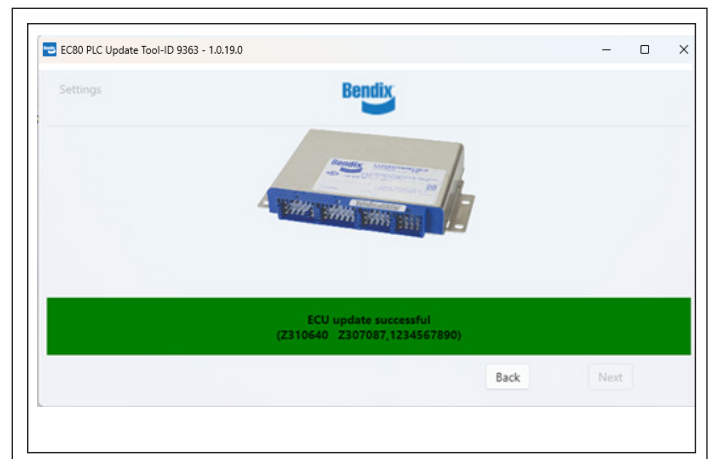
Figure 3 – Update Successful

9. If the update is successful, the screen will show that the software has been updated, and the procedure is complete. See *Figure 3*.

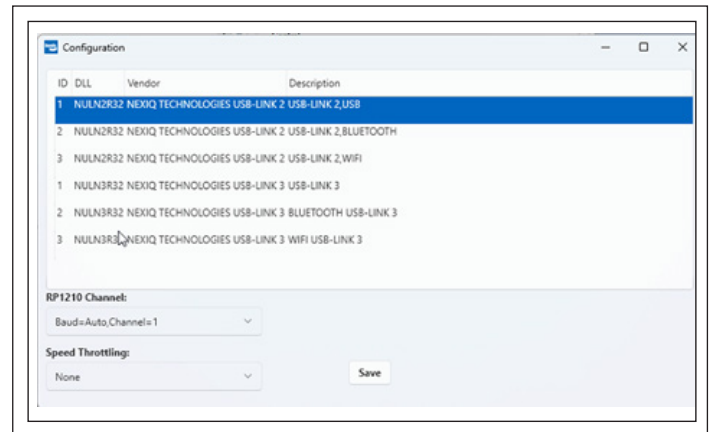
Figure 8 – Example Software Update Communication Configuration Settings Screen

b. Open the settings within software and verify the appropriate adapter, baud, and channel are selected. See *Figure 8* for an example of the Configuration settings.
