PRODUCT CAMPAIGN BULLETIN

APPLICABILITY: 2026 MY Crosstrek SHEV
 2025 MY Forester SHEV

NUMBER: WRD-26
DATE: 03/26/26

SUBJECT: Safety Recall & Stop Sale: Fuel Filler Cap Gasket
NHTSA ID:

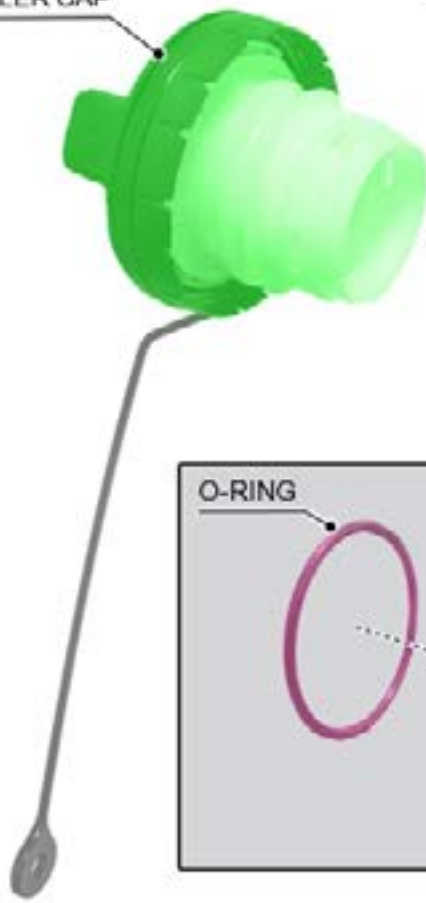
FUEL FILLER CAP

If the affected vehicles are left parked when the fuel tank is near full capacity and the vehicle is exposed to a significant rise in ambient temperature such that the fuel temperature and tank pressure increase, the affected vehicles may leak fuel from the filler cap.

For all potentially affected vehicles, Subaru retailers will replace the fuel filler cap gasket with an improved gasket incorporating an O-ring to enhance sealing performance at no cost to the customer.
