| | Safety Recall Campaign | 2026MY<br>K4 (CL4m) Hatchback<br>2027MY<br>Telluride (LQ2) |
| | SC364 | March 2026 |

SUBJECT: CENTER SEAT BELT ANCHOR BUCKLE  
INSPECTION AND/OR REPLACEMENT (SC364)

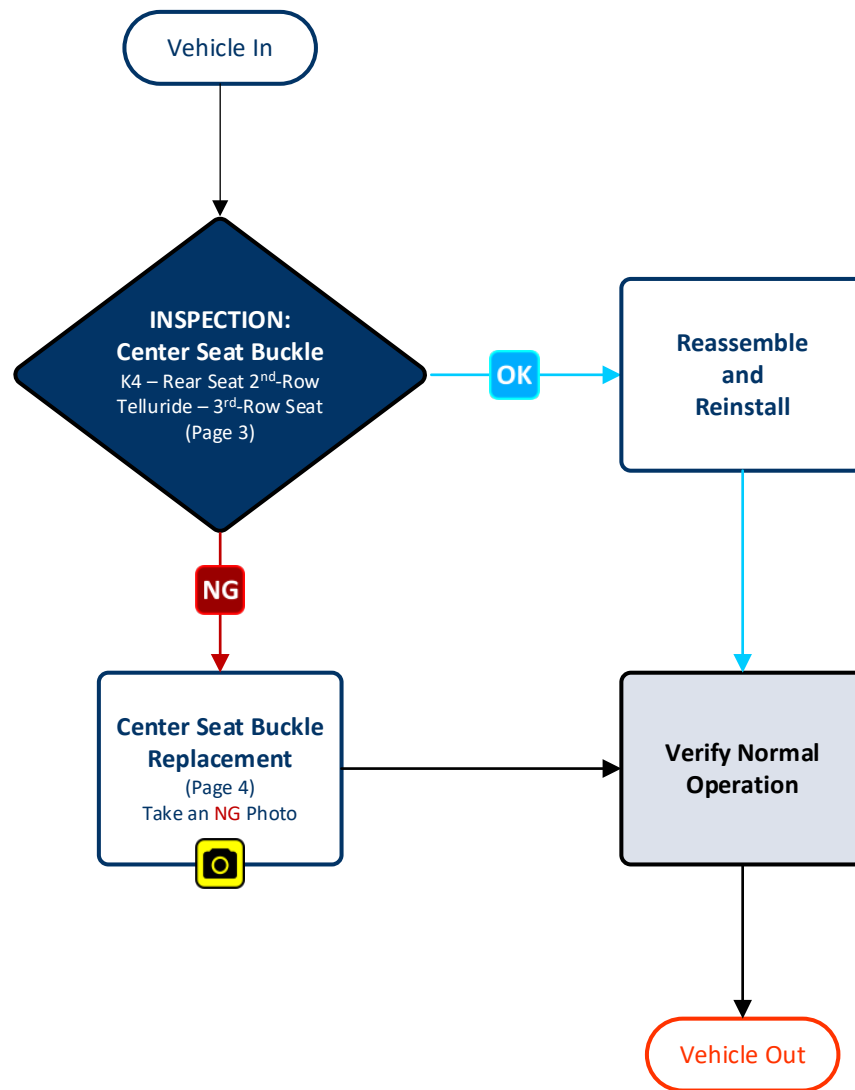
## Flowchart:

Inspection of the center seat belt buckle:

- **K4** - Rear Seat
- **Telluride** - 3<sup>rd</sup>-Row Seat

Removed **(NG)** center seat belt buckle assemblies CANNOT be reused. The removed part must be taped up and sealed in the new part's original box at the dealer for 30 days after claim payment and are subject to Mandatory Part Return (MPR). If the part is not returned, the claim may be subject to chargeback. [Refer to Warranty Bulletin 2026-10 for further instructions.](#)

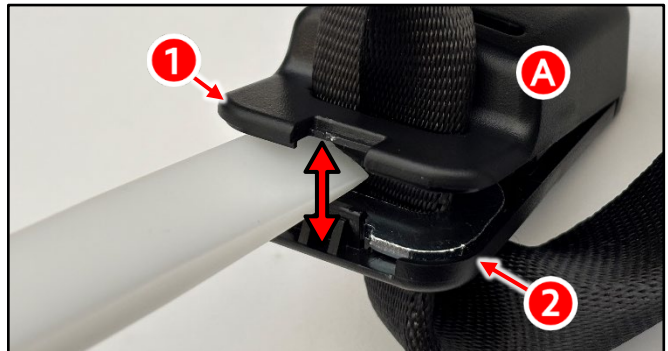
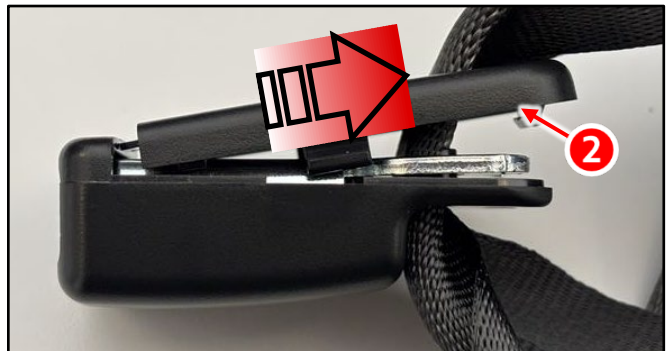
3. Slide the buckle cover (2) back
- 4a. First, lift the buckle plate assembly (B) up and away from the buckle cover (1).
  - 4b. Second, pull the buckle plate assembly (B) outward as shown to separate it from the buckle cover (1).
