# Campaign Service BULLETIN

**BULLETIN NUMBER:**  
CB26-N-001

## IMPORTANT SAFETY RECALL

### N-SERIES CAB AND CHASSIS HARNESS – 26V-210

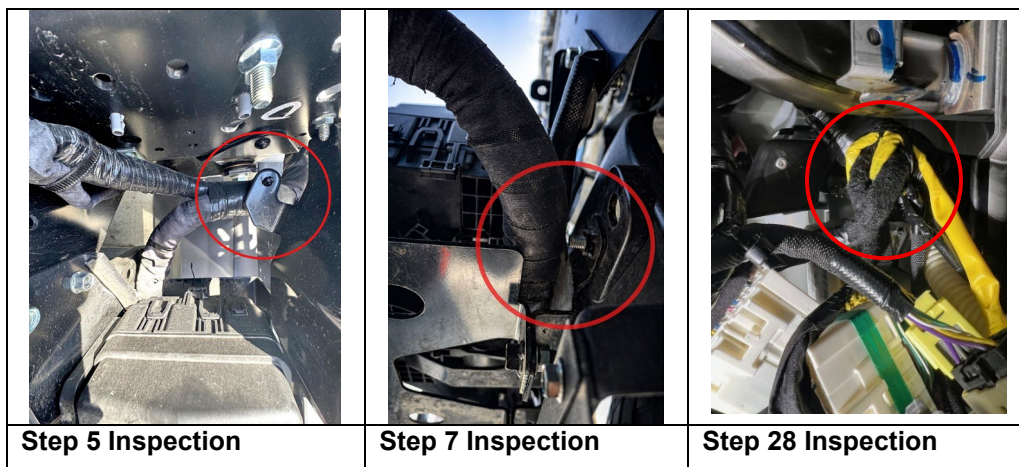
This Service Procedure will instruct a technician to inspect three areas of the vehicle’s wiring harness (two areas on the chassis harness, and one area in the cab).
