# Campaign Service BULLETIN

**BULLETIN NUMBER:**  
CB26-N-002

### **NRR-EV CAB HARNESS EXPANDED SAFETY RECALL – 26V-210 (Transport Canada 2026-386)**

- 2025-2026MY Isuzu NRR-EV (Electric Vehicles)

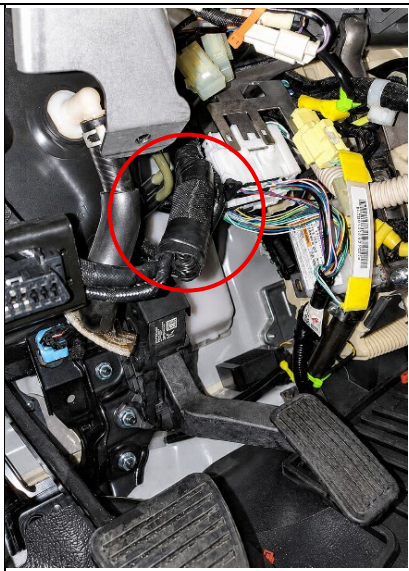
| <p><b>Step 21 – Inspection (H98 &amp; H99 Connector Harness)</b> may be previously repaired if V2602EV is already closed.</p> | <p><b>Step 28 – Inspection (Harness Above Accelerator Pedal)</b></p> | <p><b>Step 40 – Inspection (Module Stack Harness Point A)</b></p> |

21. Inspect each black wiring harness going to H98 and H99 for signs of chafing. (See Figure 17.)

- a. Any harness chafing that has not damaged the colored insulation should be rewrapped with Tesa tape 51006. After wrapping continue to the next step.
- b. If bare wiring is exposed, stop and take a digital photo of the damaged area. Make notation of the damage on your repair order and skip to Step 58.

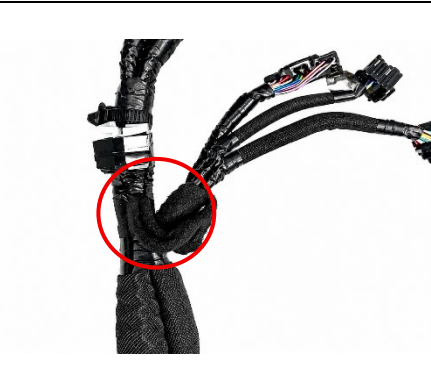
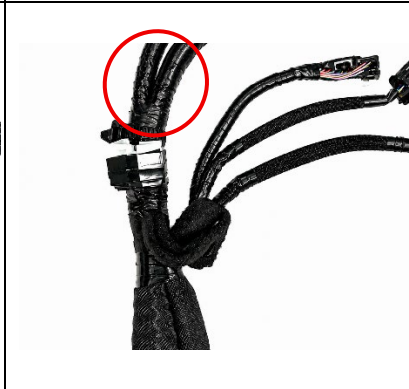
| <p><b>Step 40 – Inspection (Module Stack Harness Point B)</b></p> | <p><b>Step 40 – Inspection (Module Stack Harness Point C)</b></p> | <p><b>Step 57 – Inspection (Behind the IPC)</b></p> |

40. Inspect the three locations: [A] Root of the branch to the unit assembly harness [B] Branch to the I/O Controller and BCM [C] CGW branch on the harness for signs of chafing. (See Figure 45.)
- If there is no noticeable damage to the harness in any location, continue to the next step.
  - If the harness is chafed but has not exposed any bare wiring in any location, wrap the affected area with Tesa tape and continue to the next step.
  - If bare wiring is exposed in any location, stop and take a digital photo of the damaged area. Make notation of the location that is damaged on your repair order and skip to Step 58.

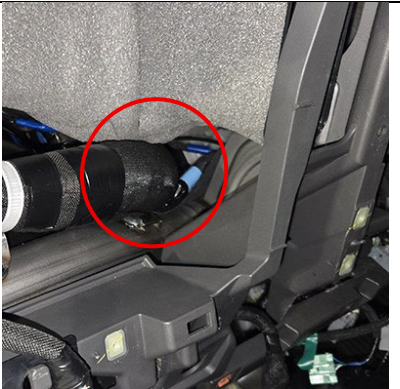
- If there is no noticeable damage to the harness, continue to Step 59.
- If the harness is chafed but has not exposed any bare wiring, prepare the **band clip with protective tape** and continue to Step 59.
- If bare wiring is exposed, stop and take a digital photo of the damaged area. Make notation of the damage on your repair order and continue to the next step.

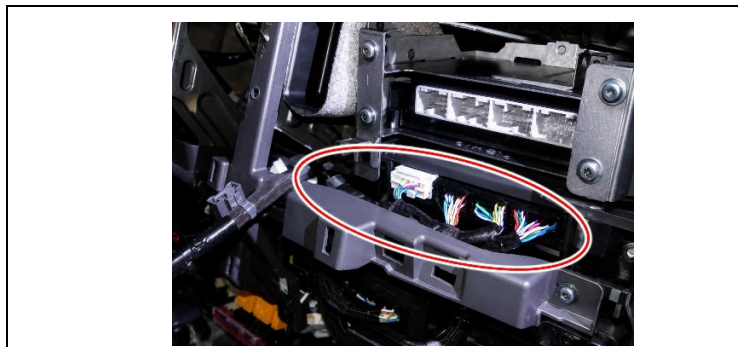
**Figure 50**

51. Tuck the BCM harness under the instrument panel as shown. (See Figure 50.)

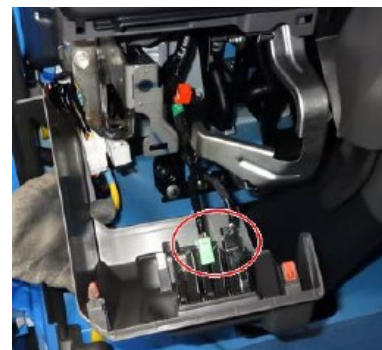
**Figure 52**

52. Remove one screw and clip from the lower instrument panel cover to the left of the steering wheel. (See Figure 51.) Pull down the lower instrument panel cover and disconnect all connectors. (See Figure 52.)

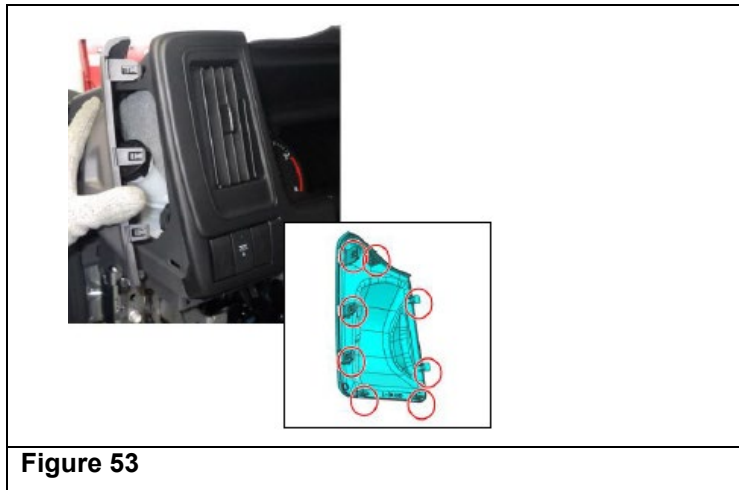
53. Remove the master cylinder reservoir cover by disengaging eight (8) retaining tabs. (See Figure 53.)

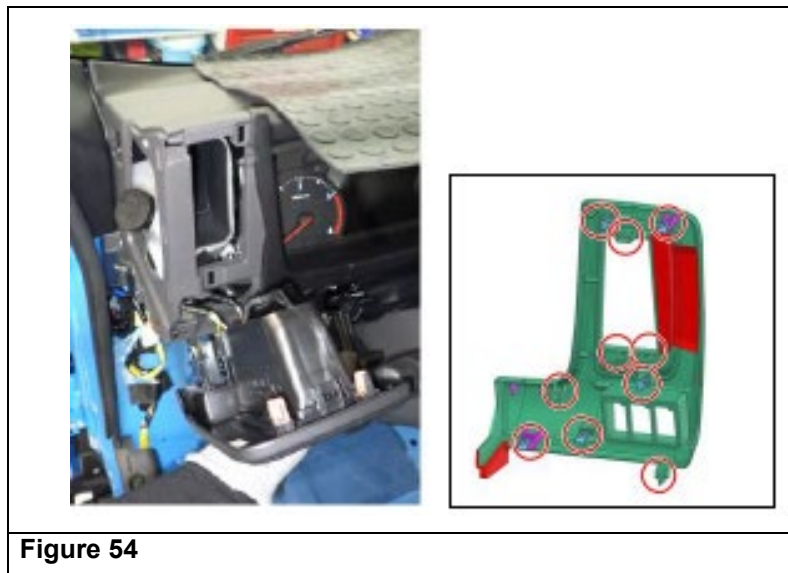
54. Remove the driver side cluster trim panel by disengaging the ten (10) retaining tabs. Disconnect any connectors. (See Figure 54.)

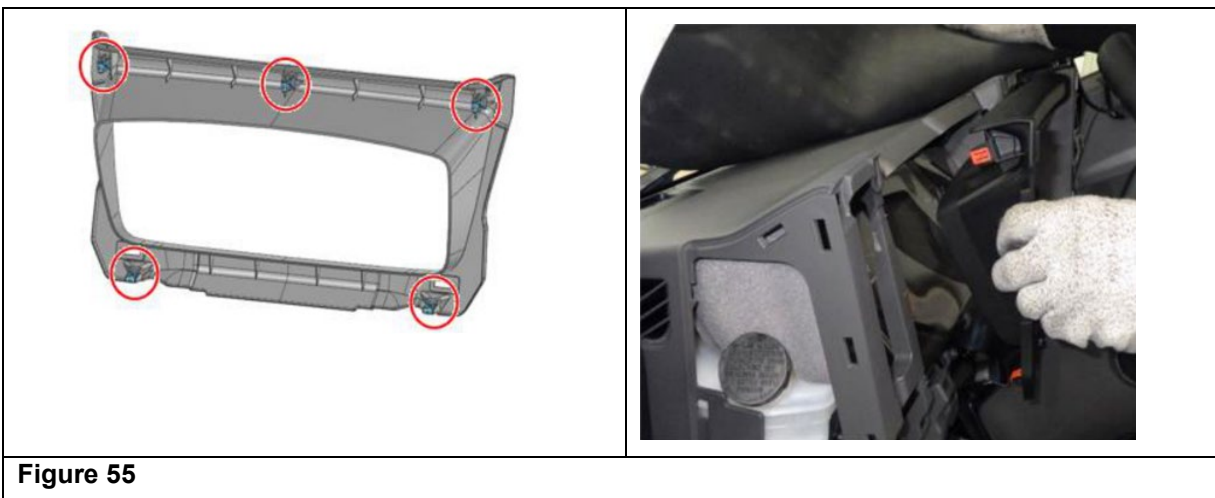
55. Remove the IPC bezel surround by disengaging five (5) retaining tabs. (See Figure 55.)

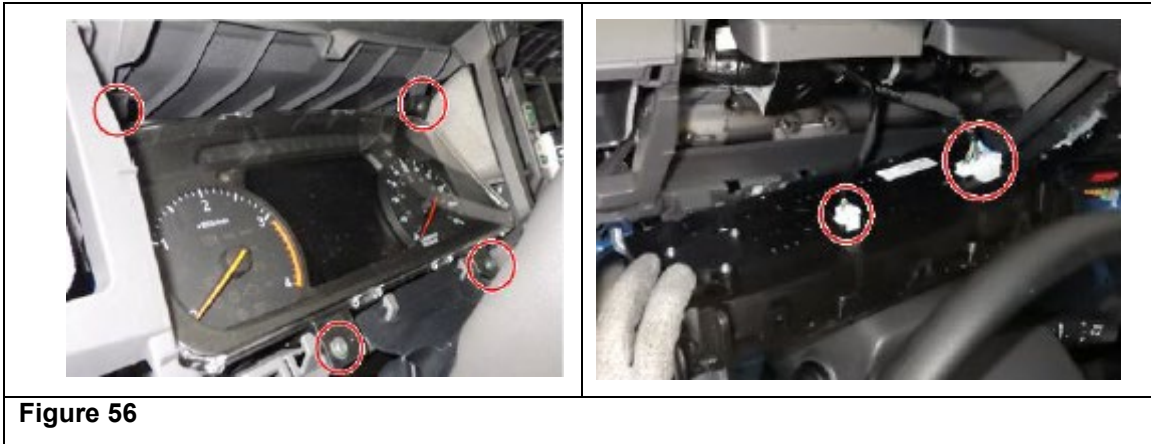
56. Remove the four (4) screws holding the IPC. Disconnect the two (2) connectors behind the IPC and remove the unit. (See Figure 56.)

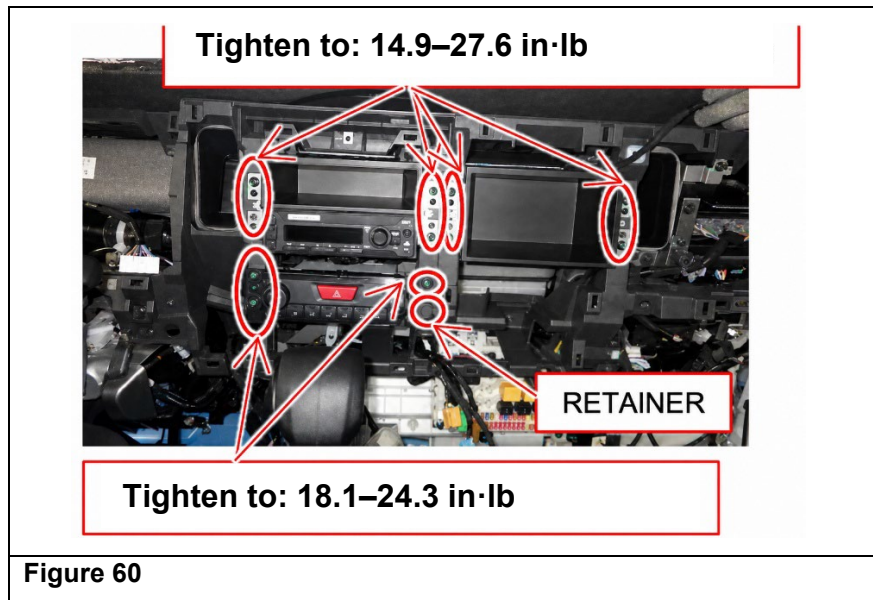
60. Reconnect the connectors on the back of the IPC and install the IPC. Tighten the four (4) screws to 17.7 in. lb.
61. Reinstall the IPC bezel surround by engaging five (5) retaining tabs. (See Figure 55.)
62. Reinstall the lower instrument panel cover by reconnecting the connector, engaging three (3) retaining tabs and installing the clip and screw. (See Figures 51 and 52.)
63. Reinstall the driver side cluster trim panel by reconnecting the connector and engaging the ten (10) retaining tabs. (See Figure 54.)
64. Reinstall the master cylinder reservoir cover by engaging the eight (8) retaining tabs. (See Figure 53.)
65. Reconnect and reinstall the HVAC control unit and tighten the T25 screws to 2.05~2.75 N·m. (See Figure 60.)
66. Reconnect and reinstall the radio and center pocket and tighten the T25 screws to 18-24 in. lb. (See Figure 60.)

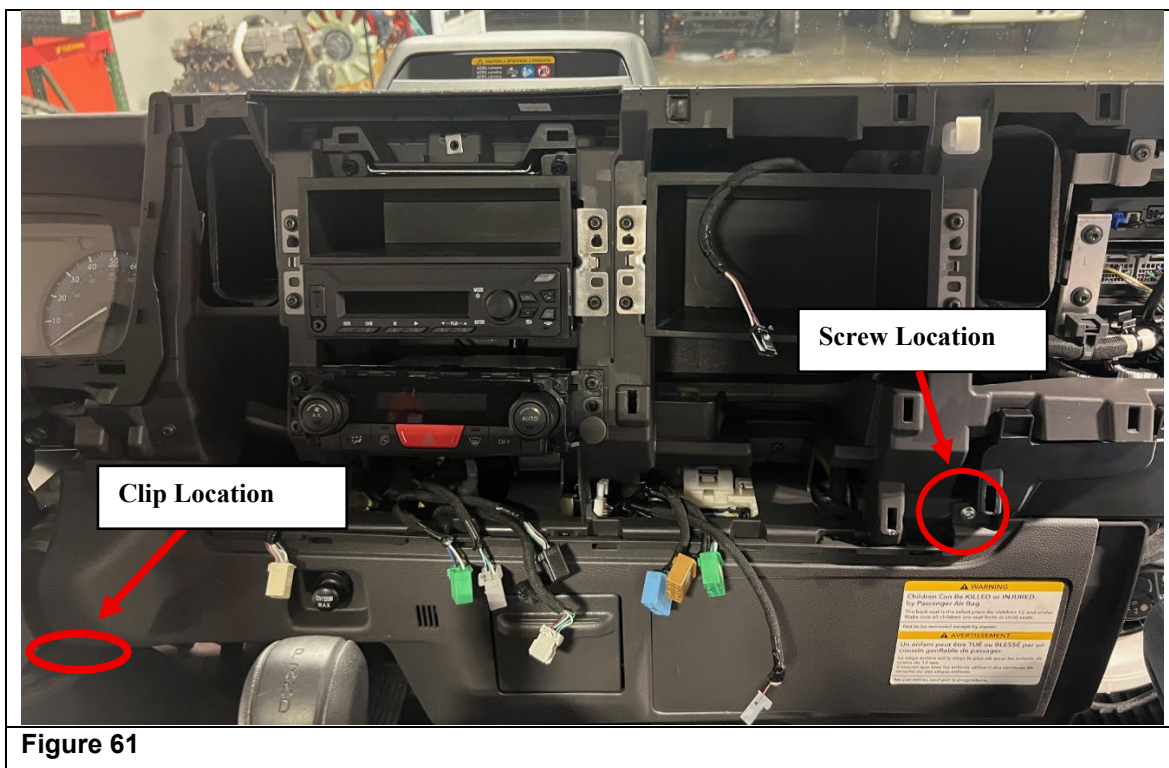
67. Put the lower instrument panel under cover in place for installation and connect the 12V accessory port and the HVAC temperature sensor housing. (See Figure 11.)
68. Install the lower instrument panel under cover and ensure all the clips are engaged. Install the screw and the plastic clip. (See Figure 61.)

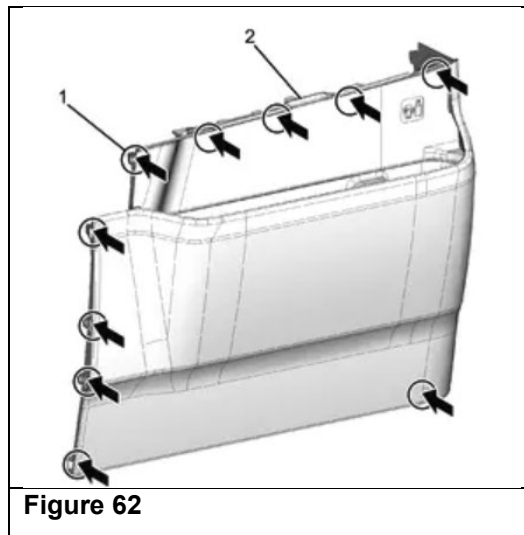
69. Connect the passenger airbag cut off switch connector and install the side under cover. (See Figure 62.)

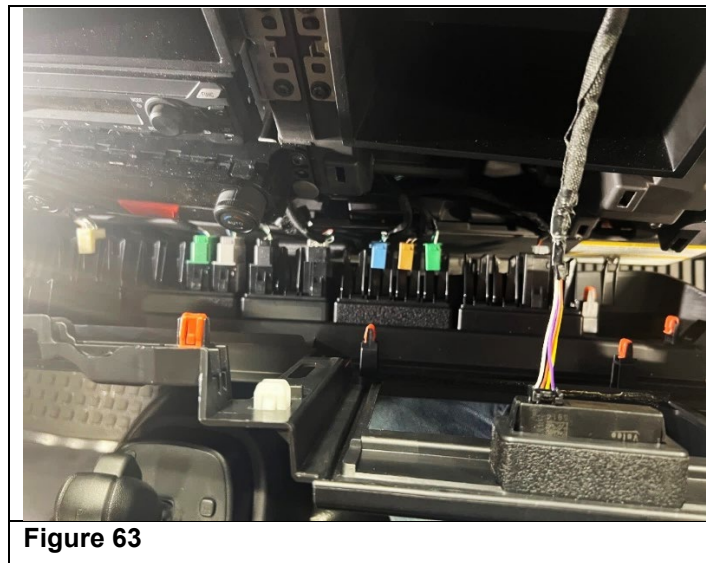
70. Hold the center cluster in place and connect all the connectors that were disconnected in Step 11. (See Figure 63.)

**NOTE: Refer to the photo captured in Step 11 for the correct connector orientation.**

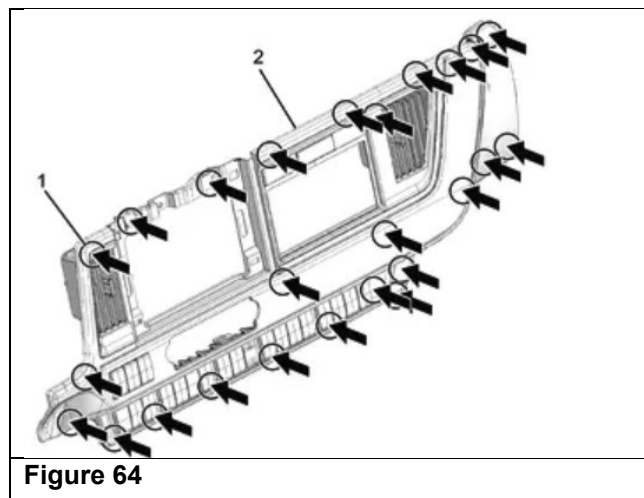
71. Install the center cluster. (See Figure 64.) Ensure that all clips are lined up properly before pushing the center cluster in place. Ensure that all clips engage properly.

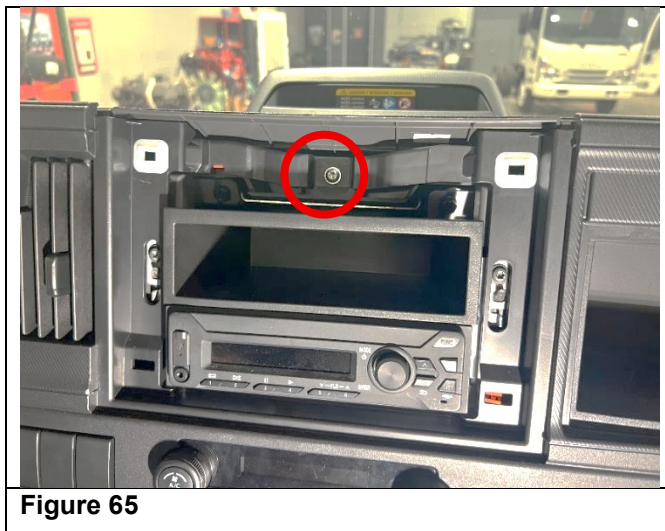
72. Install the screw into the center cluster and tighten the T25 screw to 16-19 in. lb. (See Figure 65.)

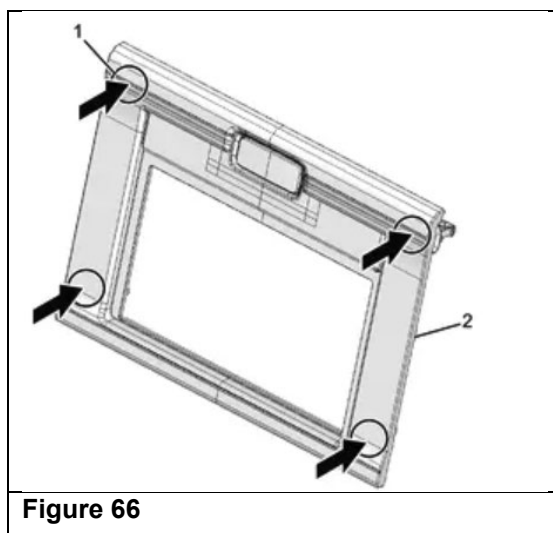
73. Install the bezel to the center cluster. (See Figure 66.)

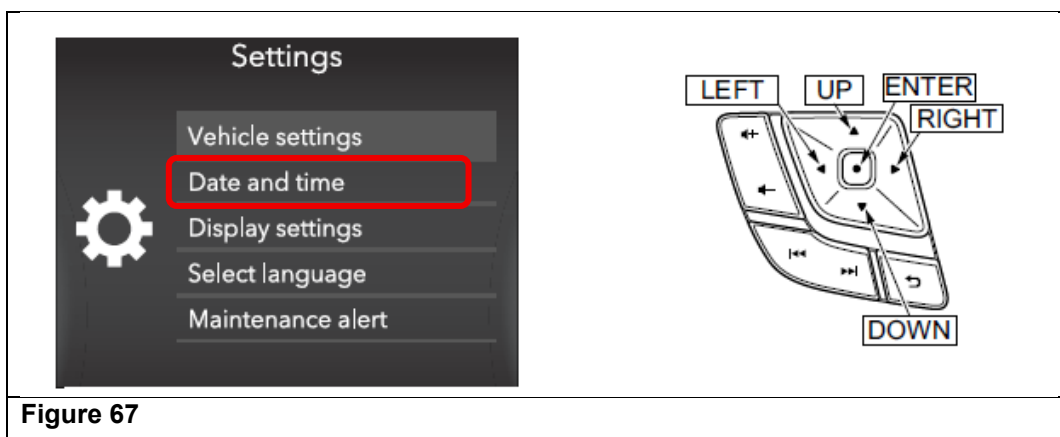
75. Turn the EV Control Switch to the “ON” position and use the steering wheel switches on the left side of the steering wheel and navigate through the Multi Information Display (MID) to the “Settings” screen. Then select “Date and Time”. (See Figure 67.)

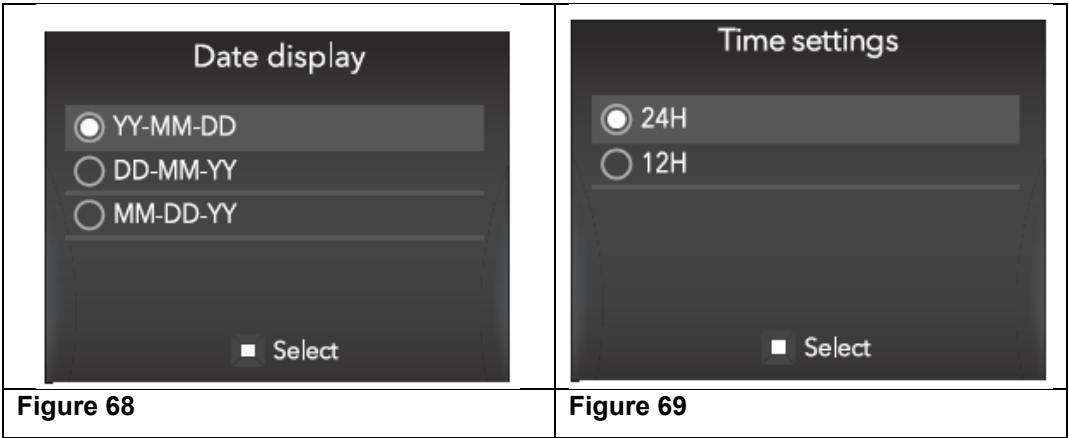
76. Follow the prompts to set the preferred date and time format. (See Figures 68 and 69.)
