# Campaign Service BULLETIN

**BULLETIN NUMBER:**  
CB26-N-001A

### **N-SERIES CAB AND CHASSIS HARNESS EXPANDED SAFETY RECALL – 26V-210**

- 2025-2027MY Isuzu N-Series Vehicles (Equipped with Diesel Engines)

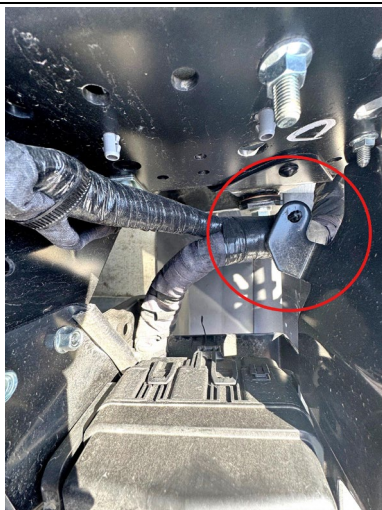
**Step 5 – Inspection (refer to NOTE in service procedure)**

5. **Single Cab Models** - from the top view, locate the wiring harness under the harness bracket tab and check for any damage. (See Figures 4 and 5.)

**Crew Cab Models** - from the side view, look past and between the fuse box and fuel sedimenter to locate the harness under the harness bracket tab. Use a telescoping inspection mirror and a flashlight to check for any damage. (See Figures 4 and 5.)

- a. If there is no noticeable damage to the harness, continue to the next step.
- b. If the harness is chafed but does not have any exposed bare wiring, wrap the affected area with Tesa tape and continue to the next step.
- c. If bare wiring is exposed, stop and take a digital photo of the damaged area. Make a notation of the damage on your repair order and continue to the next step.

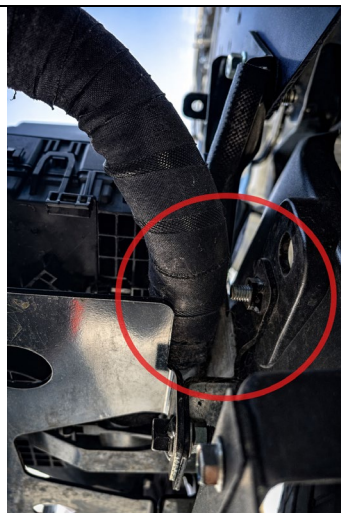
**Step 7 – Inspection (refer to NOTE in service procedure)**

7. From underneath the fuse box, locate the wiring harness near the mud flap bolt and check for any damage. (See Figures 7 and 8.)
- If there is no noticeable damage to the harness, continue to the next step.
  - If the harness is chafed but has not exposed any bare wiring, wrap the affected area with Tesa tape and continue to the next step.
  - If bare wiring is exposed, stop and take a digital photo of the damaged area. Make notation of the damage on your repair order and skip to Step 10.

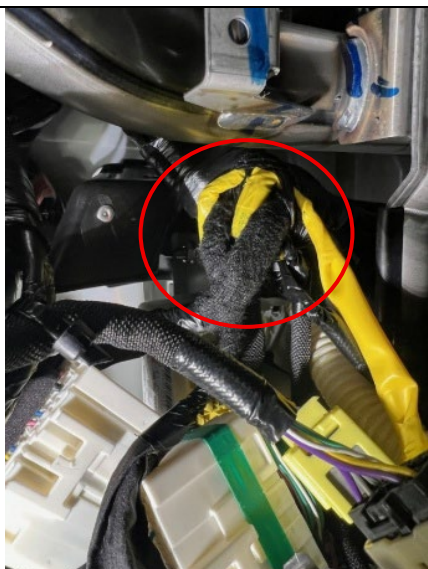
**Step 28 – Inspection (H98 & H99 Connector Harness) (refer to NOTE in service procedure)**

28. Inspect each black wiring harness going to H98 and H99 for signs of chafing. (See Figure 27.)

- a. If there is no noticeable damage to the harness, continue to the next step.
- b. If the harness is chafed but has not exposed any bare wiring, wrap the affected area with Tesa tape and continue to the next step.
- c. If bare wiring is exposed, stop and take a digital photo of the damaged area. Make notation of the damage on your repair order and skip to Step 66.

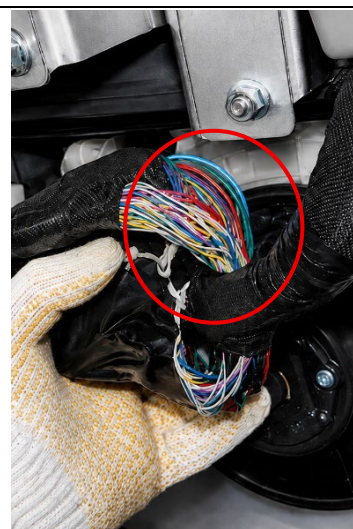
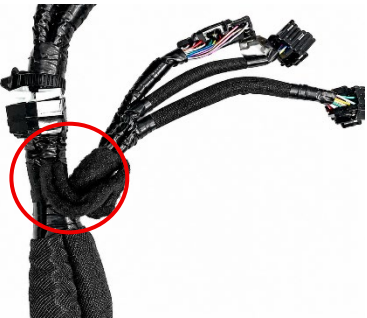
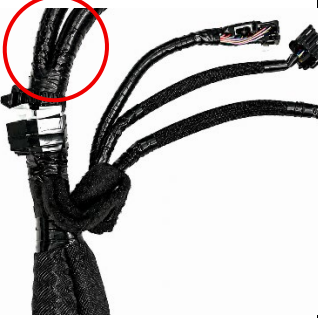
**Step 47 – Inspection (Module Stack Harness Point A)**

- If there is no noticeable damage to the harness in any location, continue to the next step.
- If the harness is chafed but has not exposed any bare wiring in any location, wrap the affected area with Tesa tape and continue to the next step.
- If bare wiring is exposed in any location, stop and take a digital photo of the damaged area. Make notation of the location that is damaged on your repair order and skip to Step 66.

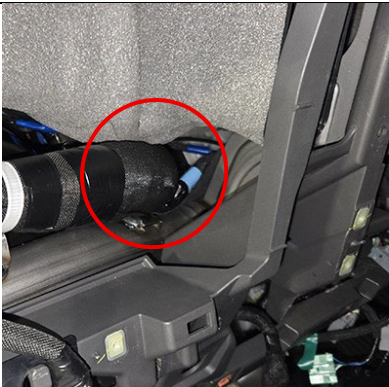
- a. If there is no noticeable damage to the harness, continue to Step 67.
- b. If the harness is chafed but has not exposed any bare wiring, prepare the **band clip with protective tape** and continue to Step 67.
- c. If bare wiring is exposed, stop and take a digital photo of the damaged area. Make notation of the damage on your repair order and continue to the next step.

66. If any inspection revealed bare wiring, refer to the “Preface” for additional information about photos and inspection step numbers to Isuzu Technical Assistance (TAC) via “Isuzu Connect”. TAC will respond via “Isuzu Connect” with additional instructions. After completing additional repairs be sure to complete any skipped steps and continue through the remainder of the bulletin.
67. Place the band clip with protective tape between the harness and the reinforcement bar. (See Figure 57.) Using both hands, slide the band clip with protective tape towards the right of the harness until it reaches the base of the wire branch with blue tape. (See Figure 58.) After confirming that the harness is fully protected, tighten and lock the band clip around the wiring harness.

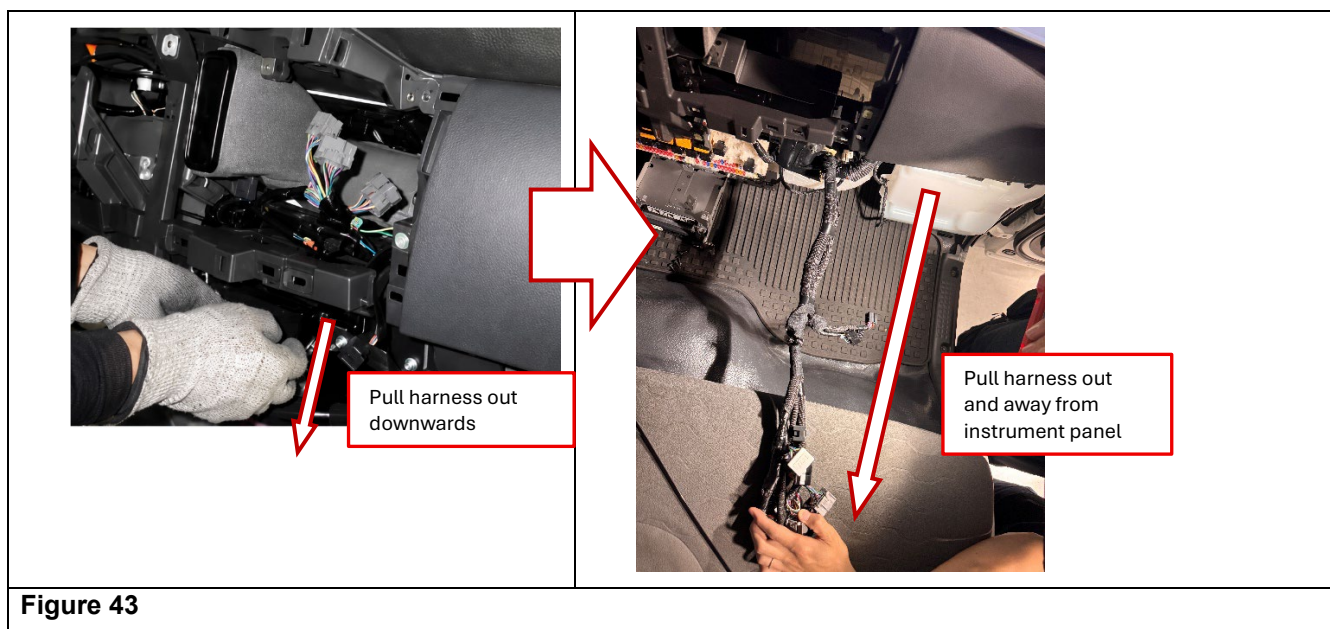
47. Inspect the three locations: [A] Root of the branch to the unit assembly harness [B] Branch to the I/O Controller and BCM [C] CGW branch on the harness for signs of chafing. (See Figure 44.)
