GROUP	MODEL
Safety Recall Campaign	2022-2026MY Carnival (KA4)
NUMBER	DATE
SC368	June 2026

# HIGH-PRESSURE CROSS-OVER FUEL PIPE TORQUE INSPECTION / REPLACEMENT (SC368)

This bulletin provides information to inspect and, if necessary, replace the high-pressure crossover fuel pipe on certain 2022-2026MY Carnival (KA4) vehicles produced from January 4, 2021 through November 20, 2025. The high-pressure crossover fuel pipe nuts may loosen over time, resulting in a fuel leak. A fuel leak in the presence of a ignition source increases the risk of fire, thereby increasing the risk of injury. In addition, the subject vehicles may be releasing air pollutants which exceed California and federal standards. These standards were established to protect the public's health and welfare from the dangers of air pollution. Follow the procedure outlined in this publication to inspect the high-presure crossover fuel pipe. If a leak is identified, dealers are to replace the high-pressure crossover fuel pipe with a new one. If no leak is identified, dealers are to securely fasten the high-pressure crossover pipe nuts on the applicable vehicle. Before conducting the procedure, verify that the vehicle is in

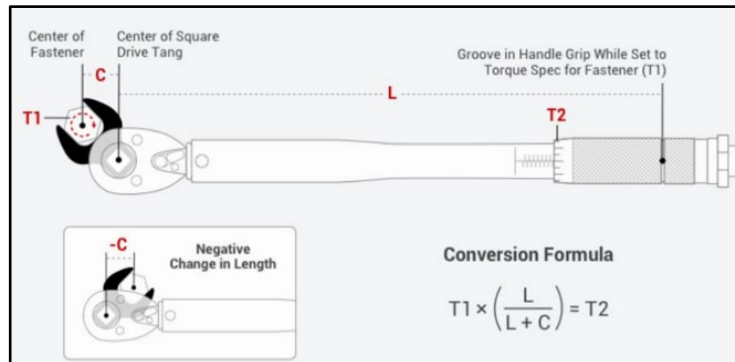
### Crawfoot Wrench + Torque Wrench Formula

(The recommended torque specification above was calculated using a 15"-16" long torque wrench and aligning the the crawfoot wrench straight with the torque wrench at 180° degrees.)

\*\*\* Use the formula below if the torque wrench you are using is longer and the crawfoot wrench is angled slightly. \*\*\*

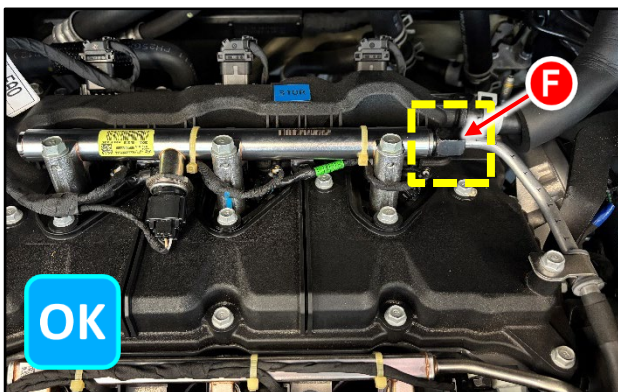
Bank 1 (rear)

5b.  Fuel leak **is not** present (**OK**). Proceed to step 6 to verify both high-pressure cross-over fuel pipe flanges nuts (Bank 1 and 2) are torqued to the required specification.

- 7a. Place the torque wrench and crawfoot wrench attachment as shown (at 180 °) and tighten the **Bank 1 (F)** fuel pipe flange to the torque specification.

Tightening torque for flange nut (F & G):  
23.9 - 26.0 lb.ft (32.4 - 35.3 N.m)  
**With crawfoot wrench: 27.4 lb.ft. (37.2 N.m)**
