**SIB 61 05 26****Recall 26V-305: C Evolution Connector Check and Cable Replacement**  
**2026-07-21**This Service Information Bulletin replaces SIB 61 05 26 **dated June 19<sup>th</sup>, 2026.****What's New** (Specific text highlighted):

**0C03 - C evolution****00 61 005 Install wiring harness repair kit****1**

## RECALL 26V-305: C EVOLUTION CONNECTOR CHECK AND CABLE REPLACEMENT

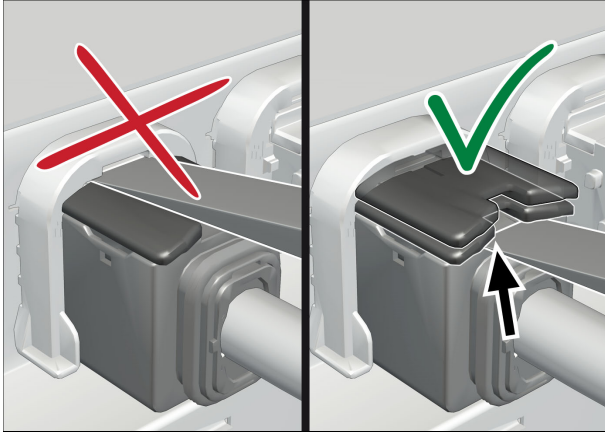
## 16

► **Disconnecting and checking connector of component connection**

- for moisture
- for corrosion

- **Install the wiring harness repair kit and seal terminal 31.**
