Safety Recall

N262557310 Roof Rail Airbag Inflator May Rupture

Release Date: May 2026

Revision: 01

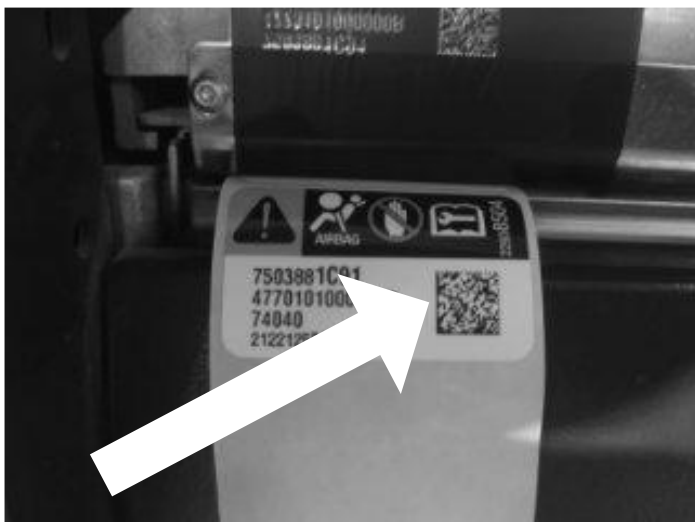
6070519

Important: Since there are 2 new parts being installed for this recall remedy, you are REQUIRED to record the RRAB serial Numbers for BOTH SIDES.

Record and submit the RPT for BOTH replacement RRAB serial numbers for RPT as shown above. Refer to TSB 25-NA-195 for more information on how to submit the RPT.
