**TECHNICAL INSTRUCTIONS**  
**FOR**  
**SAFETY RECALL 26TA11**  
**REPROGRAMMING FOR**  
**BATTERY ECU**

**CERTAIN 2026 bZ**

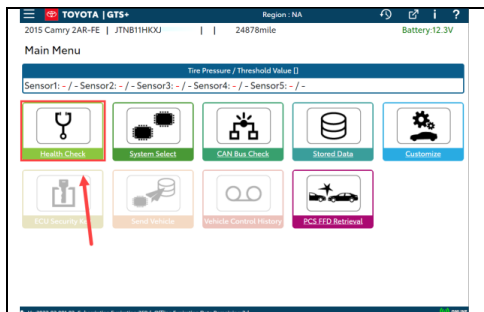
### 1. CHECK FOR DTC'S

- Using a GTS+, click the "Health Check" button on the Main Menu.

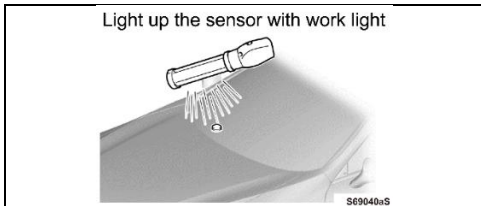
a) Confirm the following conditions:

- Ignition switch is in IG position
- Shift position is P range
- Parking brake is applied
- Turn off all electrical accessories (i.e. climate control, audio system, etc.)
- Headlight switch in the DRL OFF position. (Model has DRL off position)
- Windshield wiper switch in the OFF position.

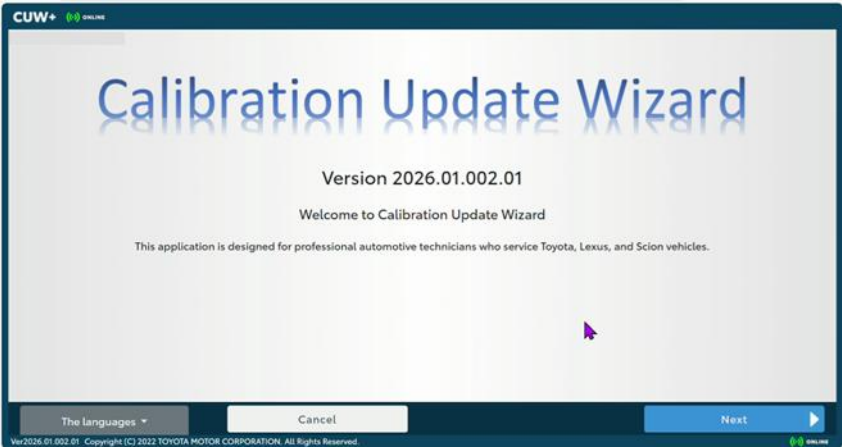
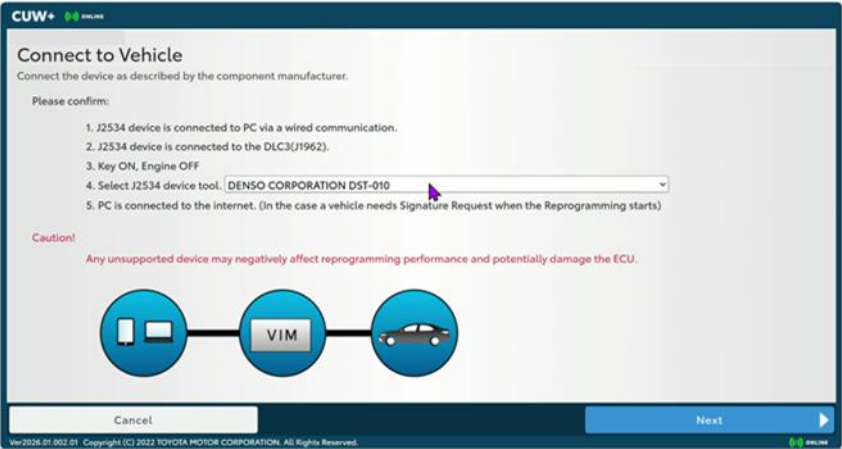
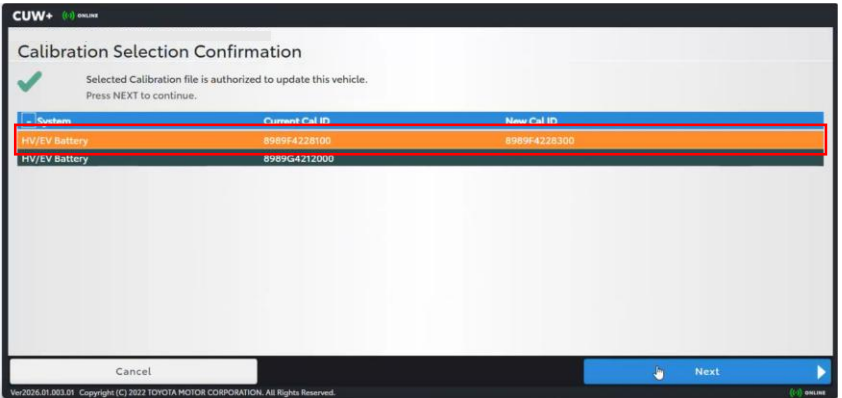
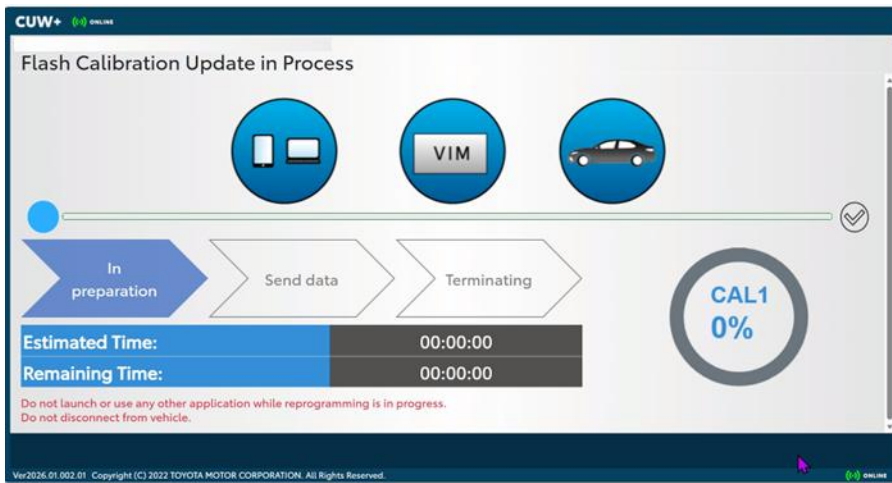
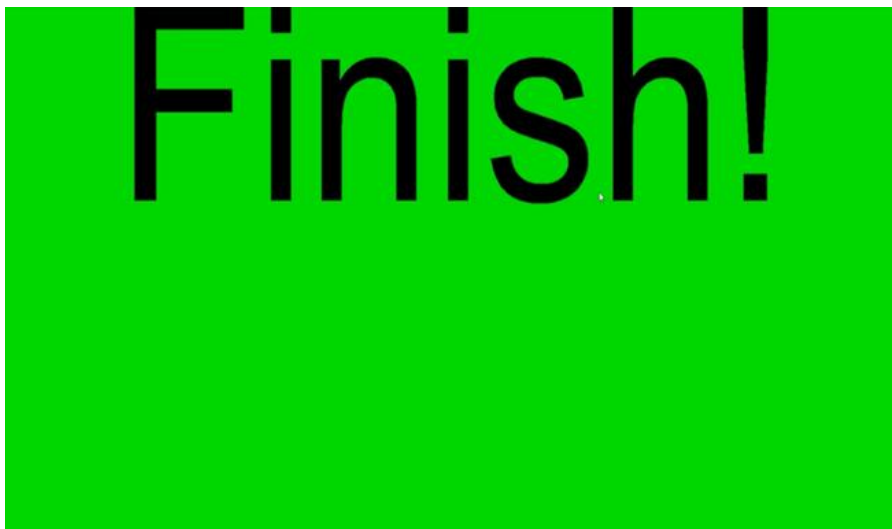
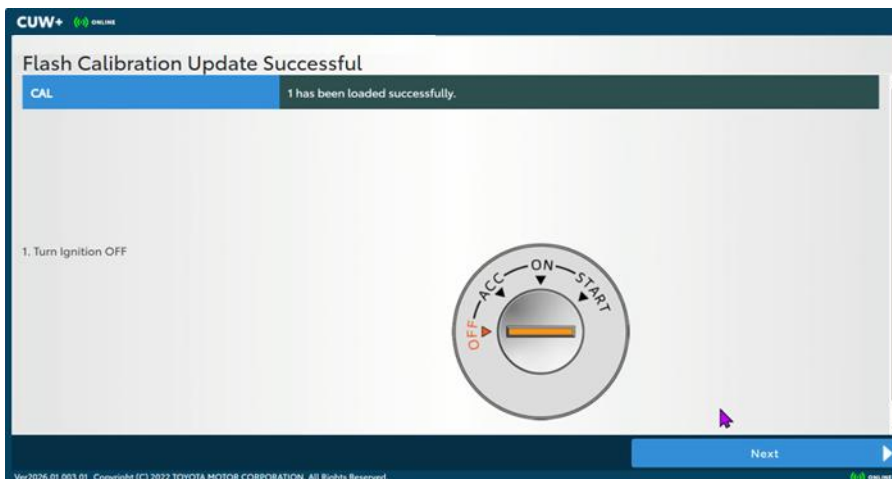
2. REFLASH THE HV/EV BATTERY SYSTEM USING FILE Calibration ID.

- a) Click “Yes” on the “Health Check Results” screen or follow the links on the table above the begin to reflash process.

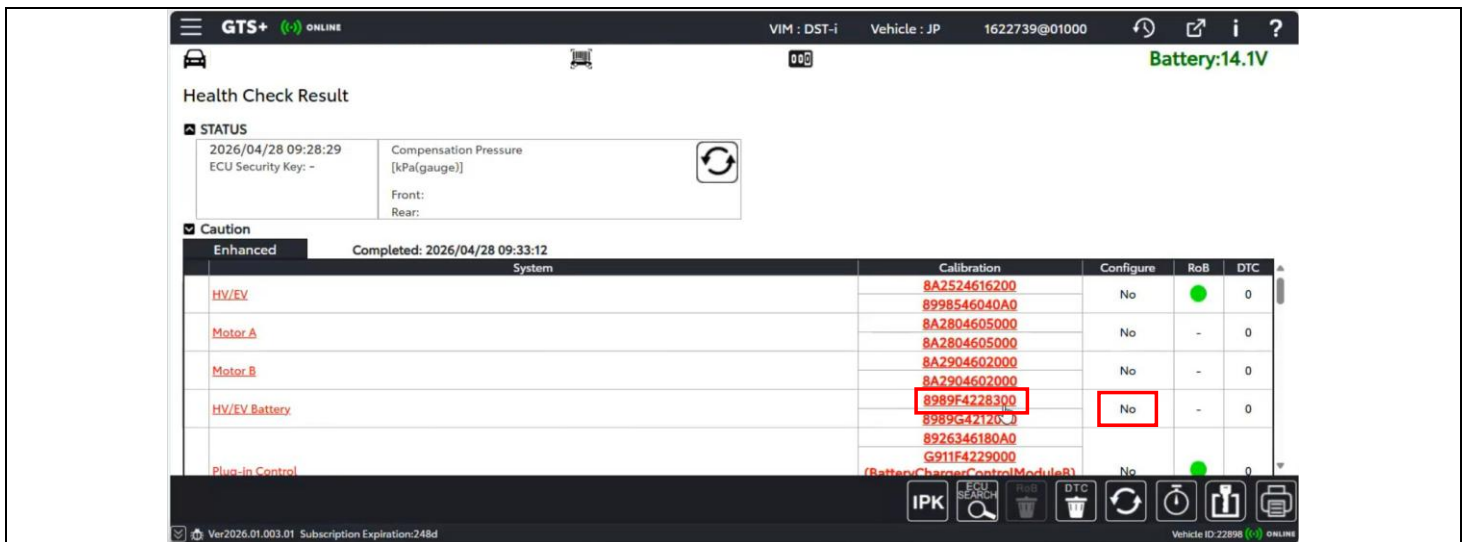
### 3. CONFIRM CID UPDATE

- On the Stored Data tab, confirm the following for the HV/EV Battery System:
  - The Calibration ID has the “New Calibration ID” number.
  - The Update column says “No”.
