# 2025–2026 Chrysler Pacifica & Voyager Side Entry — Front Seat Harness Wall Connector Spring Inspection and Repair

Version B

**Concern:** Affected vehicles were manufactured with an incorrect spring inside the wall connector for the front seat harness, on both driver and passenger sides. This procedure provides the inspection criteria to confirm whether repair is required, and the replacement procedure if it is.

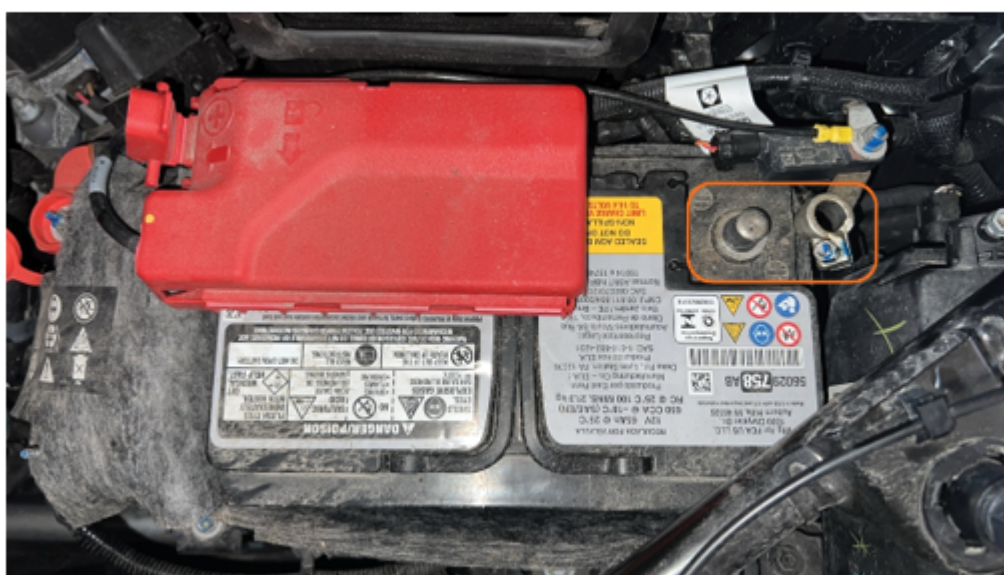
a. Using a 10mm wrench or socket and ratchet, disconnect the vehicle battery per the OE service manual.

**WARNING:** The battery must be disconnected before removing seats or working on the wall connector.
