**HYUNDAI**  
**Technical Service Bulletin**

NUMBER  
**26-01-058H**

MODEL(S)  
**IONIQ 5 (NE EV)**

**SUBJECT:** BATTERY SYSTEM ASSEMBLY (BSA) REPLACEMENT  
(RECALL 305)

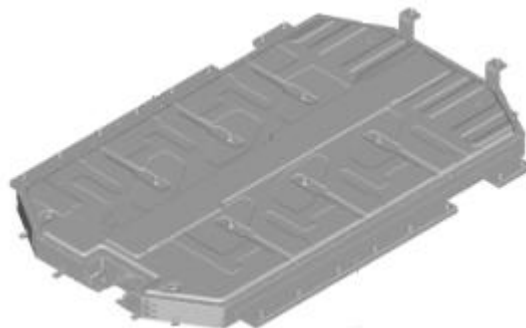
**Description:** Certain IONIQ 5 (NE EV) vehicles may contain suspect high-voltage ("HV") battery modules manufactured by the supplier during a specific production period. These HV batteries might contain individual battery cells produced with misaligned electrodes. Under certain circumstances, electrode misalignment within a battery cell can result in an internal short circuit. An electrical short circuit within the battery cell(s) increases the risk of a fire while parked, charging or driving. This bulletin provides the service procedure to replace the Battery System Assembly (BSA).
