You will find enclosed a copy of Service Bulletin S07LN regarding the routing of the alternator power cable on your Blue Bird All American model bus(es).

# Alternator Cable Routing

MODELS AFFECTED: 2007 A3FE All American

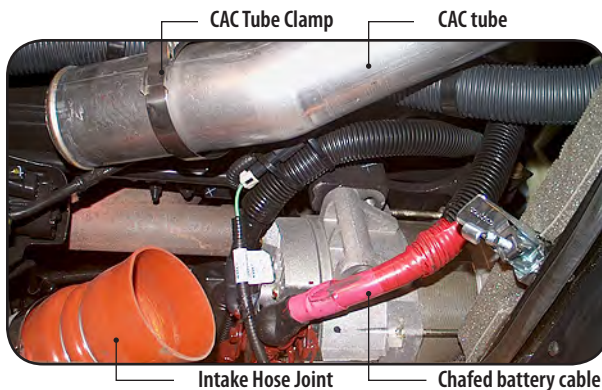
2.1 Loosen the clamp which connects the CAC tube to the orange flexible intake hose. Push the clamp forward along the CAC tube. Pull the end of the CAC tube out of the hose, and set the open end of the CAC tube on top of the engine valve cover.
