Jumper Cable Routing

MODELS AFFECTED: 2008-2009 BBCV Visions w/ 2007 Cat Engines

S08MY SERVICE BULLETIN

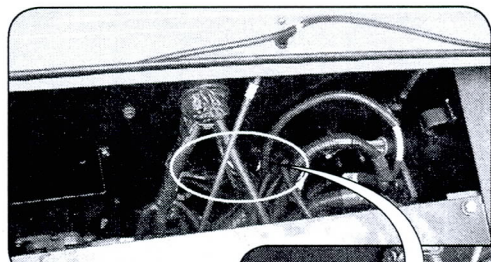
Firewall (Engine Side)

- 1** Park vehicle on a level surface, apply parking brake, turn engine off, remove ignition key and chock wheels.
- 2** Disconnect batteries.
- 3** Open engine hood and locate the Chassis Power and Electrical Power Studs.

- 4** The lower end of Cable Assembly 0111510 should be attached to the Chassis Power Stud. If the cable is in this location, no further action required. If the lower cable end is attached to the Electrical Power Stud, remove it and attach it to the Chassis Power Stud.
- 5** Tighten both stud nuts to 11- 15 ft-lbs and apply a corrosion protection such as red glyptal.
