# Voluntary Recall Campaign

**Subject: Inspection and Replacement of Turbocharger - J08E**

**Bulletin: RCB-003-11**

**Affected Models: Certain 2008 – 2010 MY ND8J, NE8J, NJ8J, NV8J models equipped with a J08E engine**

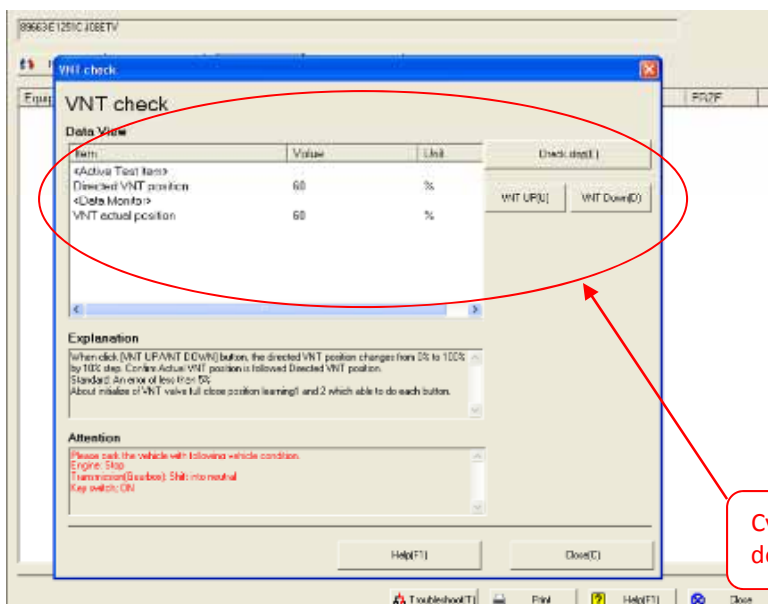
- (i) Select the "VNT Check" in the "Check Functions" menu using the DX.
- (ii) Select "Check Start(E)" and then toggle the VNT turbocharger up and down from 0 to 100 using the "VNT UP(U)" and "VNT DOWN(D)" buttons on the DX.
- (iii) Confirm the "Directed VNT Position" follows the "VNT Actual Position".

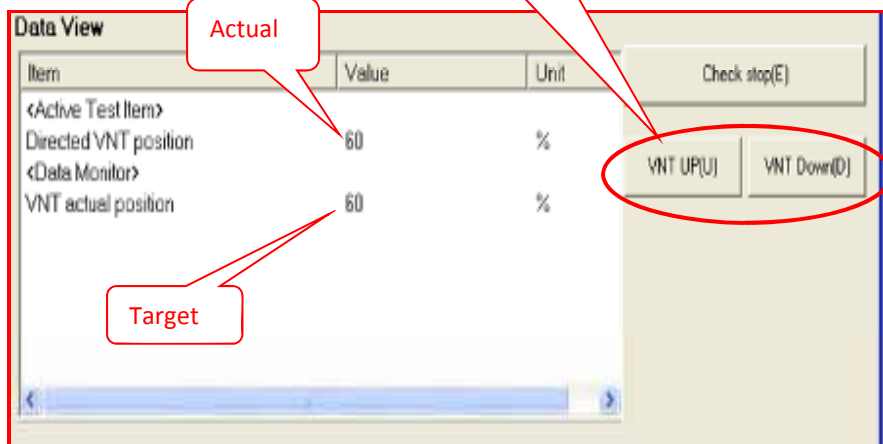
Cycle up to 100 and down to 0 – Ten cycles

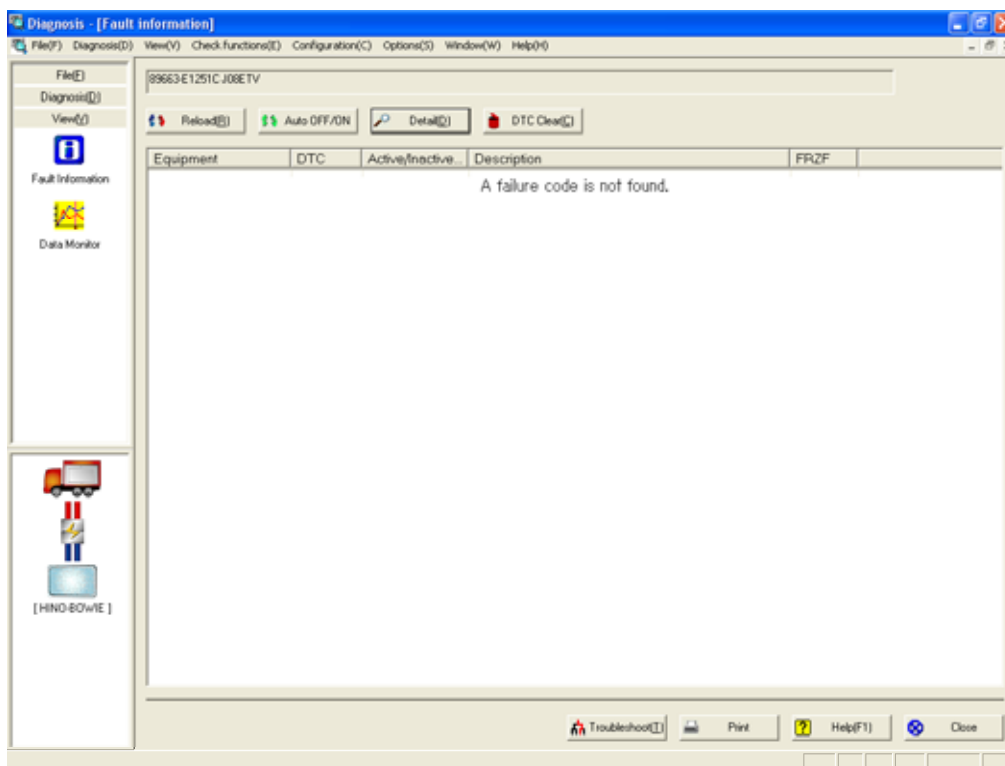
9. Recheck for DTC's by selecting the "Reload(R)" button.

- (9a) If either DTC's P0045 / U1123 were reset from STEP 9 or the "VNT Actual Position" fails to follow the "Directed VNT Position", please continue to **STEP 10**.

- (9b) If no DTC's set were reset in STEP 9 and the "VNT Actual Position" follows the "Directed VNT Position" during the VNT check, please proceed to **STEP 12**.

10. With DTC's P0045 / U1123 set or the "VNT Actual Position" fails to follow the "Directed VNT Position", confirm no related pin, connector or harness concerns are present. Reference the on-line Engine Workshop Manual under "*Fuel Control*" and then "*VNT Turbocharger Controller*" for specific pin and connector locations along with more detailed diagnostic procedures.
