# Service Bulletin

Bulletin No.: PI0813

**Subject:** Driver Airbag Light Flashing and/or Passenger Airbag ON Indicator Does Not Illuminate with Passenger Present After SDM Reprogramming

**Models:** 2012 Chevrolet Camaro  
2013 Chevrolet Malibu

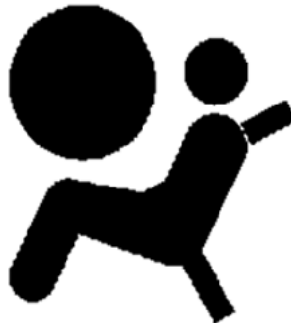
## Passenger Airbag Indicator (Malibu)

Some customers may comment that driver airbag light is flashing in the cluster and/or the passenger airbag ON indicator does not illuminate when a passenger is present.

This condition occurs when the SDM (Inflatable Restraint Sensing and Diagnostic Module) setup has not been completed after reprogramming. If the Setup is not completed, the airbag indicator located in the cluster will flash continuously and the "Passenger Airbag ON" indicator will not transition to ON when a person is in the passenger seat.

During the SDM re-programming process there are two steps required to be performed using the SPS (Service Programming System). The two steps on the supported controller screen are:

- SDM Inflatable Restraint Sensing and Diagnostic Module – Programming
- SDM Inflatable Restraint Sensing and Diagnostic Module – Setup

**Important:** DO NOT replace the Passenger Presence Sensor or the SDM (airbag module).
