Service Bulletin

PRELIMINARY INFORMATION

Subject: Accessory Soft Tonneau Cover Loose

Models: 2004-2012 Chevrolet Colorado
2007-2013 Chevrolet Silverado
2004-2012 GMC Canyon
2007-2013 GMC Sierra

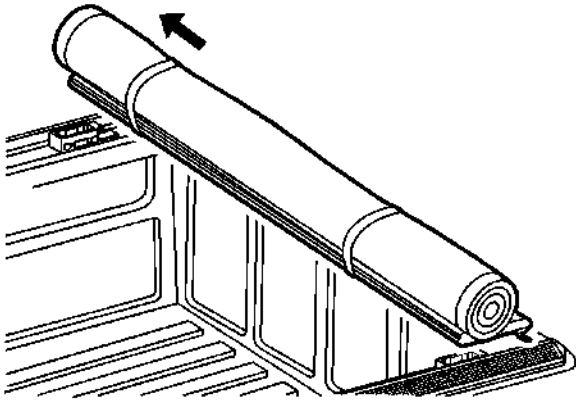
Important: When a pivot block rivet is found to be loose on either end of a tonneau side rail, always replace the rivets on BOTH of that rail's pivot blocks. Verify the condition and install a new rivet to each pivot block on the affected side rail(s). Follow the steps below, starting with the front pivot block location.

1. Remove the tonneau cover and the side rail(s) on the affected side. Refer to Soft Tonneau Cover Package Installation in SI.
