Service Bulletin

Subject: Engine Oil Consumption on Aluminum Block/Iron Block Engines with Active Fuel Management (AFM) (Install AFM Oil Deflector and Clean Carbon from Cylinder and/or Install Updated Valve Cover)

Models: 2007-2011 Cadillac Escalade Models
2007-2011 Chevrolet Avalanche, Silverado 1500, Suburban, Tahoe
2010-2011 Chevrolet Camaro
2007-2011 GMC Sierra 1500, Sierra Denali, Yukon Models
2008-2009 Pontiac G8 GT
Built Prior to February 1, 2011 (Updated Valve Cover) and October 2010 (AFM Shield)
Equipped with Any of the Following Engines:
– Aluminum Block V8 Engine with Active Fuel Management (AFM) (RPOs L94, LZ1, L99, LC9, LH6, L76, LFA, L92)
– Iron Block V8 Engine with Active Fuel Management (AFM) (RPOs LMG, LY5)
– Hybrid Engine (RPO LFA – Only Applies to Hybrid Models Built July 7, 2009 - February 1, 2011 – Prior Builds Not Cast For AFM Valve)

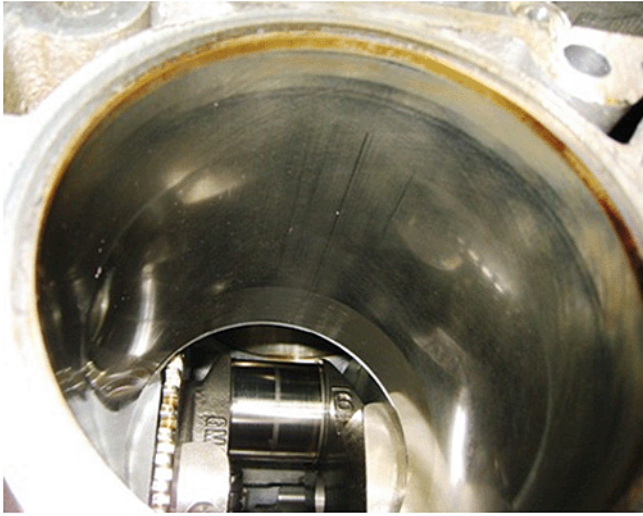
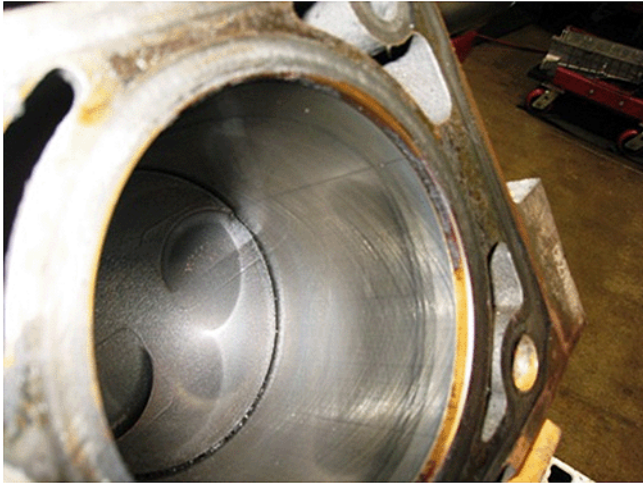
Important: Some minor scratches may be noticed on the cylinder walls during piston and ring replacement. If the scratch cannot be felt when running your finger nail over it, the scratch is considered normal wear and the block or engine should not be replaced.

Note: It is not necessary to hone or deglaze the cylinder walls. Honing may induce unnecessary cylinder wall and / or piston ring damage if it is done incorrect and/or not cleaned thoroughly. Cylinder walls should be cleaned thoroughly with brake cleaner before installation of the new pistons and rings. Numerous engines replaced for oil consumption have been inspected. The cross hatch has been consistently good and is in specification. As a result, it should not be necessary to measure the cylinders if they pass the visual inspection.

Note: After the piston/ring replacement, it will take 2000-3000 miles for the new rings to seat. Adequate break time is necessary prior to rechecking the oil consumption level.
