# Technical Service Bulletin

## 94 Headlight Warning On in Cluster (Xenon Plus With or Without Adaptive Light)

94 12 99 2029194/2 November 30, 2012. Supersedes Technical Service Bulletin Group 94 number 12-74 dated April 23, 2012 for reasons listed below.

Model(s)	Year	VIN Range	Vehicle-Specific Equipment
Q7	2010-2014	All	Premium Plus and Prestige

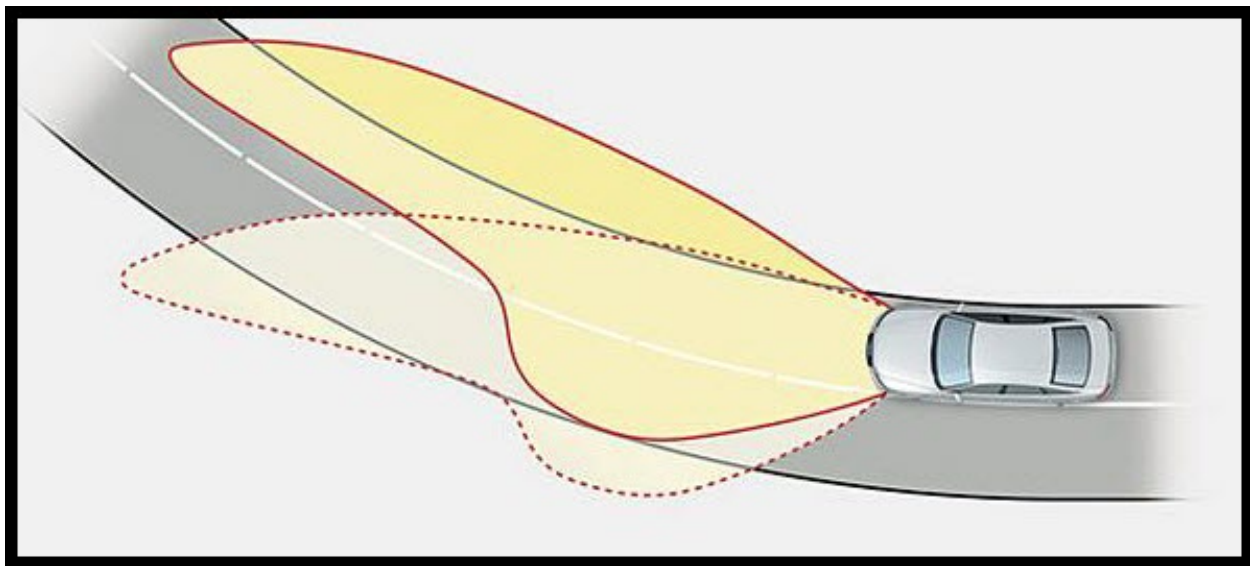
*Figure 5. Audi Adaptive Lighting illustration showing the maximum 15° curve of the light beam at speeds greater than 6mph.*

5. If no loose connector is found and the issue still persists then the issue, is outside the scope of this TSB and the remaining steps can be skipped. A swap of headlamp components between left and right is the next logical step to narrow down the failed part of the headlamp.
6. Reassemble the headlamp and install it back in to the vehicle.
7. Clear the DTC(s) and retest with low beams activated, high beams activated, and all turn signals activated.
8. If no DTC' s return, test the headlamp functionality in the garage or parking lot but also perform a short road test and repeat the actuation of all headlamps functions while at a speed. To test the adaptive light function (if equipped) the vehicle will need to be driven at speed around a corner at a speed greater than 6mph.
