# SERVICE NEWS

**Bulletin:** SNV 11-09a  
**Date:** Nov 14, 2012  
**Valid to:** Pending  
**Replaces:** N/A  
**Priority:** **HIGH**

**Subject:** EGR Delta P ports

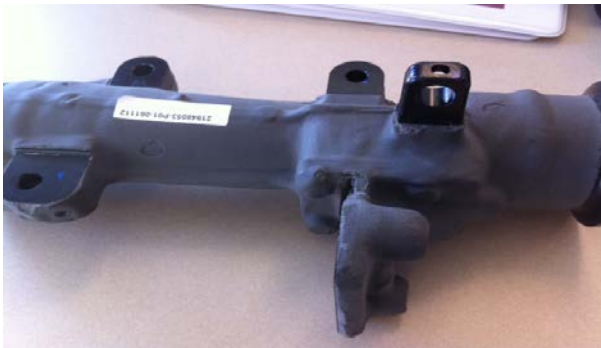
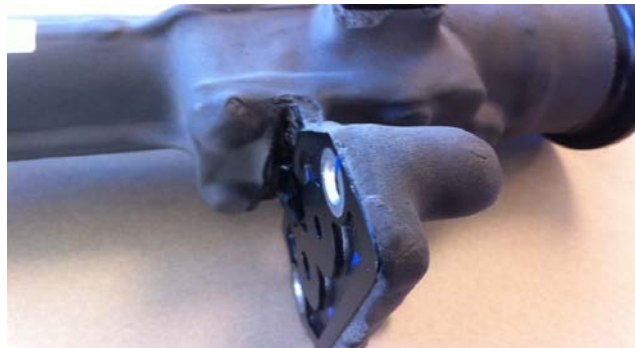
**Volvo Trucks has released an updated Venturi tube for the 11, 13 and 16 liter engines that have been coated with a special coating, if you have the updated Venturi DO NOT remove the coating this is a non-serviceable part. If during your checks you need to confirm there are no restrictions in the Venturi ports use shop air to verify ports are free from restriction. If ports are found to be clogged then replacement of the coated Venturi is required. If your truck is equipped with the old style non-coated Venturi, proceed with cleaning as per directions.**

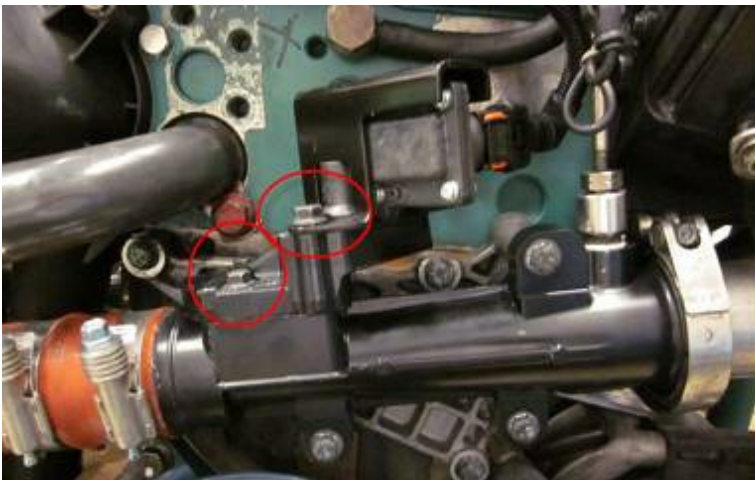
## 16L

When removing the dP sensor and the mounting adaptor, the adaptor mounting bolts for the 13L and 16L engines have thread lock applied by the component manufacturer. This may contribute to bolt breakage. A gentle application of heat to the side of the Venturi from a propane torch will melt the thread lock and allow the bolt to be removed easily. Removal of the Venturi may be needed to avoid damage to wiring when the heat is applied.

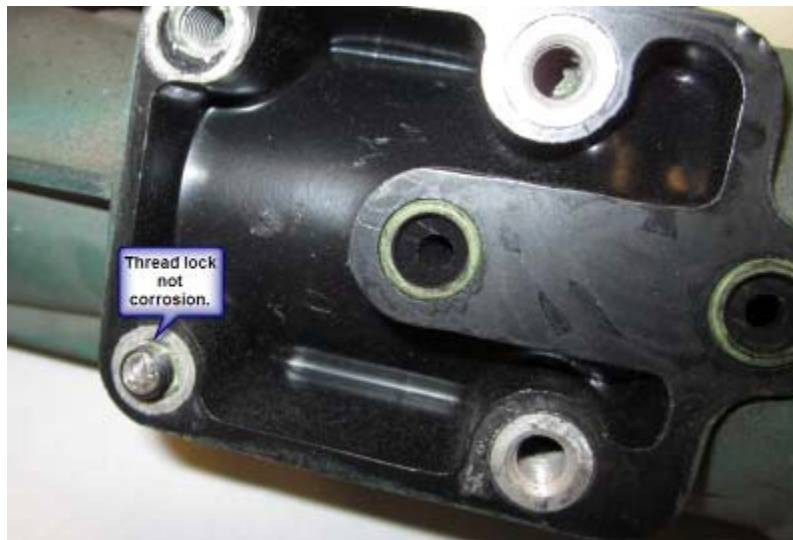
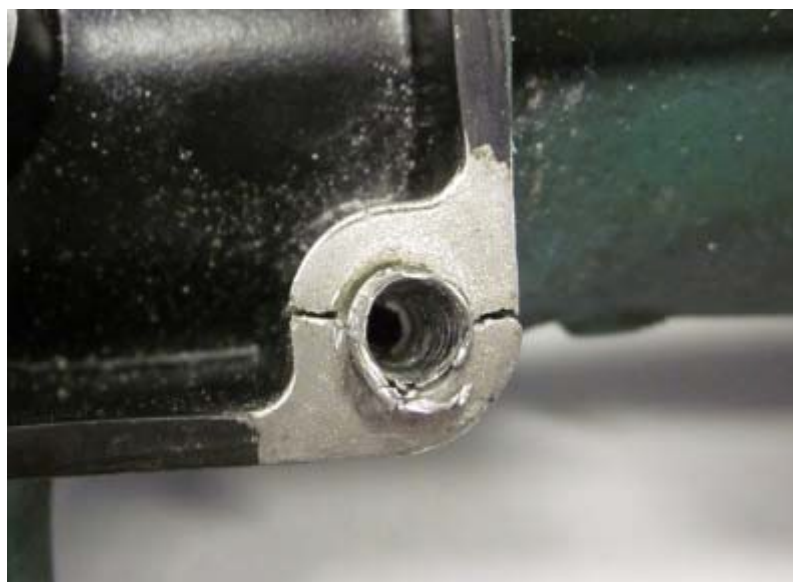
The components are aluminum and are coated to prevent corrosion. Care must be taken not to damage this coating when cleaning the blockage from the ports and tubes.

The mounting adaptor in the top picture is not to be reused. The mounting adaptor in the lower picture is borderline. If the coating comes off during proper cleaning then it must be replaced. The corrosive nature of EGR gases will attack the material now and may eventually cause a leak under the seals.

damaged the component must be replaced. Mounting adaptor bolts for the 13L and 16L engines should be reassembled using Loctite 241 or 271 and torqued to proper specs 11L engines do not get Loctite applied.
