Service Bulletin

PRELIMINARY INFORMATION

Subject: Navigation Radio Will Not Display Map Data, Message Display is On

Models: 2011 Cadillac Escalade Models
Equipped with Navigation Radio (RPO GMQ)

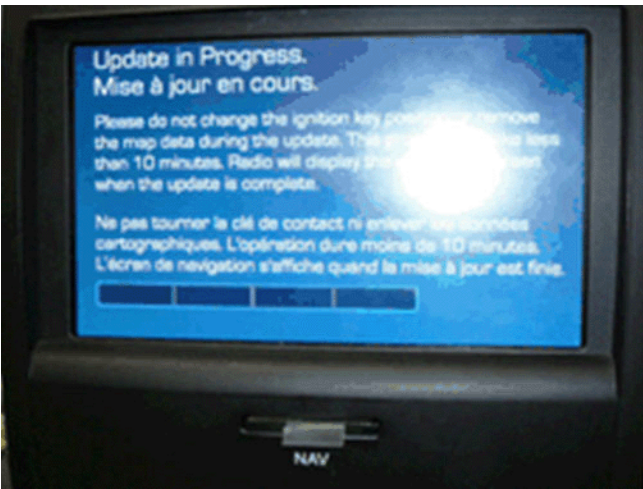
4. Power the radio on. The screen above will appear:

2. With radio powered off, eject the customers Nav compact flash card from the slot in the radio.
3. Insert the GM compact flash card included with the 2012 MY, (version 2012), or newer, GM Service Kit.
