# UPDATE Technical Bulletin

October 09, 2012 2011164

## UPDATE – 96C7 Micro Switch for Oil Level (NVLW)

Model(s)	Year	Engine Code	Trans. Code	From	To
Passat	2012 - 2013	CDVB	All	1VW_M_A3_C_000165	1VW_M_A3_D_015433

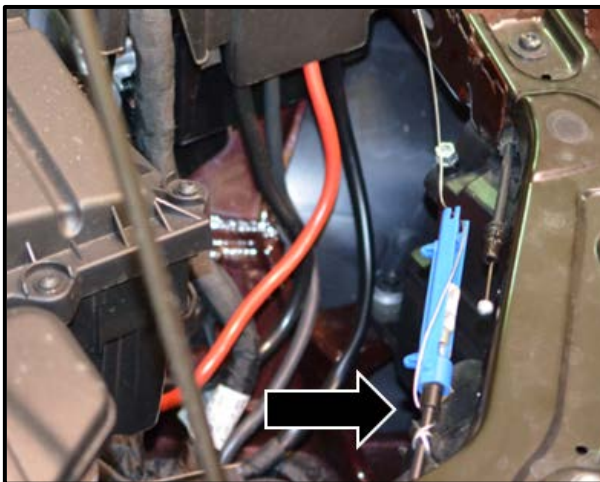
⇐ Mark the position of the latch, as shown, for reinstallation.

It may be helpful to attach a piece of mechanic's wire to the cable coupling before pulling the hood latch out.
