Technical Service Bulletin

| SUBJECT: HVAC MODE DOOR POP/CLICK NOISE | | No: TSB-12-55-006 | |
| | | MODEL: 2013 Outlander Sport/ RVR | |

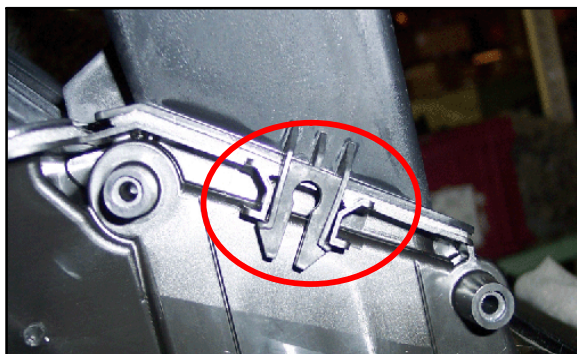
FOR REFERENCE

Correct clip position shown with HVAC assembly removed from the vehicle and mode door pivot cam removed.

1. If a noise is confirmed, place the mode selection dial to the “face” position.
2. Locate the vent duct clip next to the mode door pivot cam. Examine the position of the vent duct clip.
 - a. If the clip is properly seated, further diagnosis is required. Follow procedures in the service manual to diagnose and repair the condition.
 - b. If the clip is not properly seated, press on the clip using a flat blade screwdriver to seat it. You may also have to press downward.
3. Confirm the noise is no longer present when changing the HVAC mode.
4. Reassembly is the reverse of disassembly. Refer to Group 52A – Interior, in the 2013 Outlander Sport Service Manual for details.
