SERVICE CAMPAIGN BULLETIN

CAMPAIGN REF: 01G

TITLE : Vehicle software update to platform 9.0. **UPDATED 22/06/2012**

DOCUMENT # : 11 M 039

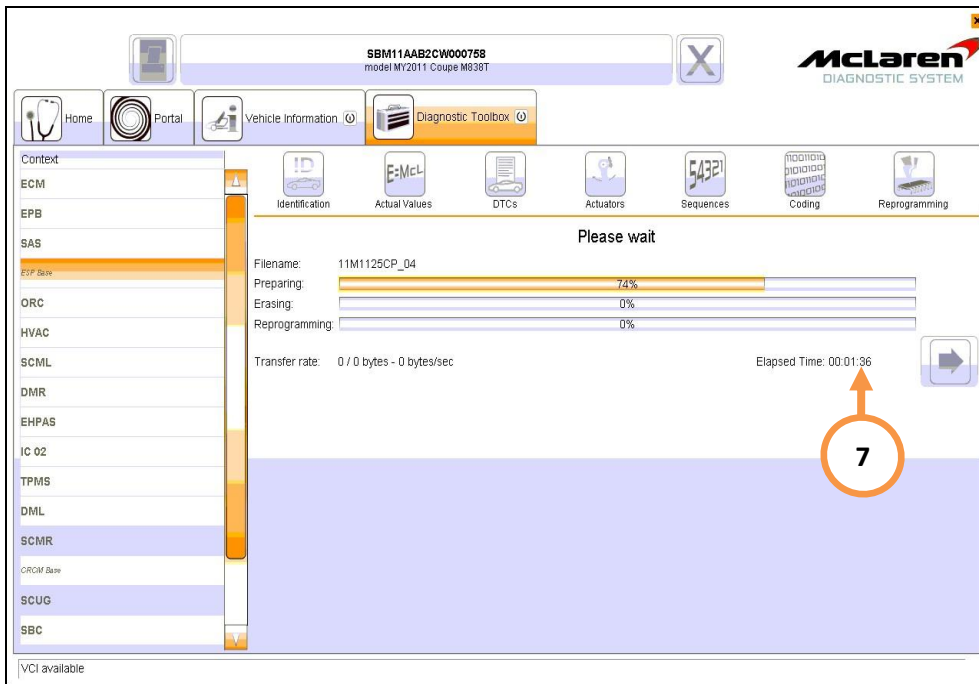
28. After the preparation phase of the download the system may inform the operator that the Erase of the ECU Flash Memory Failed". In this circumstance the ESP control unit will require a power cycle (6).

29. Proceed and reflash the ESP module, when the Elapsed Time is between 1.20 to 1.28 seconds (7), disconnect the ESP connector (9) wait for 5 seconds and then reconnect it. The “Preconditions failed” will now be displayed. Proceed to step 31.

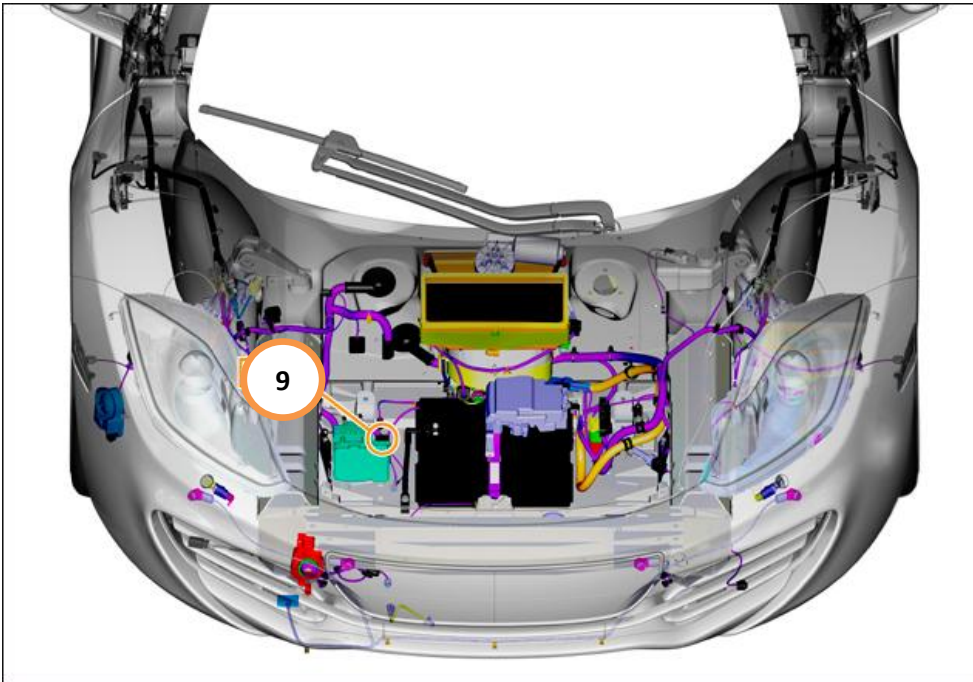
30. After the preparation phase of the download the system may inform the operator that the “Preconditions failed”. In this circumstance the ESP control unit will require a power cycle (8).

31. Disconnect the ESP connector (9) and wait for 5 seconds before reconnecting.
