ITB12-067

October 25, 2012

## **VOLUNTARY SERVICE CAMPAIGN 2013 JX35 ECM REPROGRAM FOR AIR FUEL SENSOR**

**CAMPAIGN ID #:** PC185**APPLIED VEHICLES:** 2013 JX35 (L50)**Check Service Comm to confirm campaign eligibility**

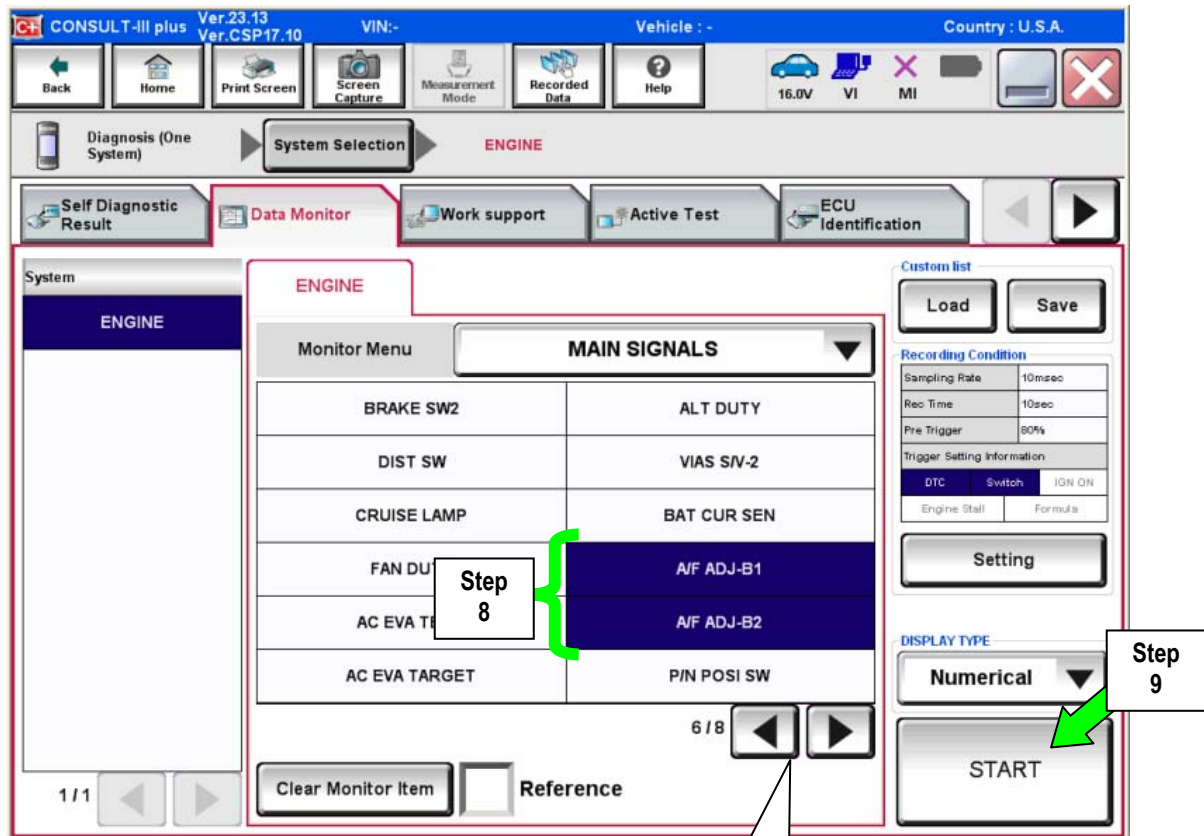
Figure A4

10. Check values for **A/F ADJ-B1** and **A/F ADJ-B2**.

- Value for each sensor should be between – **0.300** and **0.300**.
- If a sensor (one or both) is out of the above specified range, make a note of it.
- Sensor(s) that are out of the specified value will be replaced later in this procedure.

**DO NOT** replace A/F sensors at this time.

If needed, replace A/F sensors after ECM reprogramming.

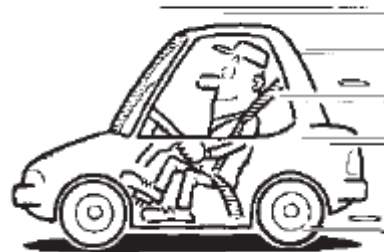
Figure 1

1. Take the vehicle for a 10 minute drive in order to meet the following Idle Air Volume Learn (IAVL) conditions:

- Engine coolant temperature: 70 -100°C (158 - 212°F)
- Battery voltage: More than 12.9V (At idle)
- Transmission: Warmed up

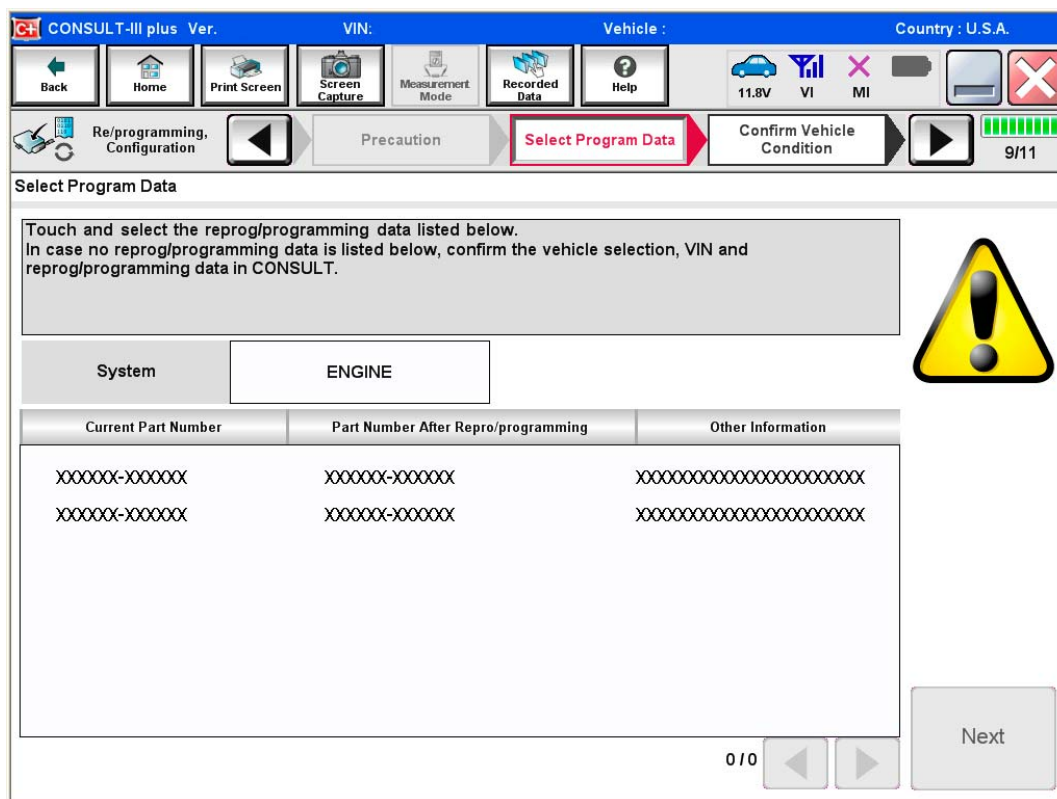
- In some cases, more than one new P/N for reprogramming is available.
  - In this case, the screen in Figure 5 displays.
  - Select and use the reprogramming option that **does not** have the message “Caution! Use ONLY with ITBXX-XXX”.
- If you get this screen and it is blank (no reprogramming listed), it means there is no reprogramming available for this vehicle.

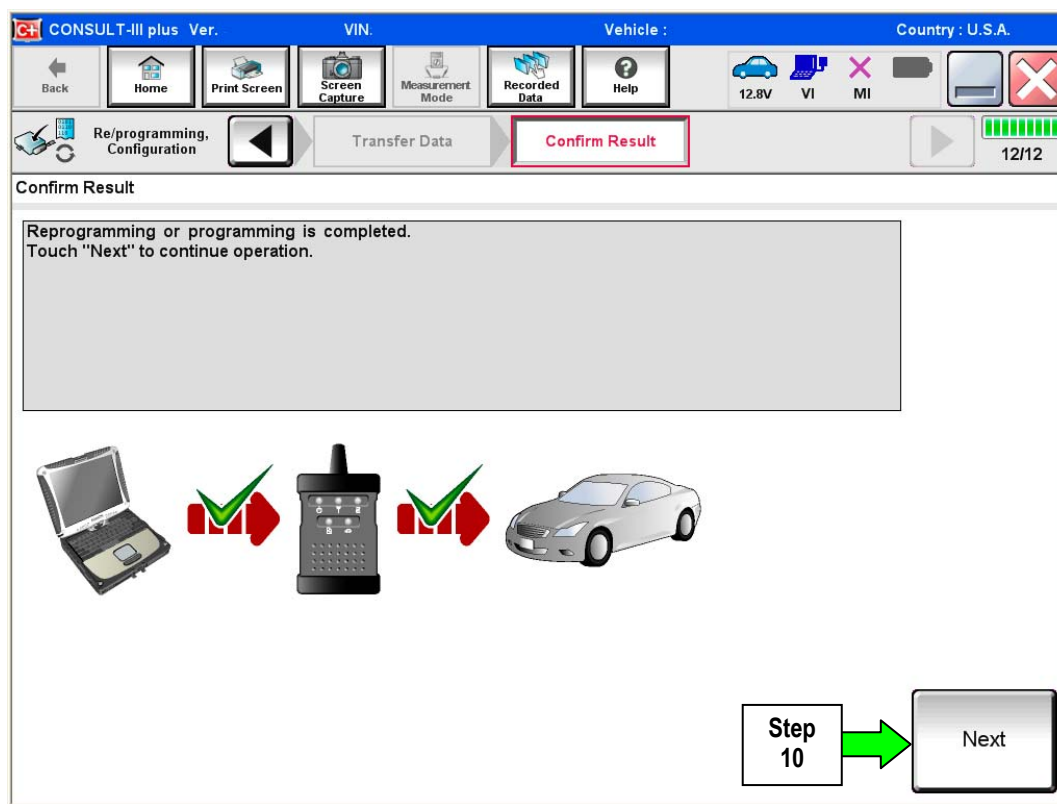
8. When the screen in Figure 6 displays, reprogramming is complete.

**NOTE:** If the screen in Figure 6 does not display (reprogramming does not complete), refer to the information on the next page.

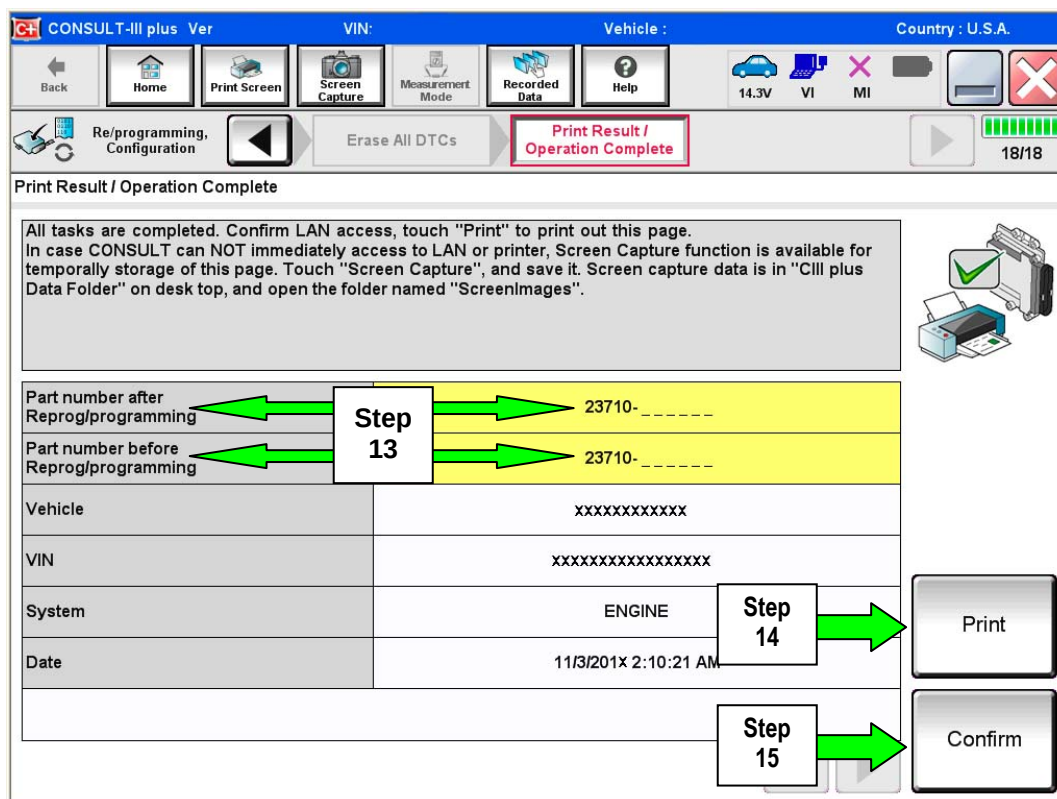
12. When the entire reprogramming process is complete, the screen in Figure 9 will display.
13. Verify the before and after part numbers are different.
14. Print a copy of this screen (Figure 9) and attach it to the repair order for warranty documentation.
15. Select **Confirm**.
