SERVICE BULLETIN

APPLICABILITY: 2012 and 2013MY Impreza and XV Crosstrek™ models with FB Engine

NUMBER: 11-124-12R

SUBJECT: Difficulty Starting, Rough Idle, Cam Position or Misfire DTCs P0301, P0302, P0303 or P0304 DTCs P0340, P0341, P0345 or P0346

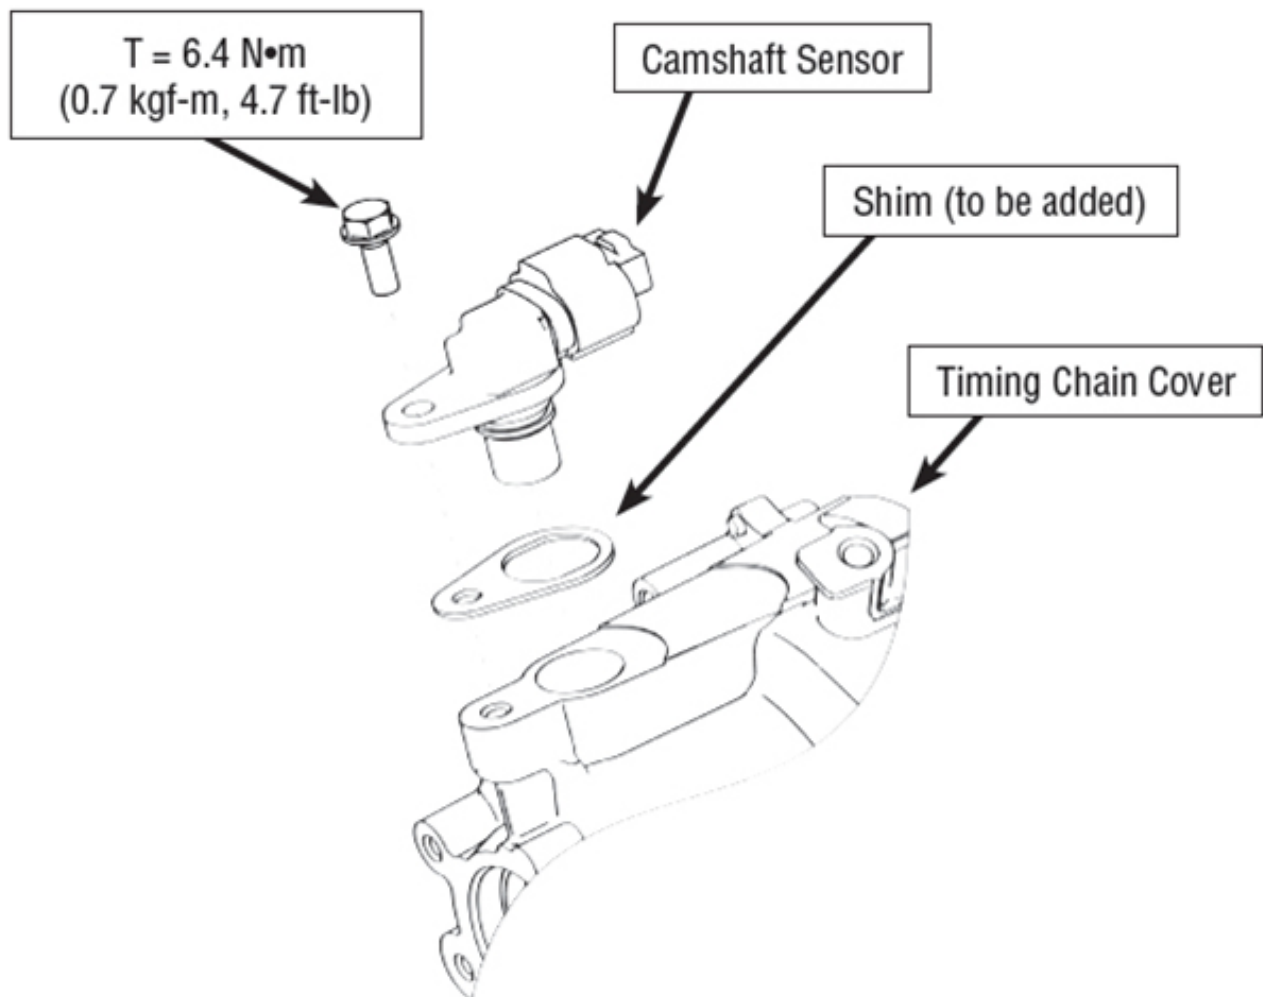
Component Overview

If an abnormal pattern is verified similar to those shown in the illustration above, measure the clearance between the end of the camshaft position sensor and the sensor plate using the following procedure. If the oscilloscope pattern is normal, refer to the applicable Service Manual for additional troubleshooting and diagnostic procedures.

The specified clearance is 1.3 +/- .05mm (1.25 to 1.35mm or .049" to .053").

- Record radio station presets (and navigation system favorites if applicable).
- Disconnect the negative battery cable.
- Remove the camshaft position sensor from the timing chain cover using the procedure in the applicable Service Manual.
